Loss of control — Embraer S.A. EMB-120ER Brasilia, VH-ANB

Darwin Airport, Northern Territory | 22 March 2010

ATSB Transport Safety Report
Aviation Occurrence Investigation
AO-2010-019
Final

Report No. AO-2010-019

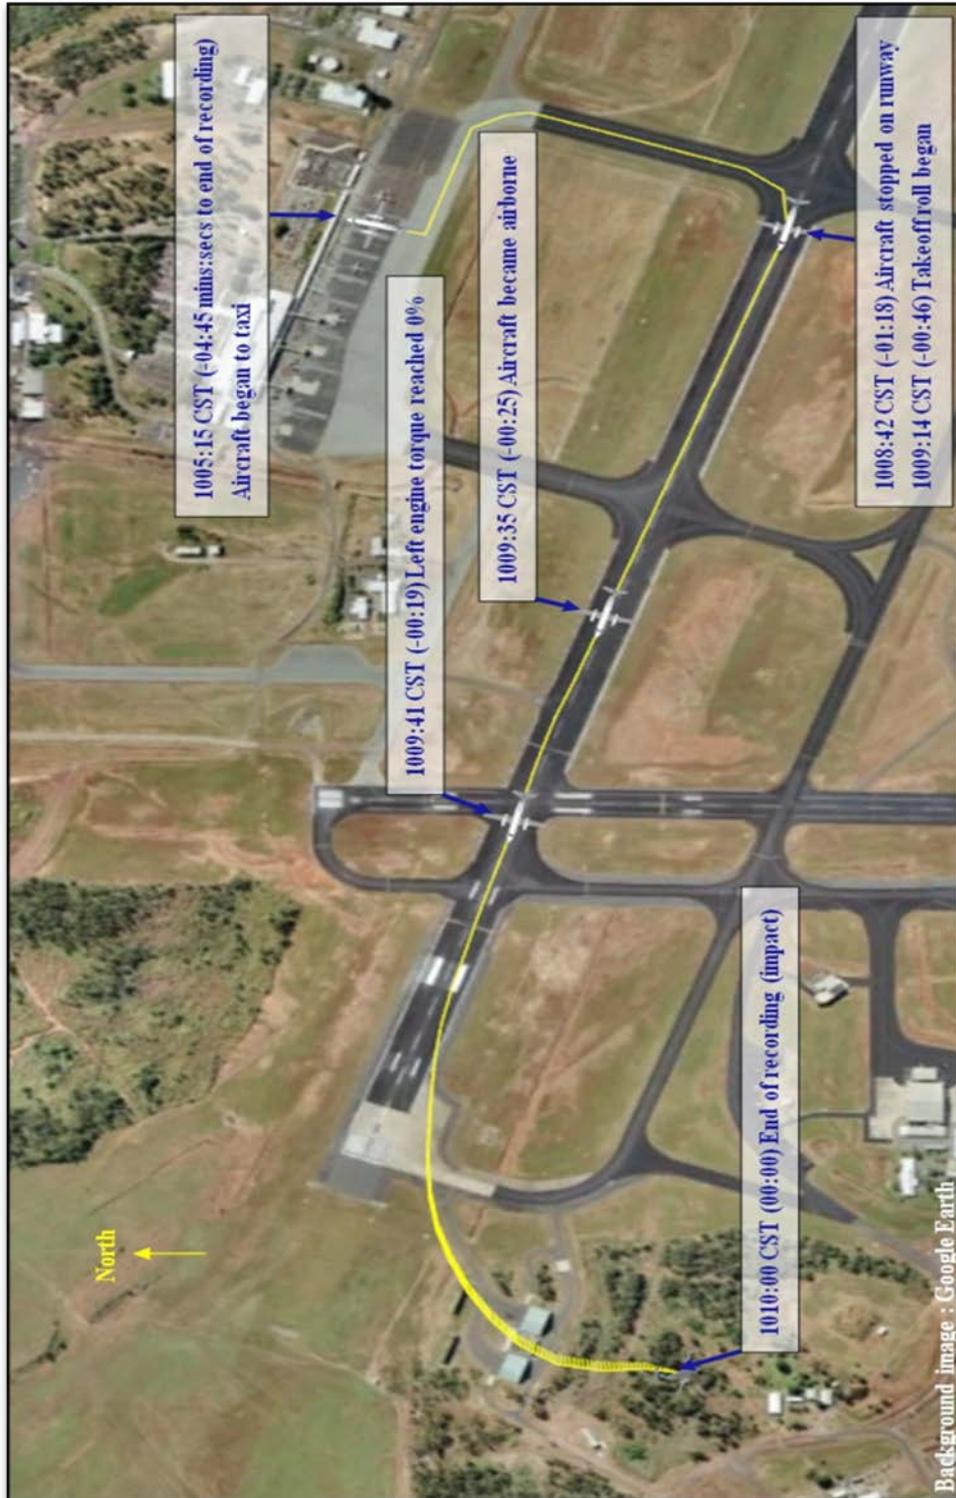
Figure 1: Aircraft's flightpath as reconstructed from the recorded data

At 1005:15, the pilots taxied for takeoff from the intersection of taxiway E2 with runway 29. The PIC, who occupied the copilot's (right) seat, advised the aerodrome controller (ADC) that the departure would incorporate asymmetric flight (a simulated engine failure on takeoff) and was approved by the ADC to perform that manoeuvre.

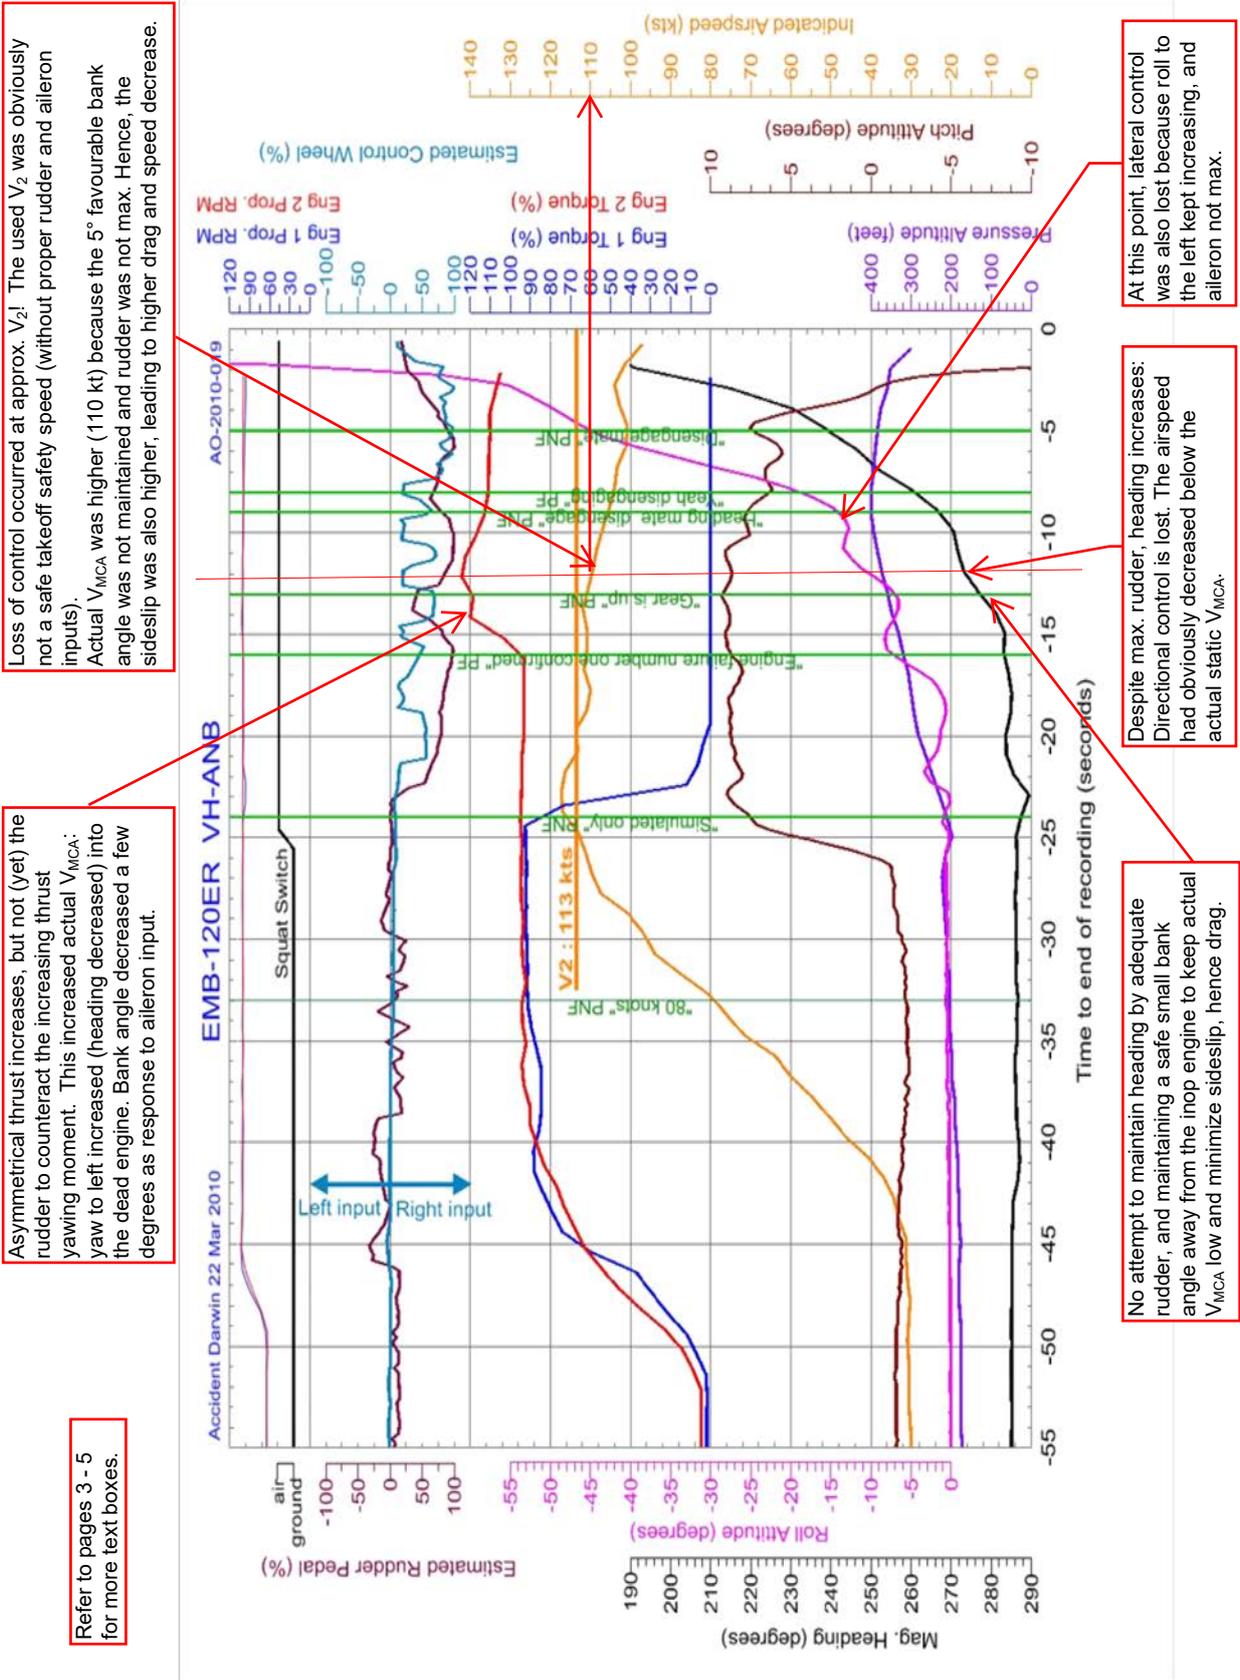
Figure 2: Flight data parameters and relevant extracts from cockpit voice recorder (superimposed in light green)

Data from the cockpit voice recorder (CVR) and the flight data recorder (FDR) were used to establish a sequence of events (Table: 1). A graphical representation of the FDR data is at Figure 2.

Does the stall warning system include the bank angle data? Believe not. So 103 kt is not the stall speed V_s of the aircraft. V_s must be below 100 kt (page 3: $V_2/1.13 = 113/1.13$), most probably below V_{MCA} (97 kt). Review stall warning system for sideslip influences.

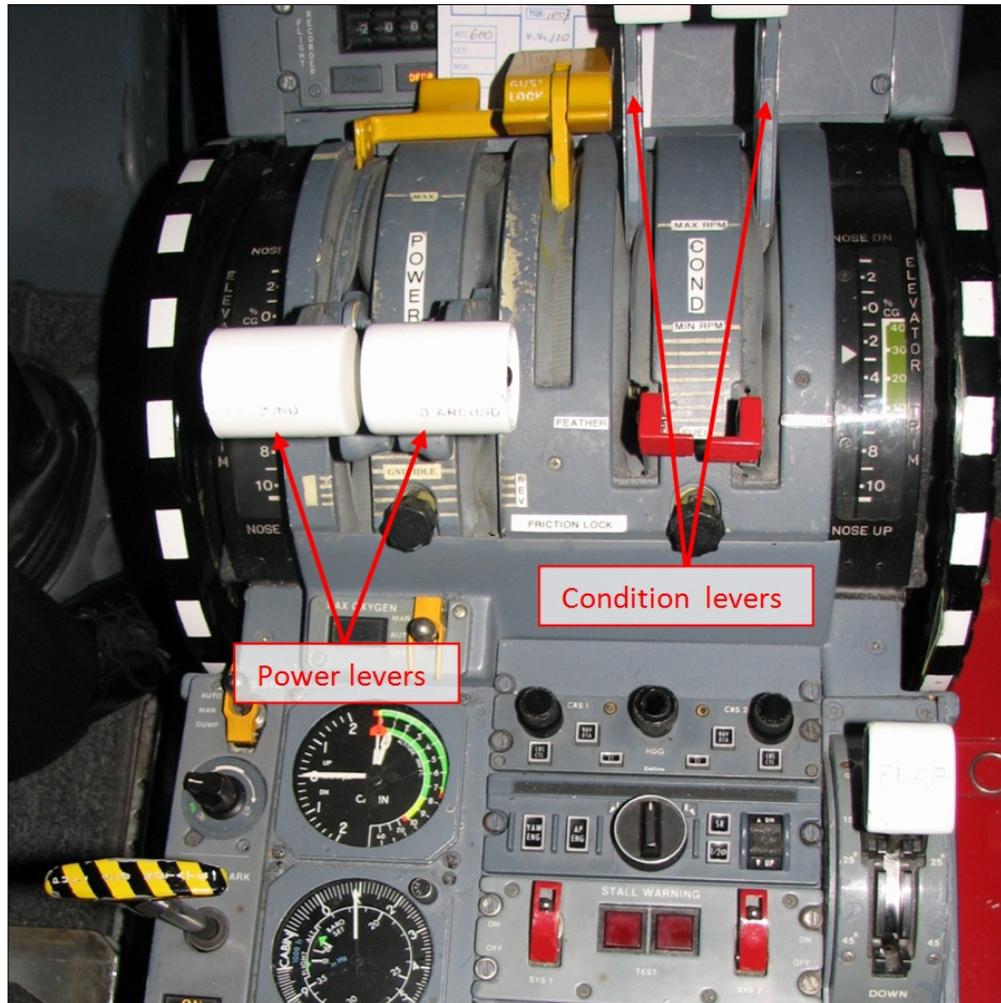
Figure 4: Power quadrant with the power levers (left) at flight idle and the condition levers (right) at maximum RPM

Two power levers, one for each engine, were located on the left of the quadrant and controlled the fuel fed to the engines through a hydromechanical unit (HMU) in conjunction with each engine's electronic engine control (EEC). A warning lamp on the centrally-mounted multiple alarm panel (MAP) illuminated when a failure was detected in the respective EEC. Both EEC warning lamps were recovered from the wreckage and their globes examined. The condition of the filaments was consistent with the warning lamps not being illuminated at impact.

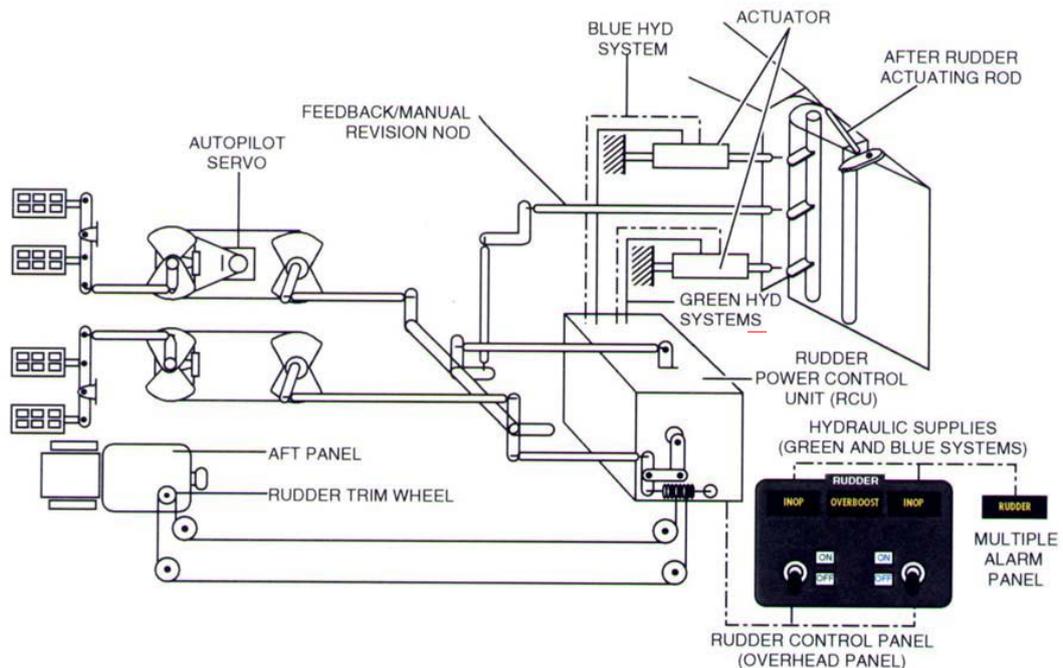
Figure 6: Rudder control system

One on each engine?

The RPCU was operated by two independent hydraulic systems that provided segregation and redundancy. Each system incorporated its own rudder actuator that deflected the main rudder in the commanded direction. At speeds below 120 kts, both hydraulic systems operated to maintain adequate rudder authority when, at such slower airspeeds, greater rudder deflections were required. In the event of a total hydraulic failure, the rudder system was mechanically actuated by the rudder pedals without hydraulic assistance. The control force required to move the rudder was considerably greater without hydraulic assistance.

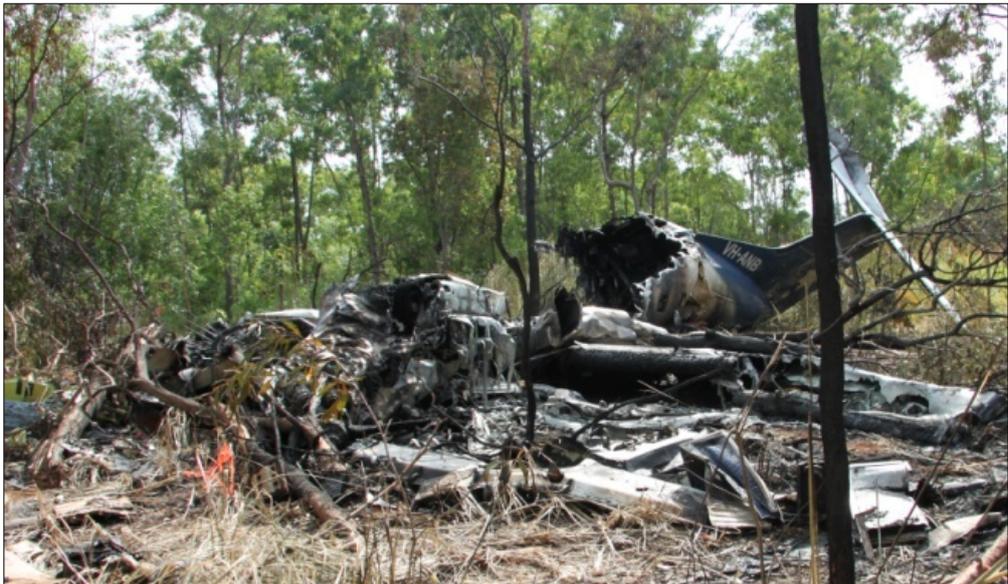
The fuselage forward of the cargo door, the inboard sections of the right wing, and most of the left wing including the engines and propellers were destroyed by impact forces and a post-impact, fuel-fed fire (Figure 12).

Figure 12: Aircraft wreckage, showing the extensive fire damage

The damaged right wing was separated from the main aircraft wreckage and was located on top of the left wing. The leading edge of the right wing had been liberated from the structure following ground impact and was extensively fire damaged. The right aileron and aileron trim tab were fire damaged and the trim position was unable to be determined.

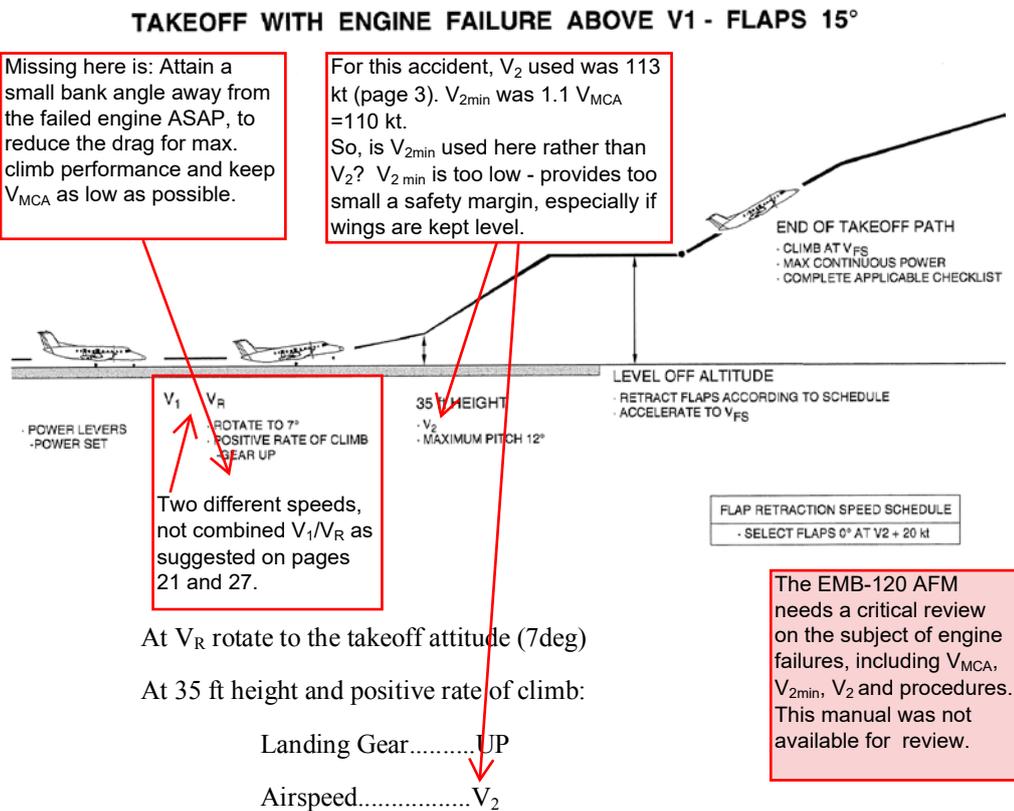
Figure 13: EMB-120 Flight Manual procedure

The procedure was designed for a level-off height between a minimum of 400 ft AGL and 1,500 ft AGL maximum. At that altitude, the aircraft was to be levelled, accelerated to $V_2 + 20$ KIAS, have the flaps retracted, and then be accelerated to V_{FS} (final segment speed).²⁹

Retract flaps at $V_2 + 20$ KIAS at the level off height and accelerate to final segment speed or, if a close-in turn is performed, maintain the takeoff flaps and the airspeed at V_2 with a maximum bank of 15 deg.

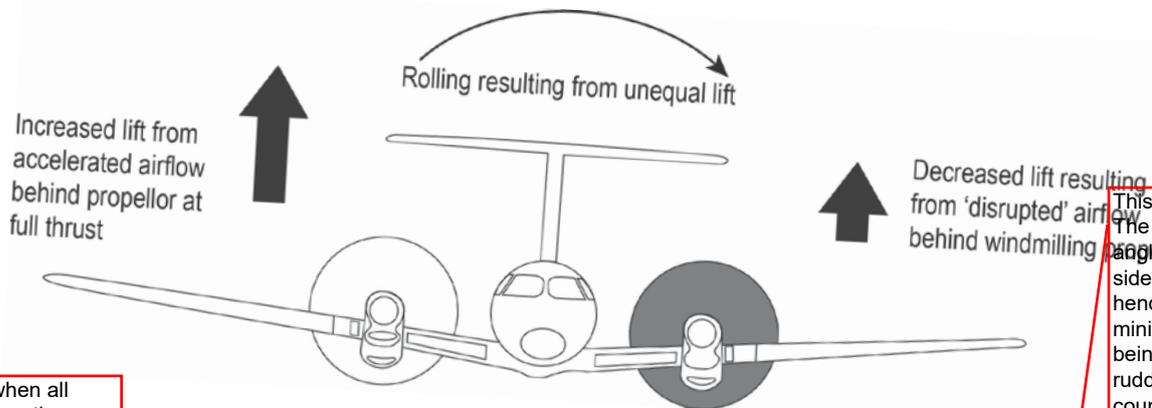
Figure 17: Unequal lift during asymmetric flight

Yes, but only when all engines are operating. When one engine is inoperative, forces and moments are different, also because a rudder deflection is required to counteract the thrust yawing moment. This causes a sideslip to the dead engine when the wings are kept level. A small bank angle can reduce the sideslip to zero by sideforce $W \cdot \sin \phi$ (bank angle) which acts in the cg. V_{MCA} is determined at this same bank angle for zero sideslip.

The published V_{MCA} was determined while banking 5° towards the operative engine. Wings level V_{MCA} is 8 - 30 kt higher, depending on airplane type. This V_{MCA} is not reduced by banking, but only the actual V_{MCA} , the V_{MCA} that the pilot would experience in-flight. This line is confusing and should be deleted from manuals for pilots.

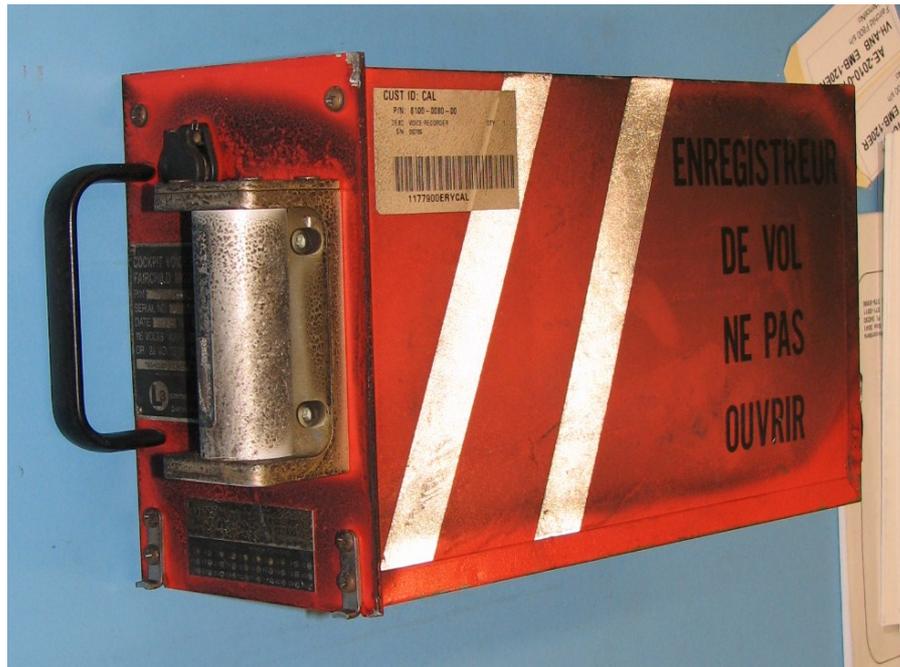
Figure B-1: Cockpit Voice Recorder as received in Canberra

The CVR dust cover was removed to allow access to the download connector and an inspection of the internal circuits and modules did not reveal any damage.
