**ANALYSIS**  
of  
**ACCIDENT MARTINAIR DC-10-30F, MP495**

**FARO, 21 DEC. 1992**

**Limited supplemental analysis  
including comments on the investigation**

**Limited Supplemental Analysis Of The Accident With Martinair DC-10-30F, MP495**

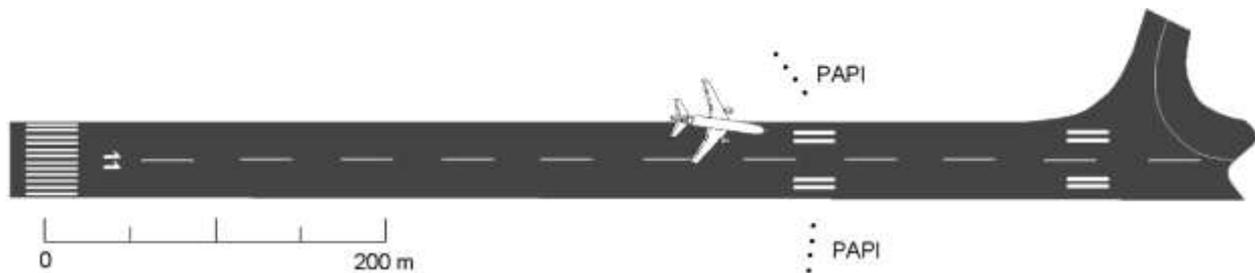
3.1.15. According to RvO § 1.12.1 the aircraft landed on the left-hand side of runway 11. However, the sketch in RvO Annex 11 which shows the location is illegible because it has been reduced and copied. In § 2.3.1 of the report by the Nationaal Lucht- en Ruimtevaart Laboratorium (NLR) in Amsterdam (ref. 6) the landing site is described in words: the aircraft landed at a distance of 392 m from the runway threshold, 124 m beyond the 268 m long touchdown zone, at 22 m to the left of the centre of the 45 m wide runway, with the centre landing gear (in the centre of the fuselage, between the two main landing gear) on the edge between the runway lights and the site. According to the NLR the left-hand main landing gear landed completely off the runway; only the right-hand main landing gear was on the tarmac of the runway. It was unclear if the site next to the runway was higher or lower than the tarmac and if the left-hand landing gear may have sunk into it, which would also explain the collapse of the right-hand landing gear. See Figure 3 below and also § 2.4.7.

Fig. 3. Landing area (touchdown) on the first part of the runway.

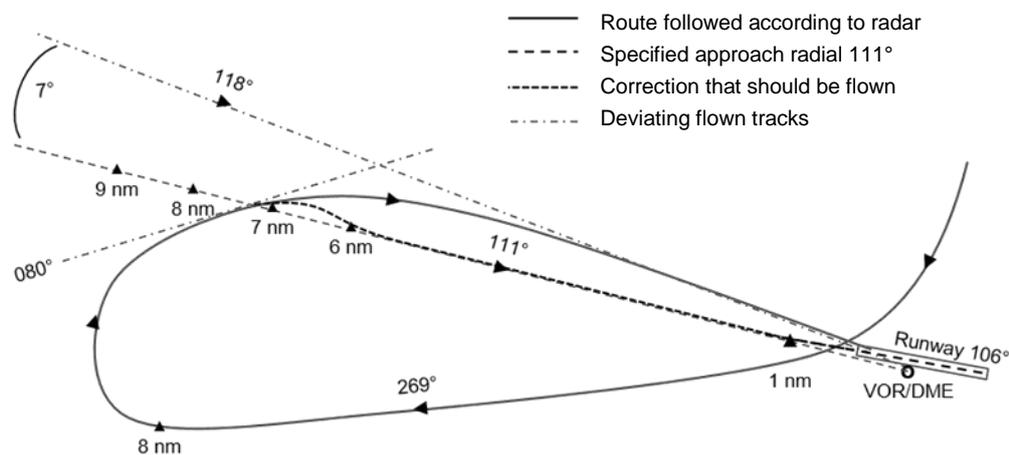
4.2.2. The approach path of the aircraft plotted in Appendix 2 and Figure 4 below shows that the turn towards the approach heading was already started at approximately 8 nm from the VOR beacon; this is too early according to the procedure and the permission given by traffic control, but it is sometimes left up to the pilot flying (if there is no other traffic). It was recorded on the CVR (07:26:43 UTC) that the captain gave permission to start the turn at 8 nm; nothing was mentioned about bad weather as a possible reason for the early turn. The approach radial of  $111^\circ$  was set at 07:28:36 UTC on the autopilot. Shortly afterwards the copilot says he wants a heading of  $080^\circ$  which the captain confirmed. A difference of  $30^\circ$  is normally used to intercept the approach radial ( $111^\circ$ ). When the approach radial is almost reached, the HSI indicates this and the heading has to be changed  $30^\circ$  to the approach radial. In this case the autopilot started the turn and reached the set heading of  $080^\circ$  exactly, as shown by the approach path drawn by the CvO. Whether or not the  $111^\circ$  approach radial was then set was not recorded on the CVR. Due to the approach radial not being set on the HSI, and an apparently late response when reaching the  $111^\circ$  radial the last turn on the radar plot in Appendix 2 looks rather affected by the wind as apparently the effect of the southerly wind was not considered.

The pilots must have been very aware of this major deviation from the approach radial as this must have been displayed very clearly on the two Horizontal Situation Indicators (and probably also on the two Attitude Director Indicators (ADI) in the cockpit). The corrective action, easing the heading to reach the correct approach ground course (VOR beacon radial), was not taken. It is possible that the pilots set a heading/radial directly to the VOR beacon.

Fig. 4. Approach to Faro airport, based on the Approach Chart in Appendix 2.

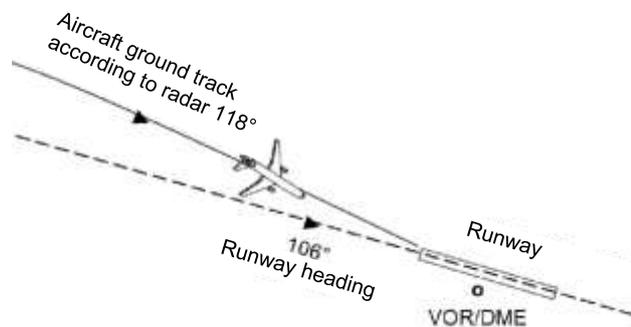
4.2.5. According to the radar, the ground track of the followed angled approach path was approximately  $118^\circ$ . The required wind correction angle for  $190^\circ/20$  kt wind was  $8^\circ$ , see Figure 5 below, hence the heading must have been  $126^\circ$ . That correspond with the heading of  $125^\circ$  recorded by the DFDR; a difference of  $1^\circ$ , a rounding error. Even from the start of the approach, after the last turn, there was insufficient wind correction into the direction of the crosswind at the time and, as shown by the radar plot (Appendix 2), the DFDR data (Appendix 3), summarised in Figure 4 above, no attempt at correction was made to fly to the approach radial. The approach path drawn by the Portuguese CvO (Appendix 2) shows that the aircraft never reached the extended centre line of the runway but approached the runway from the side. Hence the approach path was not within the required angle ( $2.5^\circ$ ) for a stable approach. The approach was not flown accurately and not according to the Approach Chart and can therefore definitely not be considered as a stable approach in accordance with the requirements of the FCOM (§ 4.2.3 above). This is another reason why the approach should have been aborted.

Fig. 5. Wind correction for wind from  $190^\circ$  at 20 kt, and at an airspeed of 139 kt is  $8^\circ$  to the right. Therefore the heading must have been  $126^\circ$  (consistent with the DFDR).

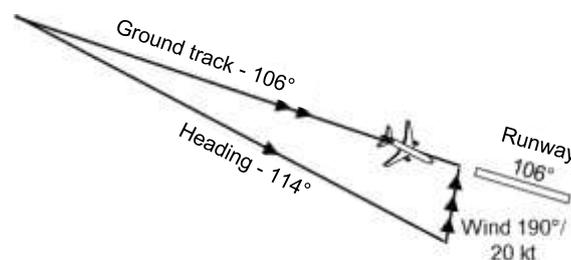
Fig. 7. The wind correction for wind from 190 at 20 kt, and at an airspeed of 139 kt is 8.5° to the right..

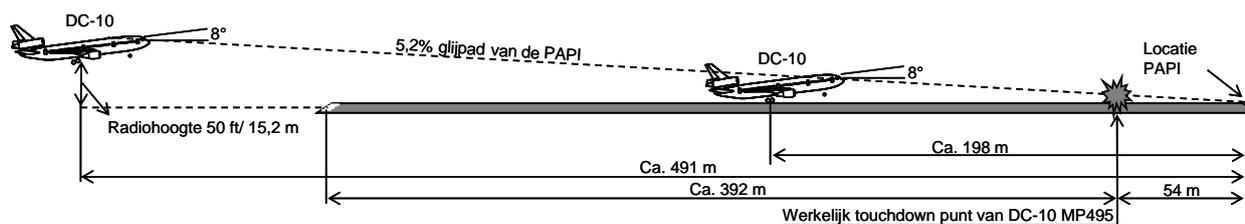
4.6.7. *Touchdown zone.* According to the airport data in RvO § 1.10.2 the touchdown zone of runway 11 had a length of 268 m. According to the NLR report (ref. 6) the initial contact with the ground was only at 392 m from the runway threshold; 124 m too far and also halfway next to the runway (§ 3.1.15). Apparently the NLR had more information than that contained in the RvO. It is inexplicable why this touchdown location and the cause of this were not described in detail in the RvO. The far touchdown location also indicates that the descent rate was not high, otherwise the aircraft would have touched down closer to the start of the runway. See Figure 8 below.

Fig. 8. Side view final approach and landing. Touchdown point from the NLR report.

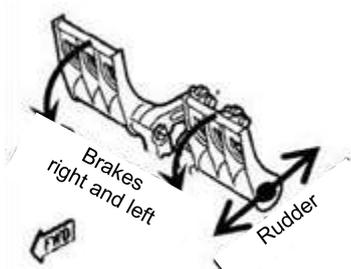
Fig. 9. DC-10 foot pedals

4.6.10. *Locking wheel brakes* The rudder pedals are combined with the brake pedals, operated with the front parts of the feet, for the separate braking circuits of the left and right main landing gear, see Figure 9 below. To prevent the brake pedals being operated together with the rudder, the pilots have to keep the heels of their shoes on the cockpit floor before and during the landing. Then, after the landing with the nose gear firmly on the ground, to operate the wheel brakes, the feet have to be placed slightly higher up so that the front parts of the feet can be used to operate the brake pedals without operating the rudder, because that is needed to keep the aircraft on the runway while the rudder is still effective at the decreasing speed. Of course, a pilot with supple ankles (and shoes) can also operate the rudder with the heels.

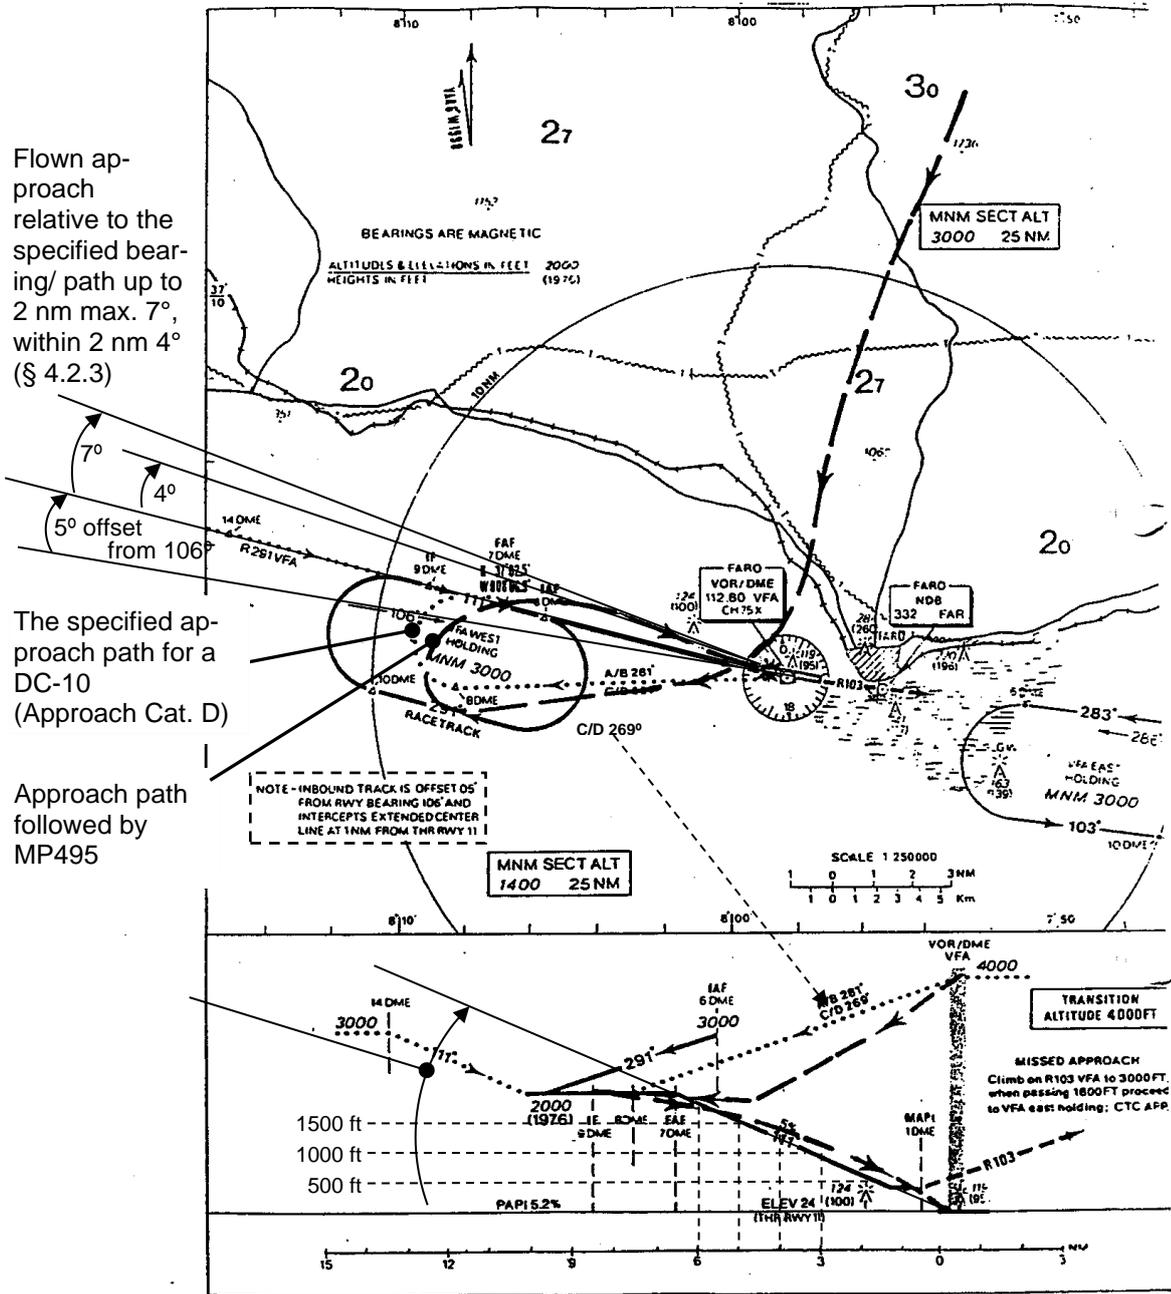
**Appendix 2. Approach Chart Faro Runway 11 with radar data plot MP495.**

If the aircraft flies the specified glide path, at Faro 5.2% (= 2.98°), then at the listed DME distances the altimeter will show the altitudes in column QNH and the radio altimeter the altitude in column Radio. Distance PAPI to VOR/DME is approx. ¼ nm. Radio altitude = QNH - 24 ft runway elevation (if the terrain is flat). The altitude was slightly too low during the entire approach..

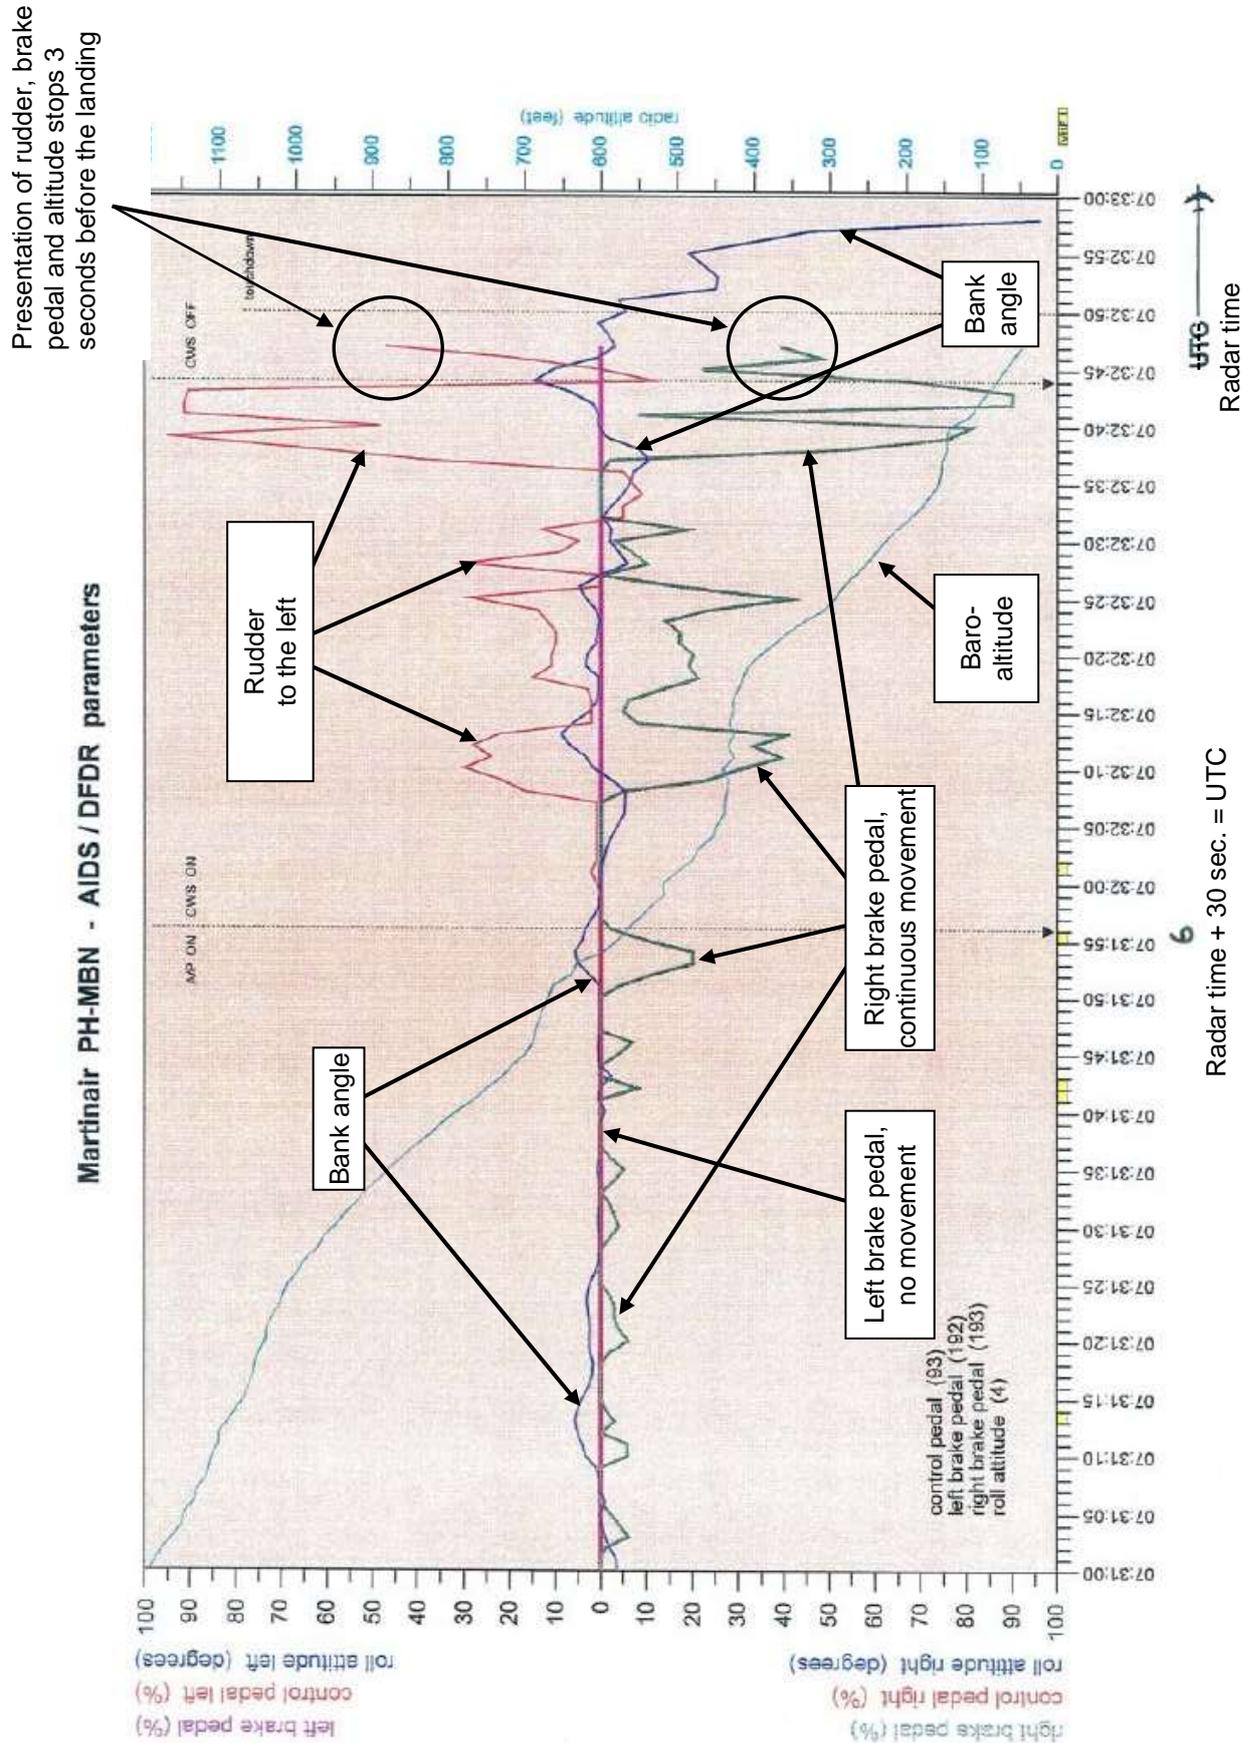
Appendix 6. Graph 6 from the RvO, Annex 9. Rudder, brakes, roll angle

Graph 6 in the RvO (Appendix 9) shows that, certainly during the last minute and a half of the flight, the pilot flying regularly operated the right-hand brake pedal with up to 20% of the maximum travel. He continued doing that when CWS was selected; the movements even increased. This shows that a strenuous effort was made to line the aircraft up. The operation of the brakes during this stage of the flight certainly indicates that the pilot flying had not placed his right foot correctly on the pedals. The brake pedal graph stops 3 seconds before the landing, so that again the NTSB's DFDR Factual Report (ref. 2) will have to provide definite information, but it is
