ANALYSIS

of the controllability of the crashed Saab SF-340B
at Schiphol Airport, 4 April 1994, during the final flight phase

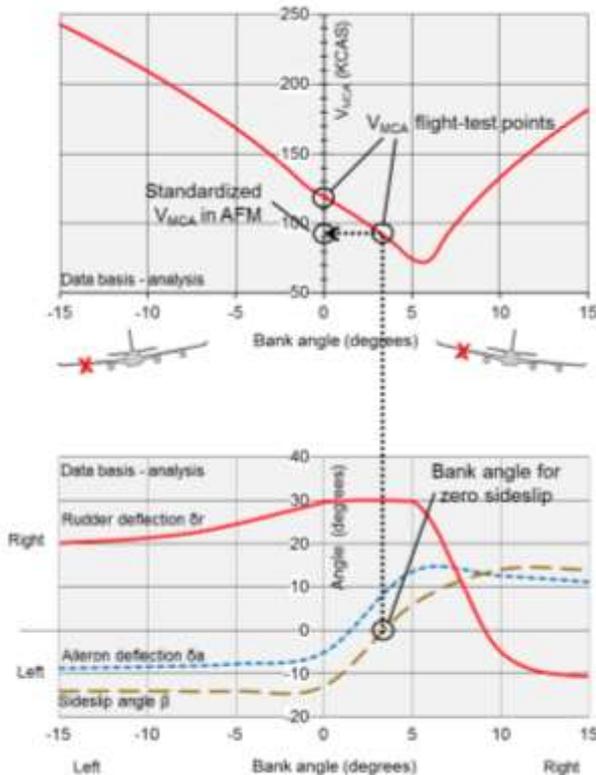
Effect of Bank Angle on V_{MCA}
as calculated in Ref. D

above the indicated airspeed, or if the airplane decelerates to an airspeed below the *actual* V_{MCA} , control of the airplane will be lost for sure. If the wings are kept level during takeoff or go-around, the *actual* V_{MCA} will most often already be higher than the takeoff speed if the other factors that have influence on the magnitude of V_{MCA} happen to be at their worst case value too. Hence, there definitely is a bank angle condition/ requirement for an airline pilot that always applies to the AFM-listed V_{MCA} (but that regrettably is almost never included, except in performance diagrams). This also means that making (procedural) turns at low speed and high asymmetrical thrust settings is very dangerous and should be avoided.

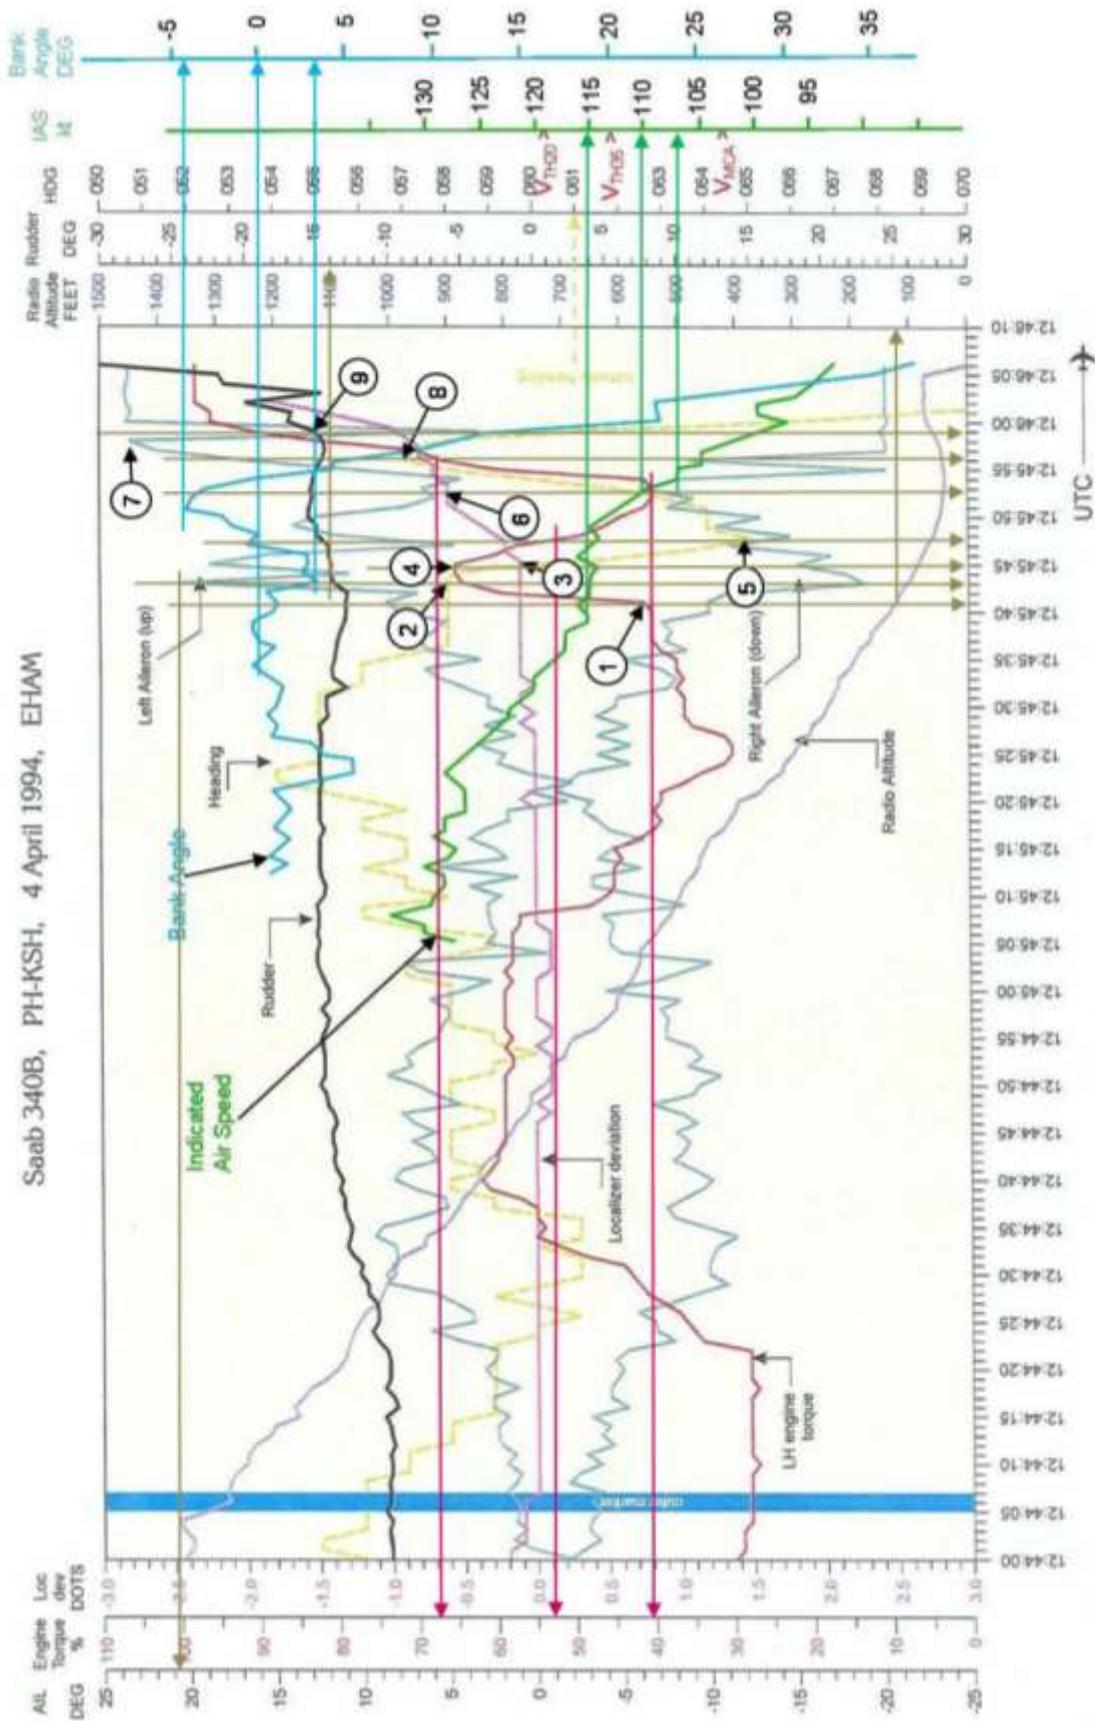
Attachment 1: Combined graph with all required data from the Aircraft Accident Report.

4.3. At 12:45:41 (①), at a radar altitude of 110 feet (ft) and an indicated airspeed of 115 knots (kt), 4 kt below the threshold speed for 20 degrees flaps (V_{TH20}), the torque of the left engine was increased from 40% to 65%. The increased propulsive lift of the blown wing section (plus flaps) behind the propeller of the left wing caused the airplane to bank from approximately wings level to 3 – 4 degrees to the right. As the bank angle started to increase to the right, the pilot increased the aileron deflection to the left, to approximately 20 degrees of max. 24 degrees, to counter the bank angle increase.

4.4. The increased thrust of the left engine also increased the yawing moment to the right. This yawing moment was enhanced by the drag of the not-feathered propeller of the idling right engine (§ 2.5). Rudder deflection was increased by only 2 degrees to 14 degrees of the available 30° degrees to the left, which was obviously not enough to counter the yawing motion at the current airspeed, because the nose of the airplane started to move to the right while the torque reached (only) 65% (at 12:45:43, ②).

Because of the limited rudder deflection for the given asymmetrical thrust setting and bank angle, the heading could not be maintained, i.e. controlled. The air speed was too low for the vertical tail with only partial rudder to generate a high enough side force to counter the yawing motion. This in fact means that the *actual* V_{MCA} at that time must have been higher than 115 KIAS (knots indicated airspeed). The airplane was in fact already out of (directional) control at 12:45:43 (②), two seconds after increasing the thrust, while the IAS was 115 kt, still 12 kt above the flight manual listed – worst case / standardized – V_{MCA} .

4.6. Then, at 12:45:45 (④), the pilot slowly reduced the torque of the left engine to 40% (in 6 seconds). The propulsive lift of the left wing decreased instantaneously, causing the bank angle to return towards wings level with the current aileron deflection. Then the aileron deflection to the left was reduced, but then again increased to the left, most probably because the pilot wanted to return to the runway centerline.

As the torque decreased below 53% (12:45:48, ⑤) and the airspeed was 115 KIAS, the heading change reversed, indicating that the yawing moment generated by the still small rudder deflection could overcome the yawing moment due to the asymmetrical thrust and the drag of the right propeller. Since directional (yaw) control was regained at this time, the *actual* V_{MCA} had obviously decreased below the IAS. This decrease was caused by both the bank angle change (from 3 degrees into the wrong side to wings level) and the thrust reduction (⑤).

4.7. At 12:45:53 (⑥), the airplane had apparently drifted so much to the right of the runway centerline that the pilot decided to go-around. The airspeed at that time was 110 kt, 9 kt below V_{TH20} but still 7 kt above the Flight Manual-listed V_{MCA} . The torque of the left engine was increased from 40% to 98% in 7 seconds. The rudder deflection remained unchanged, approximately halfway, 15 degrees, to the left. Due to the increase of the propulsive lift of the blown wing section behind the left propeller, the aircraft started to bank to the right to which the pilot responded with full aileron deflection to the left (⑦). The bank angle however continuously increased slowly (3 degrees per second) to the right for the remainder of the flight while the aileron deflection remained full left, apart from a pulse to the right. This pulse is not visible in the right aileron graph and might be a data glitch. Due to the low airspeed, the ailerons were no longer effective enough to control the banking under the given thrust and drag asymmetry con-

ditions; lateral control was lost. The *actual* V_{MCA} must have increased to a value higher than 107 KIAS (§ 2.6).

4.8. After the engine torque increased above 67% (⑧), the half rudder deflection to the left could not prevent the yawing motion from reversing to the right. The yaw rate increased to approximately 4 degrees per second to the right, also for the remainder of the flight. Directional control was now also lost (⑧). At event ⑨, about 7 seconds prior to the impact with the ground, the rudder deflection was finally increased, with some hesitation, to be fully deflected to the left at the moment of impact. The two-second discontinuity in the bank angle and airspeed data as shown in the graph may have been caused by the increased rudder deflection or the aileron pulse to the right (⑦). In any case, the full rudder deflection came way too late.
