Controllability of a Boeing 747-258F After Separation of Two Engines

4 October 1992, Amsterdam

Including The Theory of Engine-Out Flight And Systemic Errors in Controlling Multi-Engine Airplanes When Engine(s) Failed

Limited To Flying Qualities, Handling and Performance

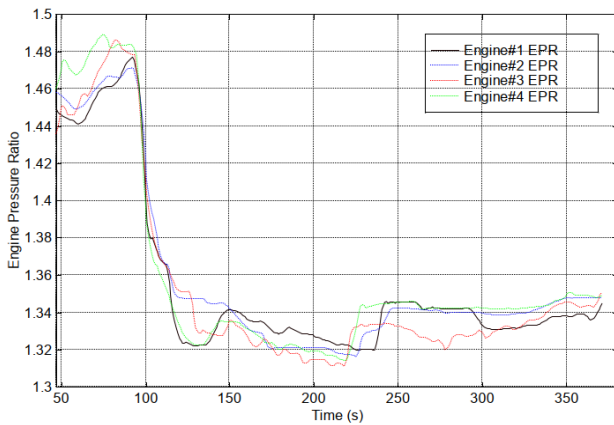
Figure 9. FDR Engine Pressure Ratio (EPR) data (NLR, ref. 2, Fig. 34.)

5.2.4. During takeoff, the initial thrust setting (Engine Pressure Ratio – EPR) was between 1.44 and 1.46 (Figure 9 below), which is lower than the maximum approved 1.72. Engine thrust during takeoff may be larger than Maximum Continuous Thrust (MCT - EPR 1.32) for an approved period, usually during a few minutes. Thereafter, the engine thrust must be reduced to MCT. This is what the Boeing 747 pilot factually did (Figure 9).

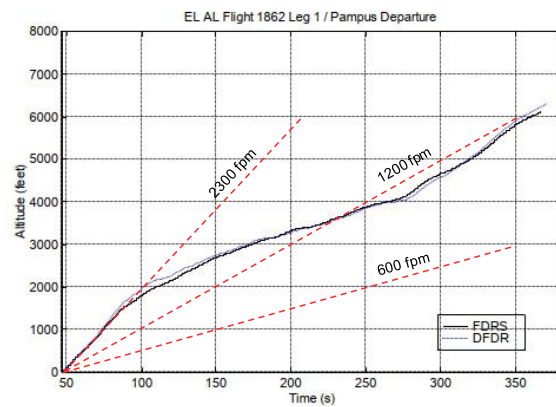
Figure 10. FDR altitude data and climb performance (NLR, ref. 2, Fig. 23).

5.2.5. The FDR-recorded altitude is presented in Figure 10, including a few lines showing the ROC in feet per minute (fpm). As shown, the ROC after liftoff from the runway was initially 2300 fpm, and from 100 seconds an average of 800 fpm until \approx 225 seconds after liftoff.

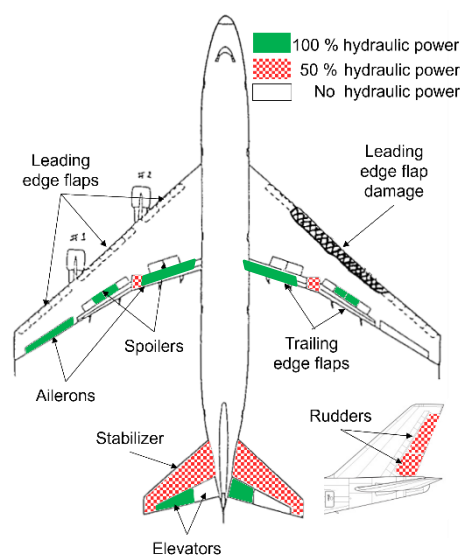
Figure 12. Remaining aerodynamic control surfaces after separation #3 and #4.

5.4.1. At 17:27:30 UTC (event 15 in Figure 11), while the airspeed was 270 knots Calibrated Air Speed (KCAS, ref. 2) and the airplane climbed through 6,500 ft, at a distance of approximately 18 nm from the airport, a fuse pin failure in pylon 3 caused engine 3 and its pylon to separate from the wing and knock off engine 4 including its pylon as well (ref. 1).

The cause of the separation, the failure of the fuse pin in pylon 3, was analyzed in detail in ref. 1; it is not the subject of this controllability analysis. The separation caused damage to the right wing. Below, the consequences of the loss of two engines, and of the damage of the right wing will be explained and analyzed.

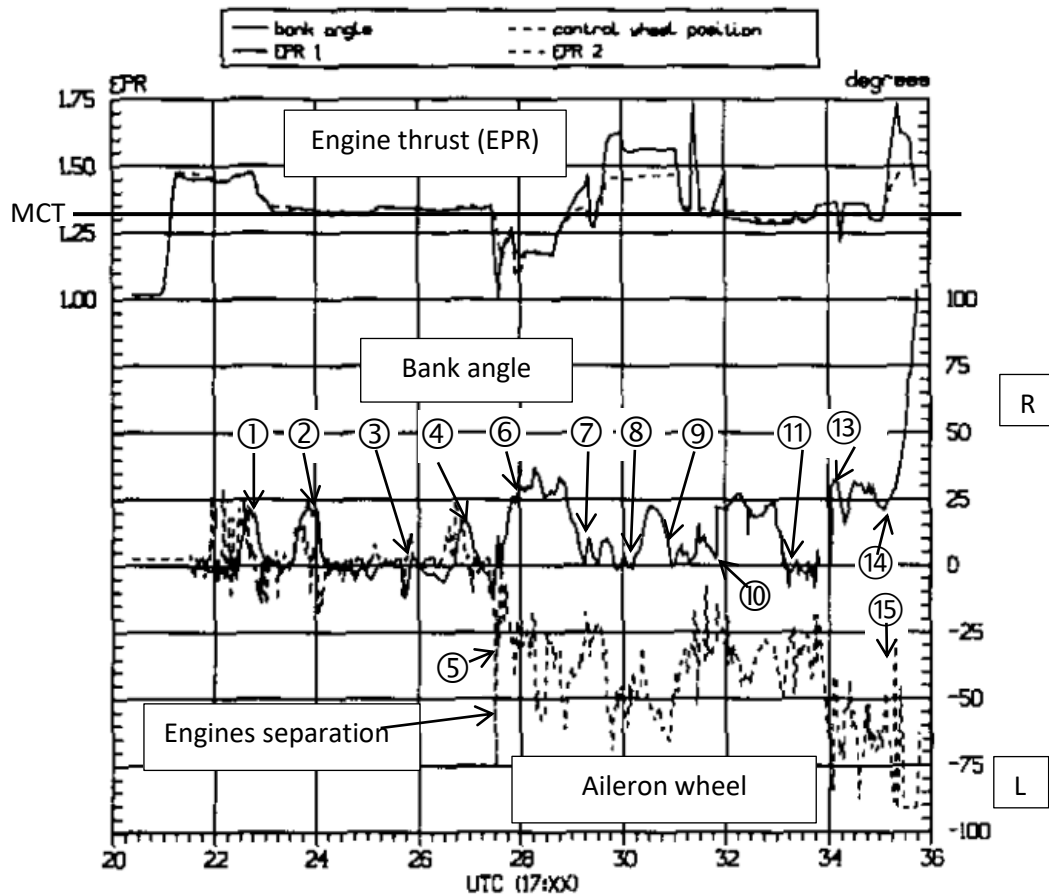
Figure 15. Bank angle, aileron wheel and EPR (FDR data, ref. 3). The circled numbers correspond with events in Figure 11.

5.4.14. An average of 35° of aileron control wheel input to the left was required during the remainder of the flight for maintaining lateral control at the average airspeed of 270 kt and an average EPR of 1.30. At this airspeed and this thrust setting, that was less than maximum EPR 1.72, the equilibrium of lateral forces and moments could obviously be maintained, because the airplane remained controllable.

5.4.18. **Forces and Moments at a Larger Bank Angle.** During the final turn from event ⑬ in Figure 11 and in Figure 15, an average bank angle of 25° to the right was attained. As was discussed in § 3.1.8 above, when an airplane is banked, a component of the weight

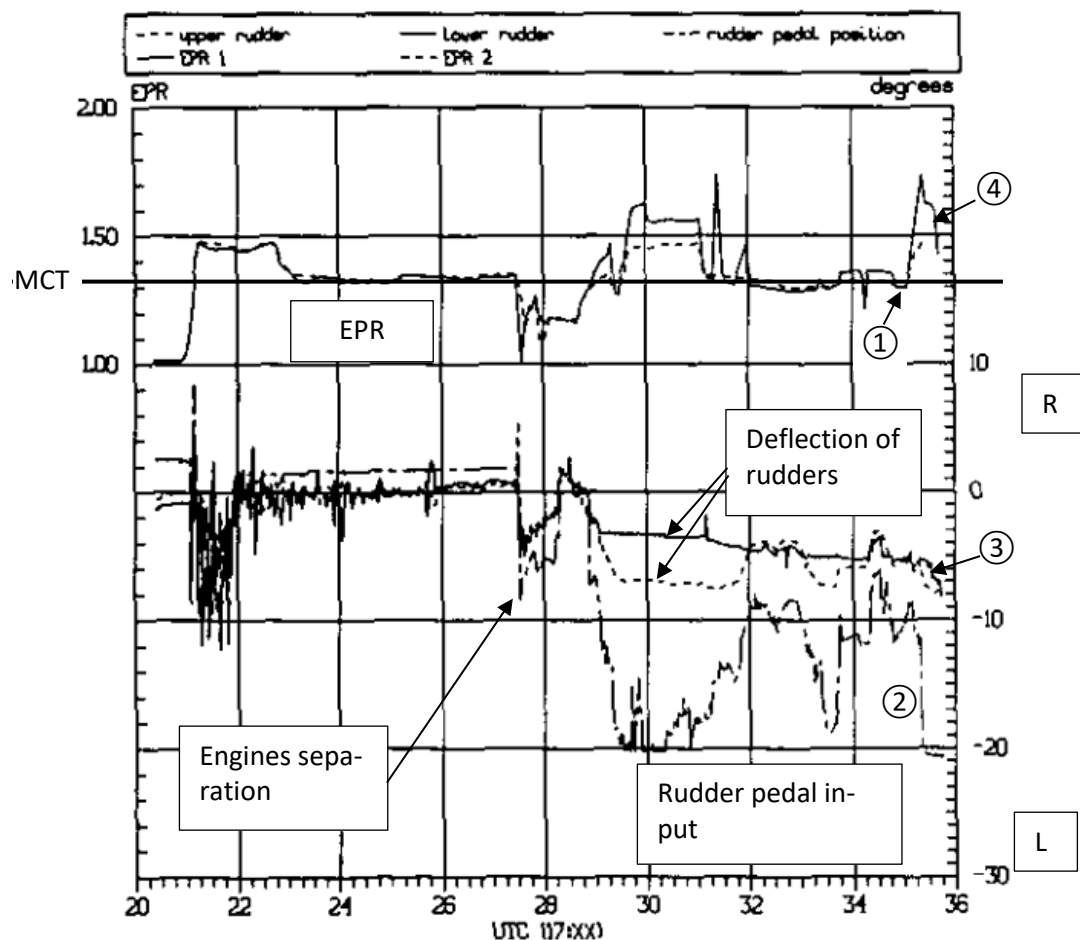
Figure 18. Rudder deflection, rudder pedal position and EPR (FDR data ref. 3).

sideslip, which increases the static pressure on one side of the fuselage. Also obvious is the limitation of the rudder deflection by the rudder ratio changers to the maximum 8° (Figure 18 above) at larger pedal inputs at an airspeed of 260 kt.
