Controllability of a Boeing 747-258F After Separation of Two Engines

4 October 1992, Amsterdam

**Including The Theory of Engine-Out Flight
And
Systemic Errors in Controlling Multi-Engine Airplanes
When Engine(s) Failed**

Harry Horlings
Graduate FTE USAF Test Pilot School

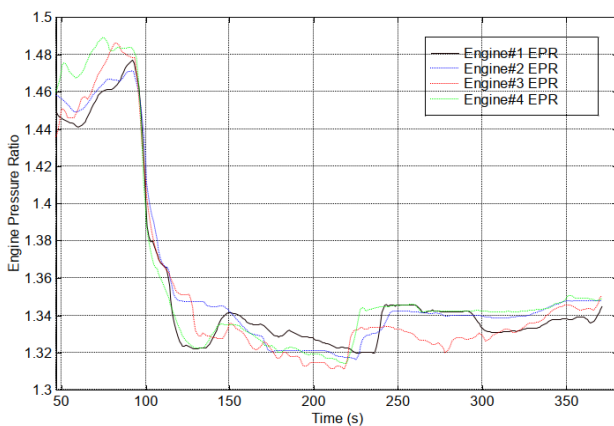
Figure 9. FDR Engine Pressure Ratio (EPR) data (NLR, ref. 2, Fig. 34.)

5.2.4. During takeoff, the initial thrust setting (Engine Pressure Ratio – EPR) was between 1.44 and 1.46 (Figure 9 below), which is lower than the maximum approved 1.72. Engine thrust during takeoff may be larger than Maximum Continuous Thrust (MCT - EPR 1.32) for an approved period, usually during a few minutes. Thereafter, the engine thrust must be reduced to MCT. This is what the Boeing 747 pilot factually did (Figure 9).

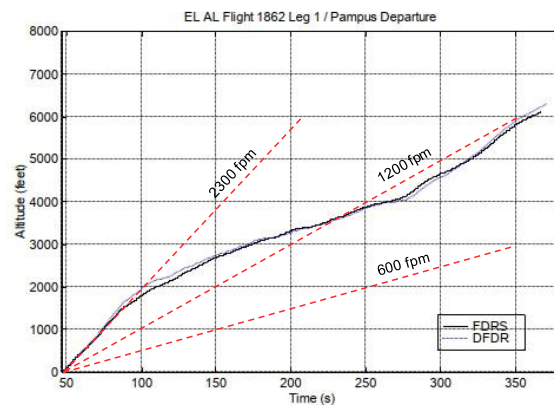
Figure 10. FDR altitude data and climb performance (NLR, ref. 2, Fig. 23).

5.2.5. The FDR-recorded altitude is presented in Figure 10, including a few lines showing the ROC in feet per minute (fpm). As shown, the ROC after liftoff from the runway was initially 2300 fpm, and from 100 seconds an average of 800 fpm until \approx 225 seconds after liftoff.

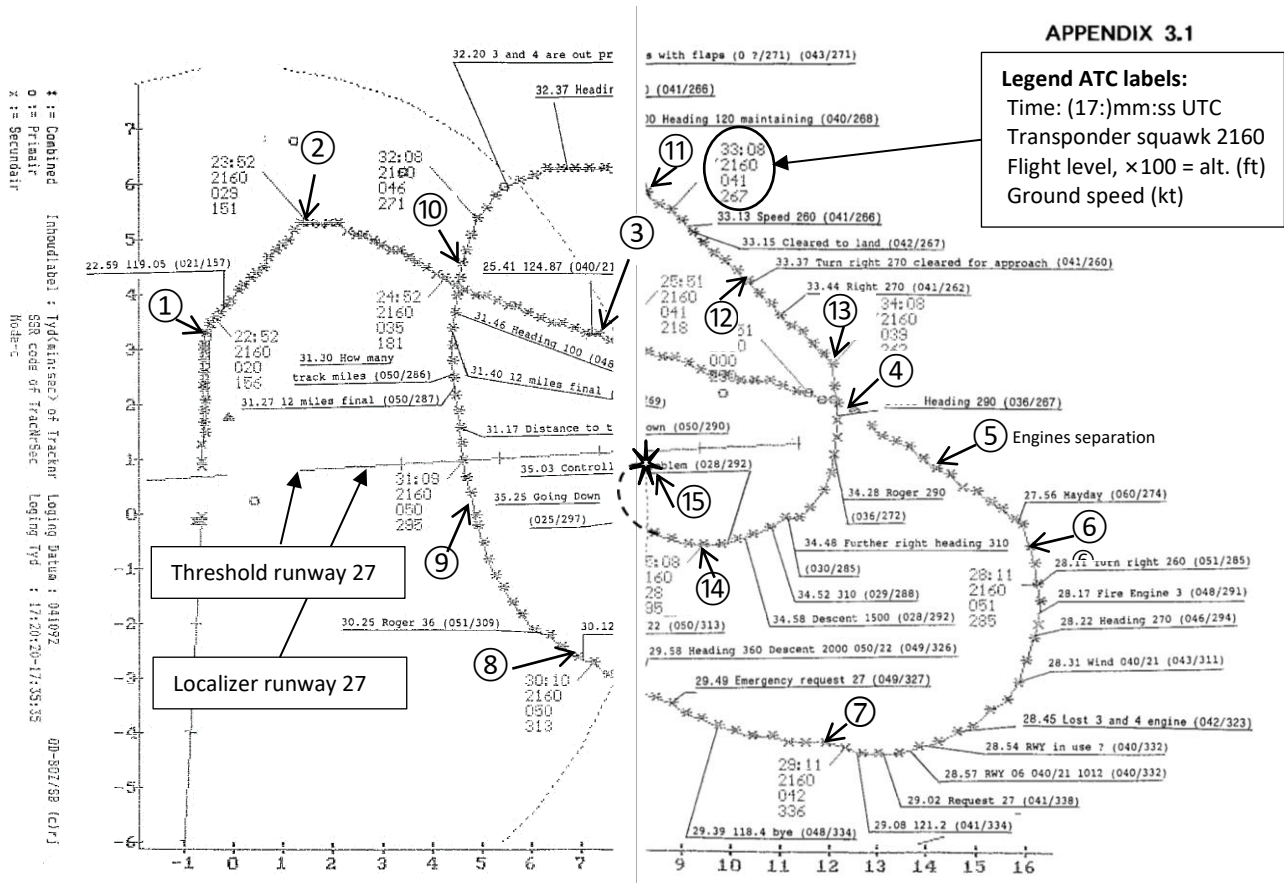
Figure 11. Departure and approach ATC radar ground track, one data point per 4 s, Appendix 3.1 of Accident Report.

5.3.1. The flight path, i.e. the plot of the ground radar track of the airplane from takeoff to the crash was included in the accident report (ref. 1, Appendix 3.1) and is copied in Figure 11 below. The circled numbers refer to events in the FDR bank angle data of the flight in Figure 15 below, that show the turns before and after the engine separation, and are used in the analysis from § 5.5 below as well. The plot was however not the original plot.

5.3.2. A board member testified⁹ that changes were made in the first part of the route, and the lead investigator testified¹⁰ that the track was calculated by using both the FDR heading data and the wind. However, the FDR-recorded heading of an airplane of which two engines are inoperative cannot be used to calculate the true course of the airplane, because this heading includes a large sideslip angle, unless straight flight is being maintained while also maintaining a small bank angle between 0 and 5° into the good engines, when sideslip is zero (Figure 6, bottom right). The angle of sideslip is not measured in an airliner and hence, is not recorded on the FDR, but can be up to 14°, as shown in Figure 6 above for bank angles between -15° and +15°. Hence, the FDR-recorded heading cannot be used with the drift angle due to the wind to calculate the ground course/track. As was mentioned a few times before, a flight is not coordinated, when the thrust is asymmetrical. The lead investigator was obviously unaware of the difference between sideslip and drift angles. The exact ground track is not of importance for the analysis below, which is aimed at the controllability after engine failure; therefore, it is assumed that this figure presents the correct ground track, just for reference purposes.

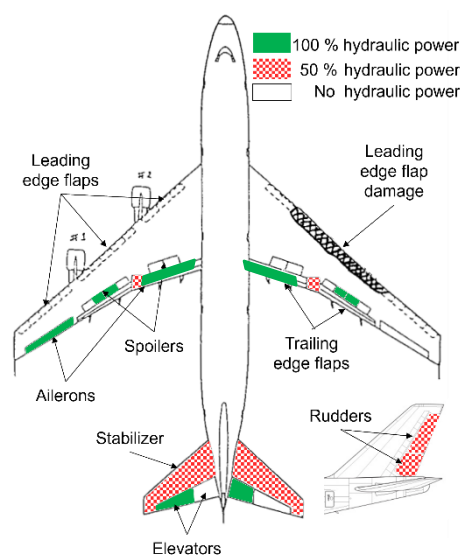
Figure 12. Remaining aerodynamic control surfaces after separation #3 and #4.

5.4.1. At 17:27:30 UTC (event 15 in Figure 11), while the airspeed was 270 knots Calibrated Air Speed (KCAS, ref. 2) and the airplane climbed through 6,500 ft, at a distance of approximately 18 nm from the airport, a fuse pin failure in pylon 3 caused engine 3 and its pylon to separate from the wing and knock off engine 4 including its pylon as well (ref. 1).

The cause of the separation, the failure of the fuse pin in pylon 3, was analyzed in detail in ref. 1; it is not the subject of this controllability analysis. The separation caused damage to the right wing. Below, the consequences of the loss of two engines, and of the damage of the right wing will be explained and analyzed.

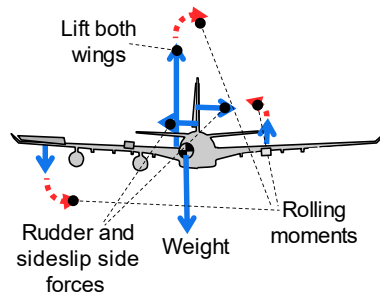
Figure 14. Shift cg and lift vector both wings, reduced roll control.

5.4.11. **Wing Lift Imbalance After the Separation of Two Engines.** When a wing is damaged and its generated aerodynamic lift decreases, the vector representing the sum of the lift vectors of both individual wings together, which normally acts in the aerodynamic center

center on the centerline, would then displace laterally too, and generate a rolling moment. If the displacement is large, outside of the displaced cg, the displaced combined lift vector of both wings generates a rolling moment to the right, as is shown in adjacent Figure 14. The rolling moments generated by the rudder and sideslip side forces, which act above the cg, are not shown here; forces are not to scale.

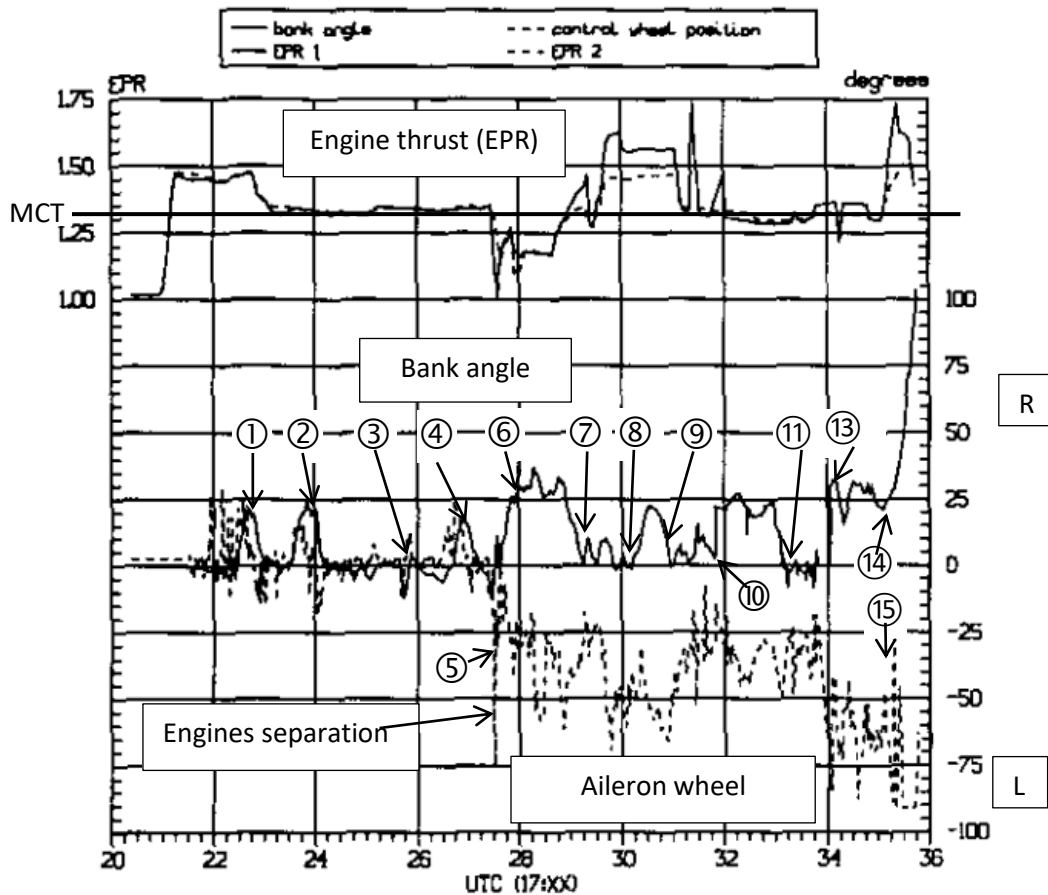
Figure 15. Bank angle, aileron wheel and EPR (FDR data, ref. 3). The circled numbers correspond with events in Figure 11.

5.4.14. An average of 35° of aileron control wheel input to the left was required during the remainder of the flight for maintaining lateral control at the average airspeed of 270 kt and an average EPR of 1.30. At this airspeed and this thrust setting, that was less than maximum EPR 1.72, the equilibrium of lateral forces and moments could obviously be maintained, because the airplane remained controllable.

5.4.18. **Forces and Moments at a Larger Bank Angle.** During the final turn from event ⑬ in Figure 11 and in Figure 15, an average bank angle of 25° to the right was attained. As was discussed in § 3.1.8 above, when an airplane is banked, a component of the weight

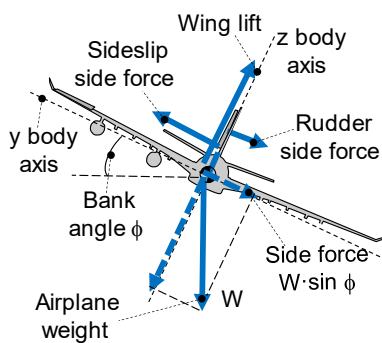
Figure 16. Side forces during banking 25° into the lost engines, damaged right wing. Forces not to scale.

acts as side force $W \cdot \sin \phi$ in the center of gravity (in the body axes system) and hence, does not generate a yawing moment (moment arm = zero). The yawing moment to counteract the thrust yawing moment (about the z axis), still needs to be provided by the rudder though (Figure 16).

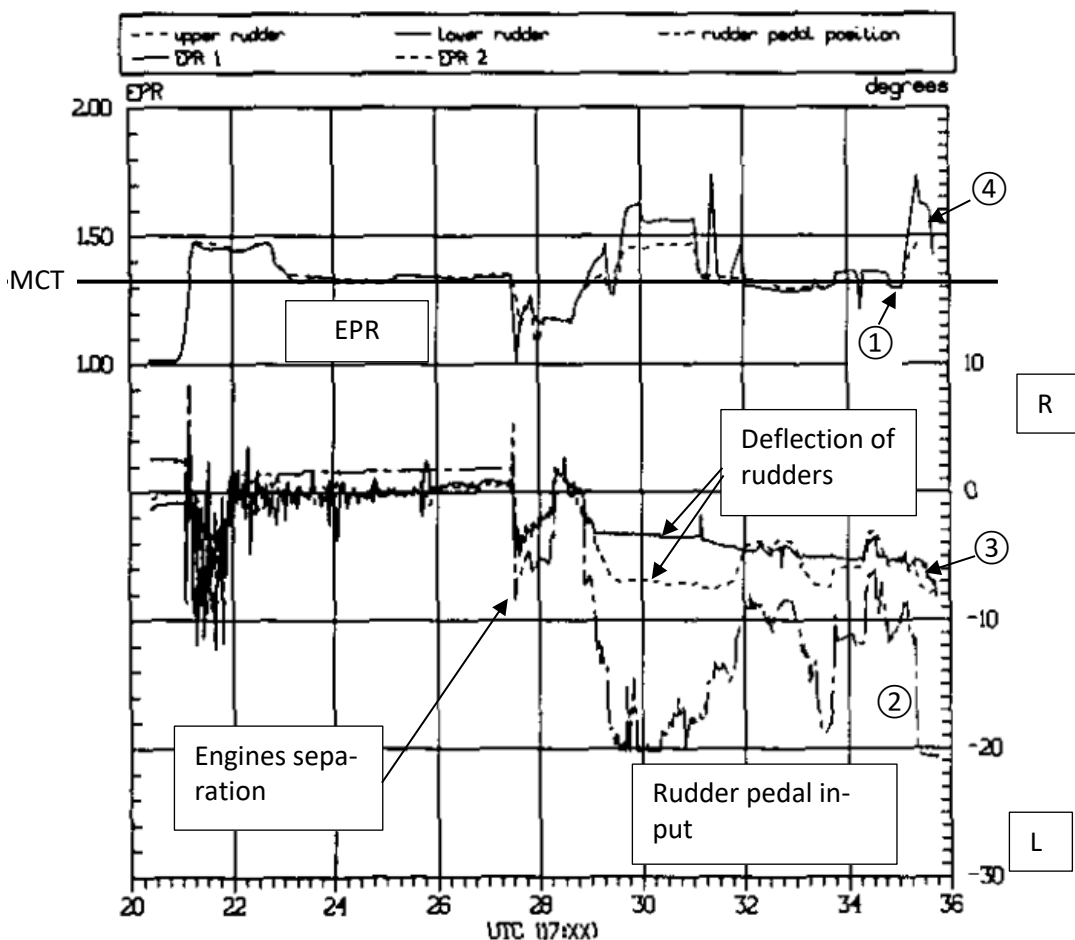
Figure 18. Rudder deflection, rudder pedal position and EPR (FDR data ref. 3).

sideslip, which increases the static pressure on one side of the fuselage. Also obvious is the limitation of the rudder deflection by the rudder ratio changers to the maximum 8° (Figure 18 above) at larger pedal inputs at an airspeed of 260 kt.
