Runway excursion after loss of thrust at low speed

Limited review by Harry Horlings, AvioConsult.
Lt-Col RNLAF ret., graduate FTE USAF Test Pilot School.

Identification number:	2017118
Classification:	Serious incident
Date, time of occurrence:	11 November 2017, around 22.36 hours ¹
Location of occurrence:	Maastricht Aachen Airport (EHBK)
Registration:	TC-ACR
Aircraft type:	Boeing 747-400 ERF
Aircraft category:	Aeroplane
Type of flight:	Commercial cargo flight
Phase of operation:	Take-off
Damage to aircraft:	Substantial
Flight crew:	Two (captain and first officer)
Other crew:	Two (technician and load master)
Passengers:	None
Injuries:	None
Other damage:	Deep tracks made by the landing gear in the soft ground of the airfield
Light conditions:	Darkness

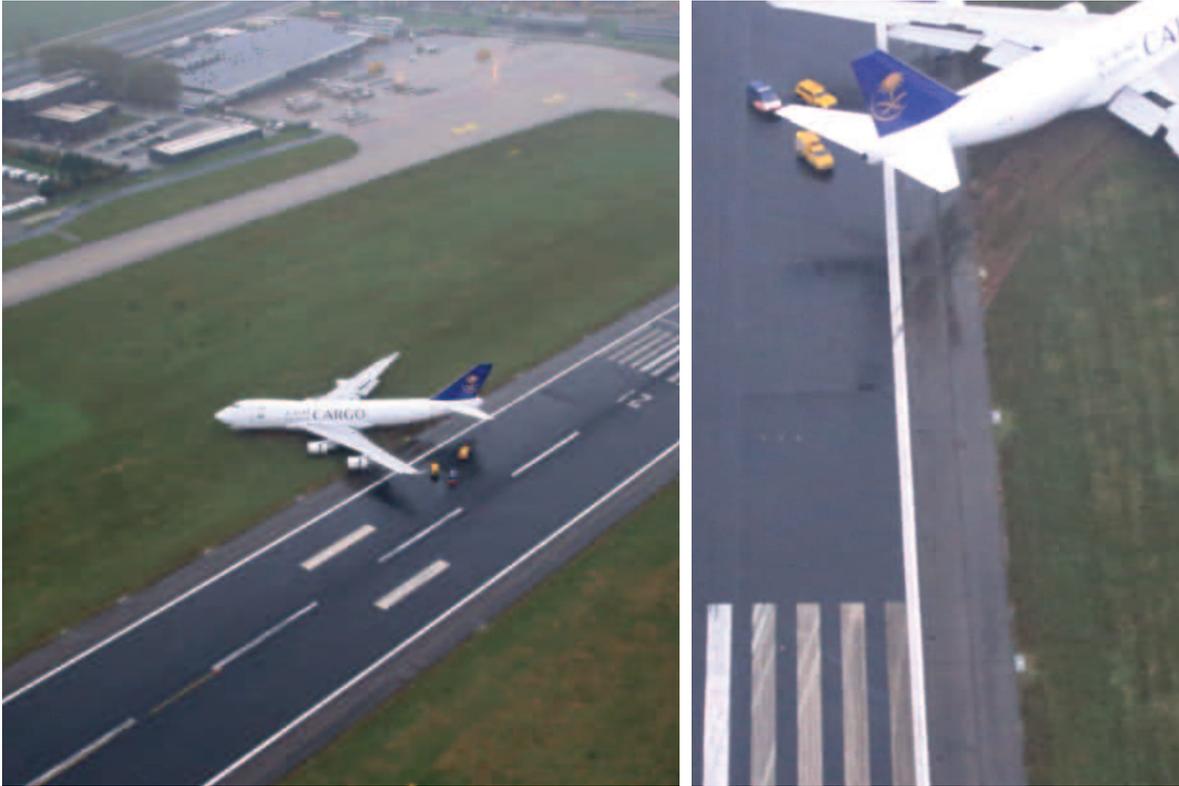
The aircraft had veered off the runway and had come to a standstill in the soft soil of the grass field on the right side of Runway 21. After the occurrence, it was found that all of the aircraft's engines were in reverse and its speed brakes were up.

Figure 1: Aerial pictures of the runway excursion. (Source: Aviation police)

The aircraft sustained substantial structural damage as a result of the occurrence. This damage consisted of several bent and deformed skin panels and stringers. In addition, the nose wheel well web had several deformations on the right- and left-hand sides. As a result of this damage, the manufacturer of the aircraft had to carry out major repairs at Maastricht Aachen Airport.

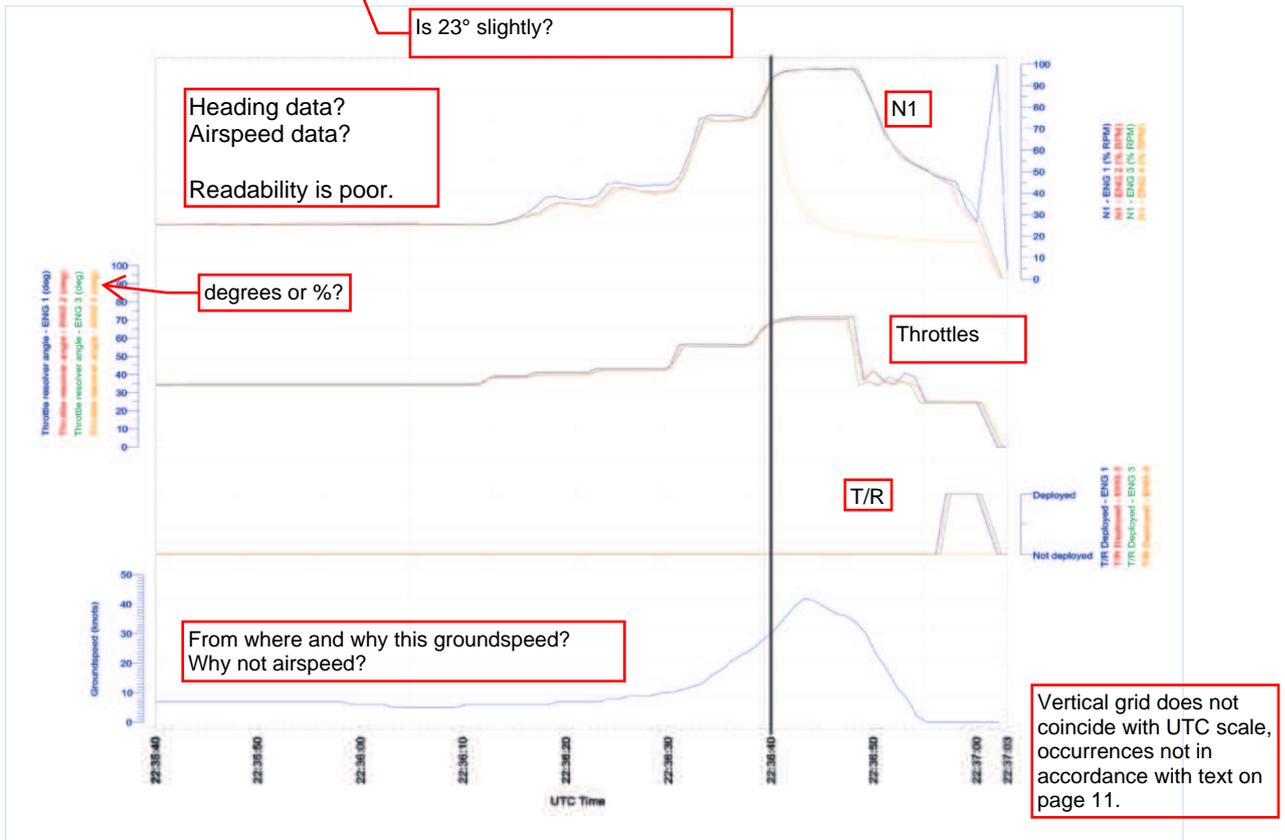
Very unclear analysis, not in agreement with bottom line pag. 15. Rudder graph on page 32 has bad time scale.

Figure 2: Plot of FDR data (N1, TRA, T/R, GS). The vertical line indicates the moment at which engine #4's N1 dropped.

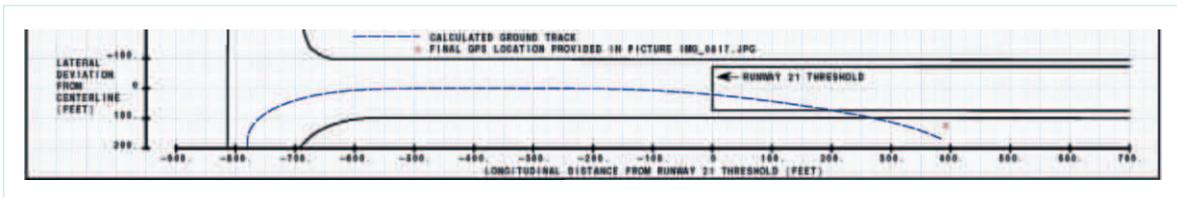
Figure 3: Ground track analysis. (Source: Boeing)

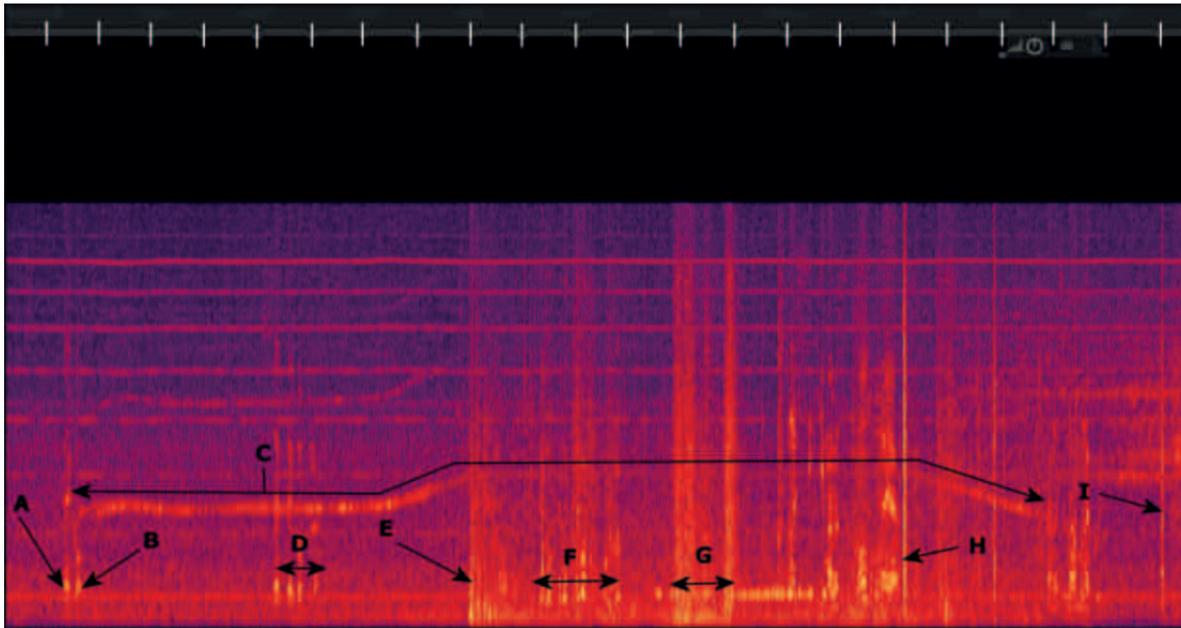
Is not spectrum. A spectrum shows the level of, and the occurrence of different frequencies. Horizontal scale of a spectrum = frequencies, not time; is frequency domain. What we see here is just sound level (amplitude) during the displayed time.

throttles. TRA indicates throttle angle, the position of the levers. Meant here is noise of throttle levers. You can't hear TRA's.

Figure 4: Spectrum analysis of the occurrence. Each vertical white line corresponds to 1 second.

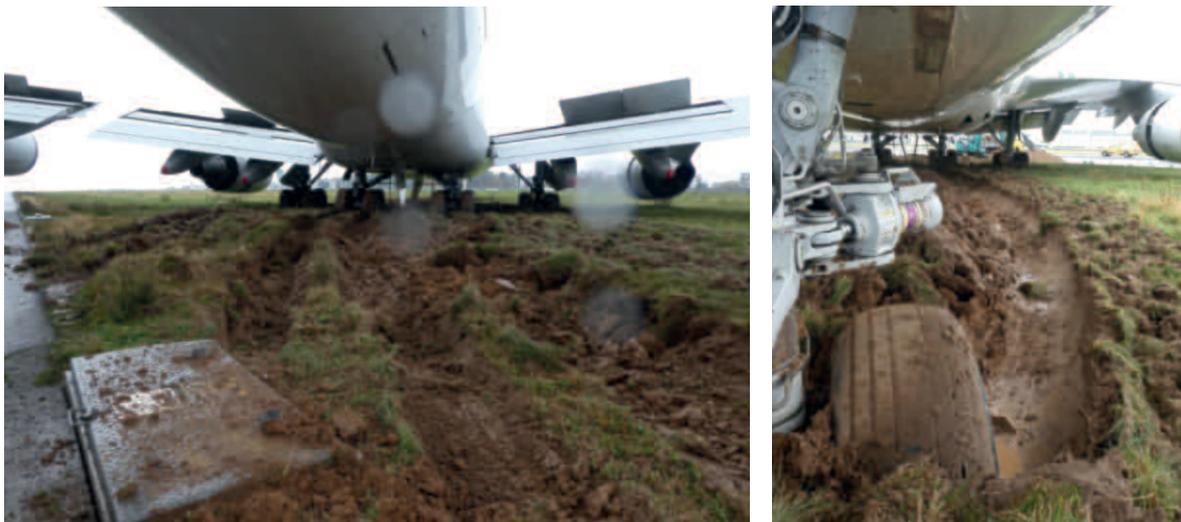
After veering off the runway, the aircraft came to a standstill in the field to the right of Runway 21. All of the main gear's wheels had left deep tracks in the soil. A single track made by the nose gear was clearly visible, as were the double tracks left by each main gear. The left nose wheel had left a curved track, which was wider than the tyre itself. Mud had also been thrown up to the right side of the track. The nose wheels were turned slightly to the left.

Figure 5: Photographs of wheel tracks in the soft ground.

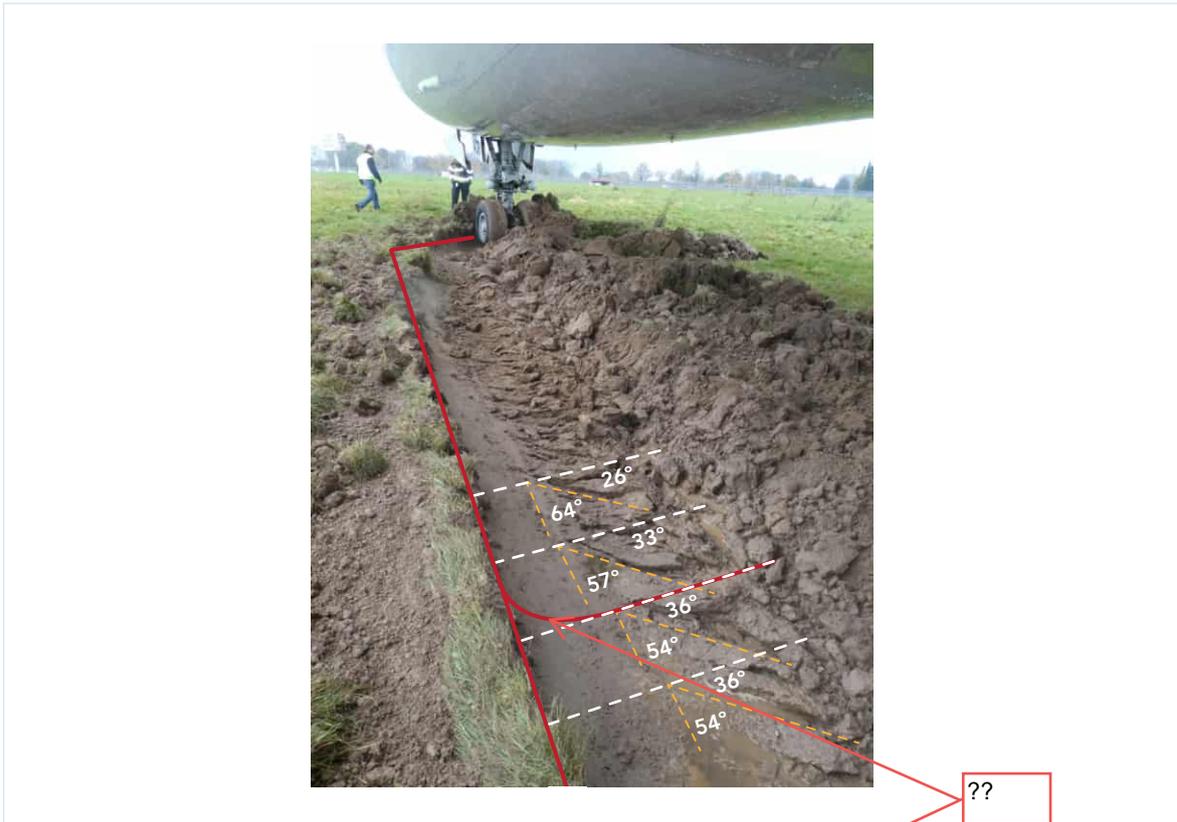
The tyre marks associated with each individual landing gear strut were carefully examined. The nose wheel tracks in the grass were of particular interest. It was concluded that the shape and size of the nose wheel track in the grass indicated a nose wheel steering angle ranging from around 26 degrees to around 36 degrees to the left. This track ran from the point where the nose wheel had left the runway surface to the aircraft's final resting place. Although the calculated steering angles (based on the nose wheel track) are merely an indication, they clearly exceed the maximum steering angle of 7 degrees that can be achieved by pedal steering. It is, therefore, very likely that this was caused by inputs to the tiller nose wheel steering system.

Couldn't this be caused by the drag of the mud also? Kind of skidding?

Figure 6: Analysis of the nose wheel track. The red line indicates the orientation of the aircraft; the yellow line indicates the angle of the nose wheel.

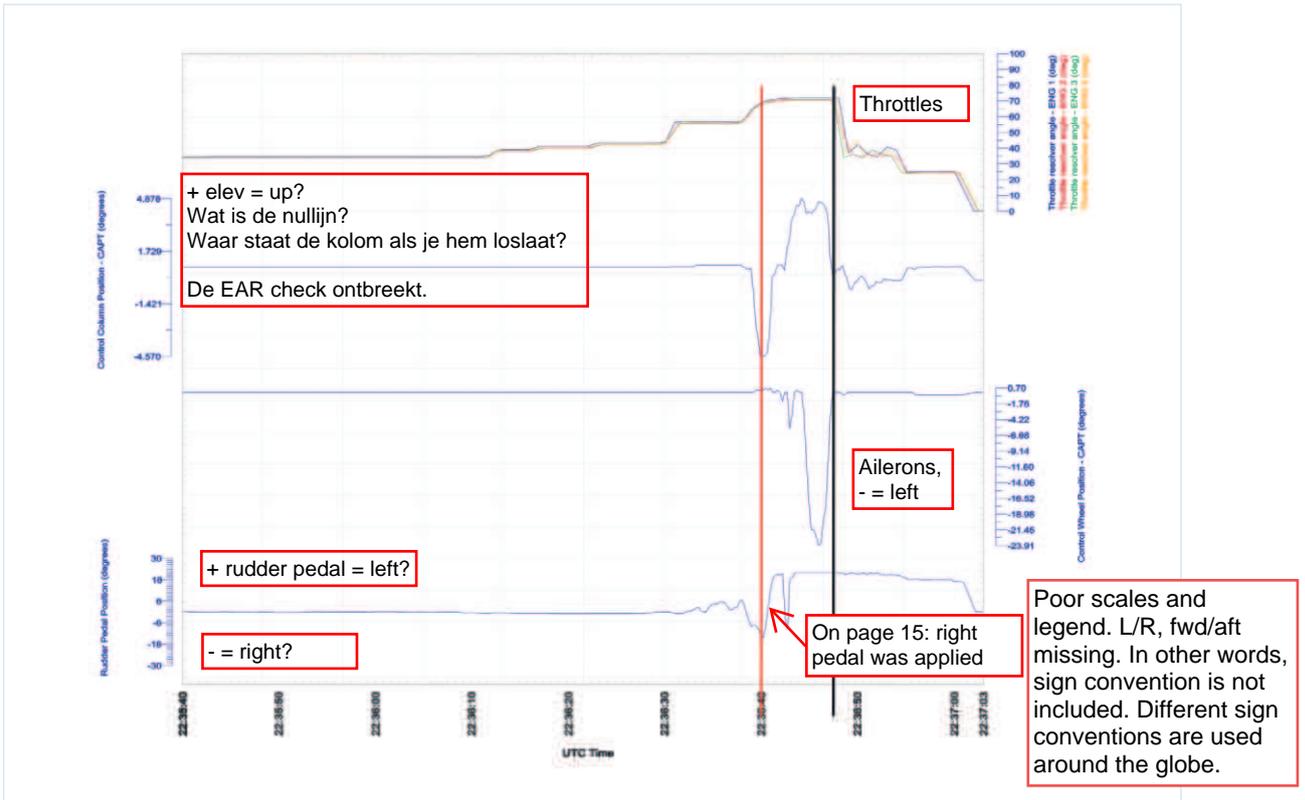
FDR analysis revealed that left control wheel input was recorded from the moment the engine failure occurred until the moment the throttles were finally retarded to idle. There was an interval of 1 second between control column release and retardation of the throttles. This is consistent with the time required for the captain to move his right hand from the control column to the throttles. Accordingly, it is likely that the captain was not holding the control column with his left hand, but that he was instead using this hand to operate the tiller. It can be concluded that the captain was holding and using the tiller throughout the event, making control steering inputs that exceeded 7 degrees of nose wheel steering. ??

No, FDR data doesn't show this, see Figure 7 below.

Figure 7: Plot of FDR data (TRA, control column, control wheel, rudder pedal). The red vertical line indicates the point at which the N1 of engine #4 dropped; the black vertical line indicates the moment at which the throttles were retarded.
