National Transportation Safety Board Aviation Accident Final Report

Location:	Addison, Texas	Accident Number:	CEN19MA190
Date & Time:	June 30, 2019, 09:11 Local	Registration:	N534FF
Aircraft:	Textron Aviation B-300	Aircraft Damage:	Destroyed
Defining Event:	Loss of control in flight	Injuries:	10 Fatal
Flight Conducted Under:	Part 91: General aviation - Personal

Performance Study
CEN19MA190, Textron Aviation B300, N534FF

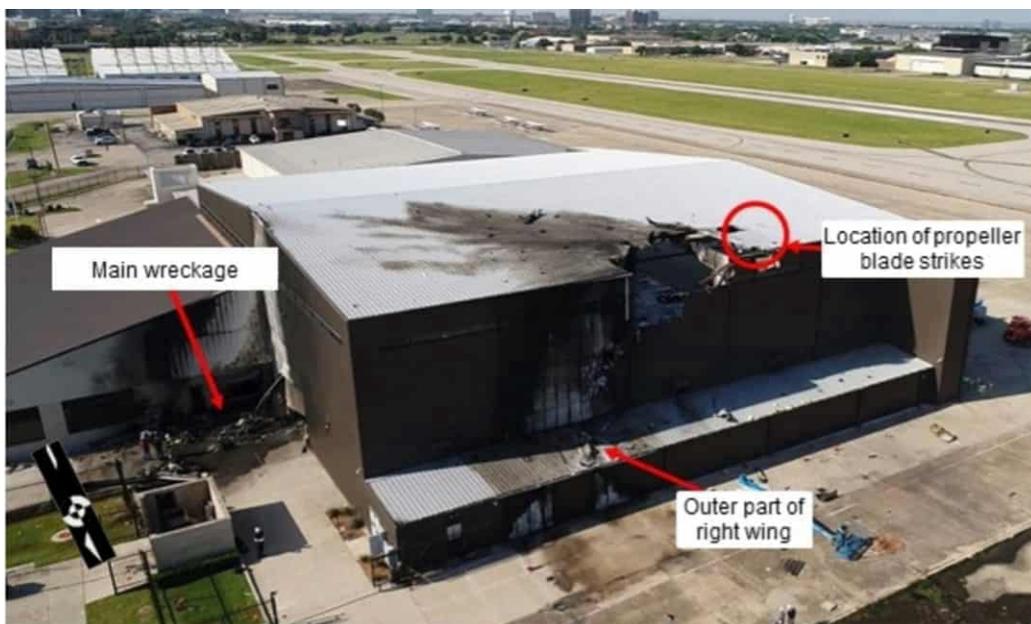
Figure 2. Photograph of an aerial view of the accident site

located on top and inside of the hangar and immediately to the north of the hangar. The main wreckage, which included the right engine and the fuselage, was located outside of the hangar and came to rest on its right side adjacent to a brick wall. Portions of all the crew and cabin seats were identified, and all showed evidence of various degrees of fire consumption. Some seats exhibited deformation consistent with impact damage. Wreckage examination found no evidence of an in-flight fire before the impact with the hangar.

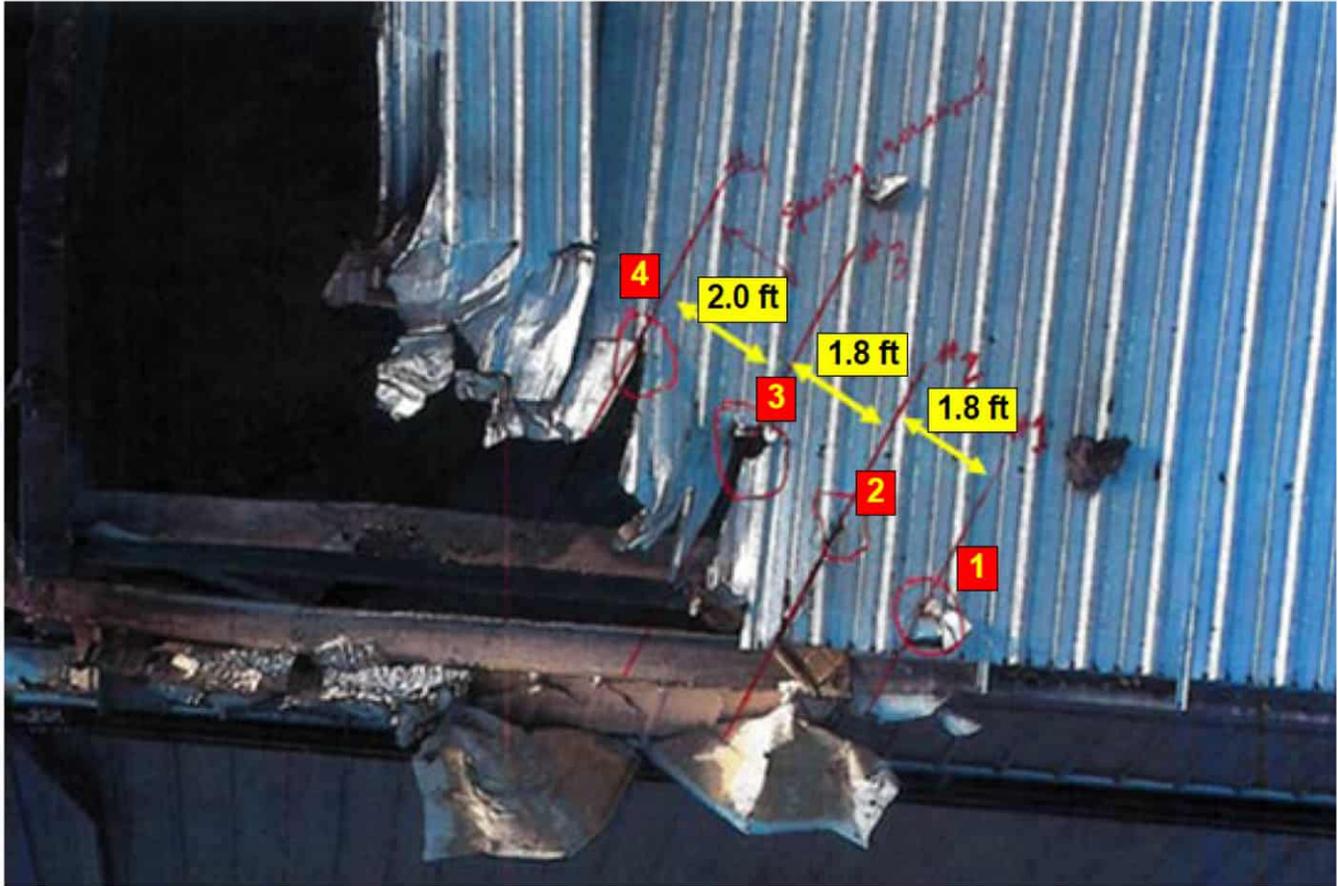
Figure 3. Photograph of propeller blade strikes in hangar roof

Propeller blade strikes (see figures 2 and 3) were observed at the airplane's initial point of impact including a strike to a hangar roof truss, which was coated white. Evidence indicates that the strikes were made by the left propeller. The distances between the propeller blade strikes were measured to determine propeller speed at impact (see figure 3). The left propeller's speed at impact was estimated at 1,259 to 1,300 rpm.

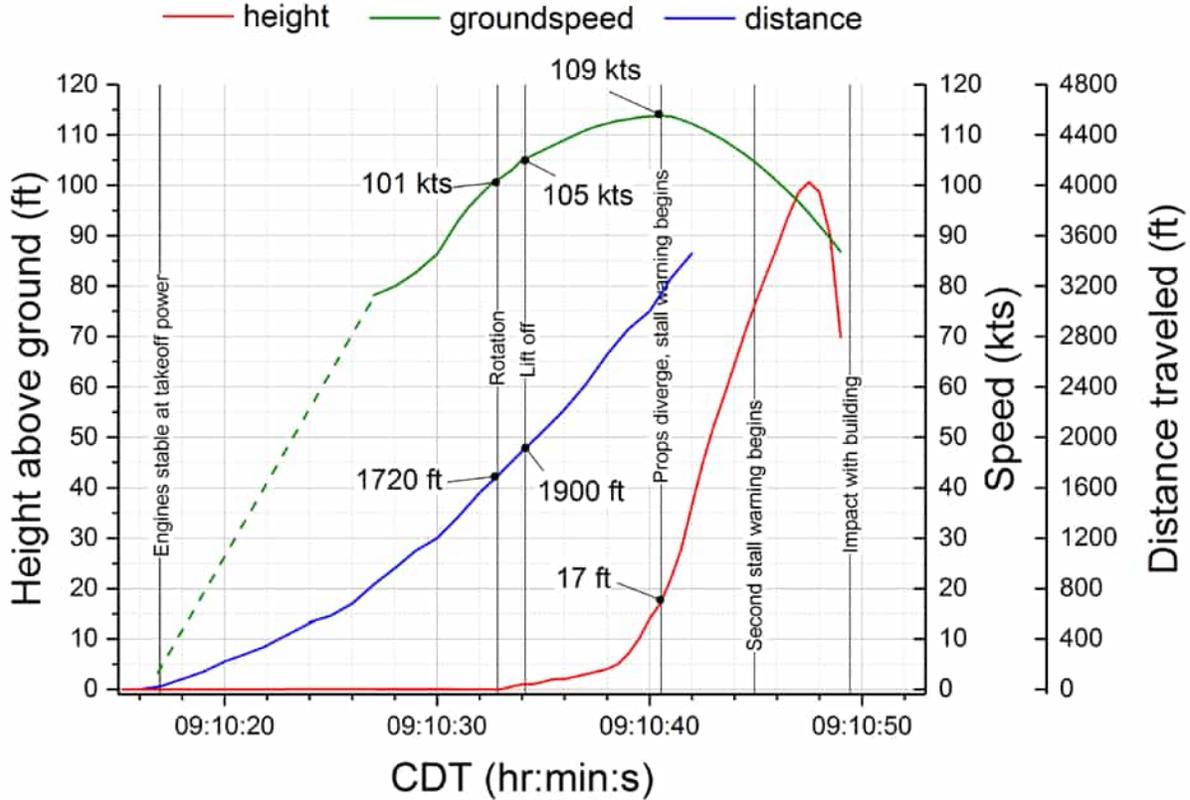
Figure 6. Height above ground, groundspeed, distance traveled, and selected CVR events.

Figure 6 shows the height above ground and groundspeed of the accident flight with selected CVR events. Engines were stable at take-off power at 09:10:16, which was selected to be the start of the take-off roll and the beginning of distance traveled down the runway. Rotation occurred at 09:10:32.8 according to the CVR, when the groundspeed was estimated to be 101 kts (102 kts calibrated airspeed), 1,720 ft down the runway. The airplane lifted off at 09:10:34, at a groundspeed of 105 kts (106 kts calibrated airspeed) and 1,900 ft from the beginning of the take-off roll. At 09:10:40.5, at 109 kts (calibrated airspeed 110 kts) and 17 ft above the runway, the CVR recorded the sound of the left and right propeller speeds diverging and a stall warning alarmed in the cockpit. The initial stall warning ended at 09:10:43, then a second began at

Rotated at too low speed, 8 kt above Vmca, close to wings-level Vmca. VLOF was Vmca + 12? But asym. thrust was not max.

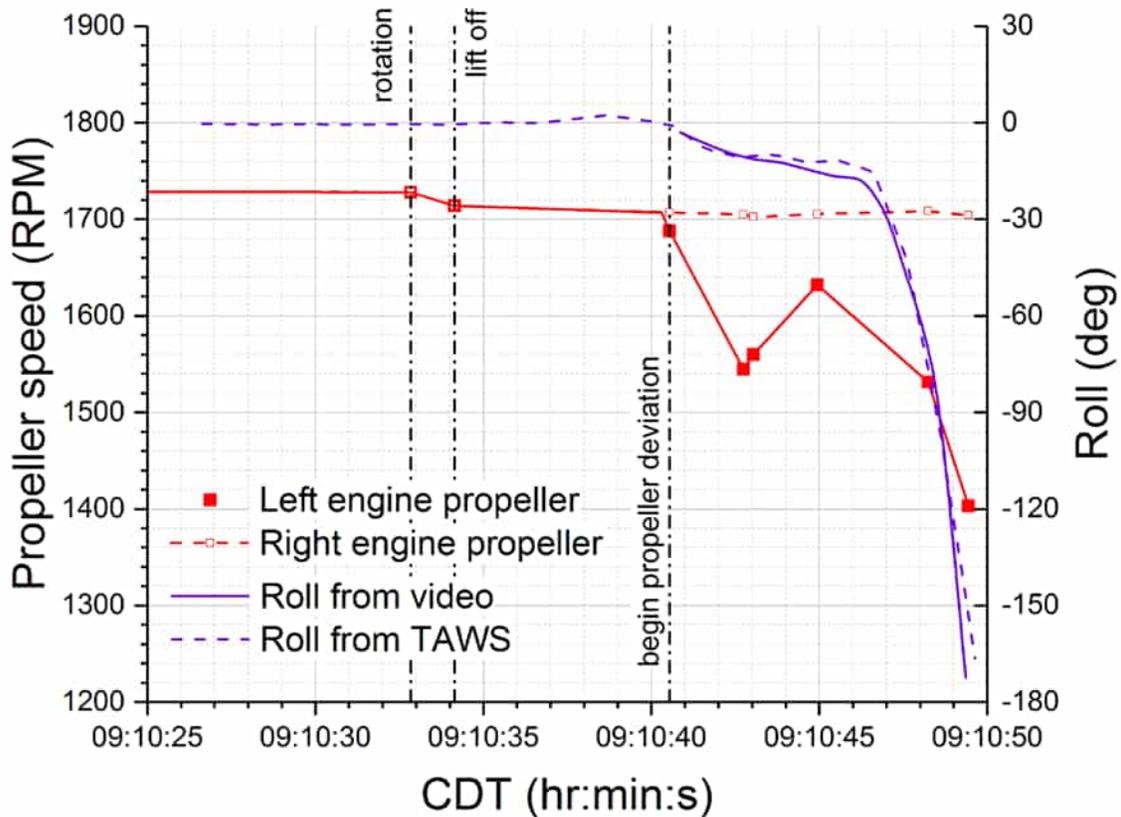
Figure 7. Accident flight propeller speeds and airplane roll angle.

Figure 7 shows the propeller speeds as determined from the CVR. Propeller speeds at the time of lift-off were estimated to be 1,714 RPM to 1,748 RPM. The CVR report found that the propeller sound was consistent between engines until 09:10:40.5 when the left engine’s propeller speed (1,688 RPM) slowed in comparison to the right (1,707 RPM). By 09:10:42.7, the left engine propeller speed was 1,545 RPM. It rebounded to 1,632 RPM by 09:10:44.9 before further falling. By the end of the recording, the left engine was at 1,403 RPM, while the right was above 1,700 RPM. The propeller speed deviation corresponded with the airplane’s left roll. The figure shows the roll from the video and the roll recorded by the TAWS. The airplane rolls from a wings level attitude to -10.6° in the two seconds after the beginning of the propeller speed deviation. This initial roll rate for the first five seconds after the event was about $-5^{\circ}/s$. Then, the roll rate rapidly increased to over $-60^{\circ}/s$ by 09:10:49 and the airplane rolled inverted.

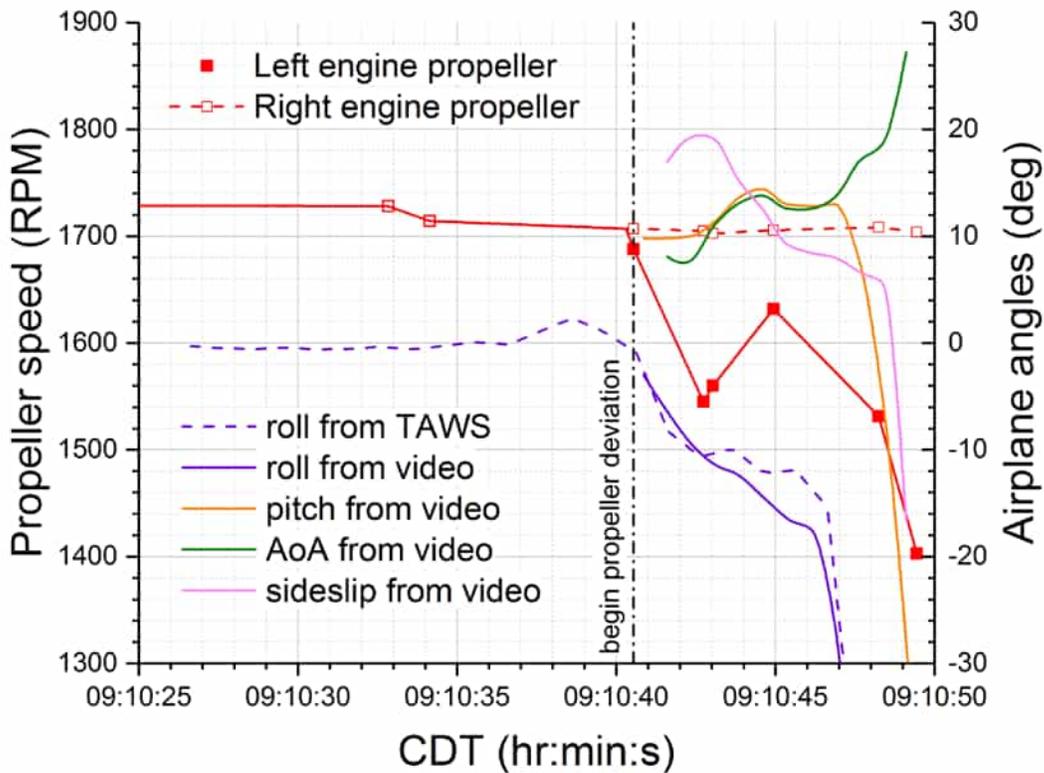
Figure 8. Accident flight propeller speeds and airplane roll, pitch, angle of attack (AoA), and sideslip.

In addition to roll, the video analysis estimated the airplane’s pitch, angle of attack (AoA), and sideslip angle. In Figure 8, the roll angle is truncated to more clearly show the changes in pitch, AoA (α), and sideslip (β). Sideslip was greater than 16° nose left one second after the first record of propeller speed deviation but decreased as the airplane continued to roll to the left. By 09:10:42, the airplane’s flight path was tracking to the left (Figure 4). Pitch and angle of attack increased together to about 13° , when the roll rate drastically increased. AoA increased to nearly 30° while the airplane rapidly pitched down. After the propeller speed deviation, the airplane was slowing and experiencing large changes in attitude, which is consistent with the stall warnings heard in the cockpit.

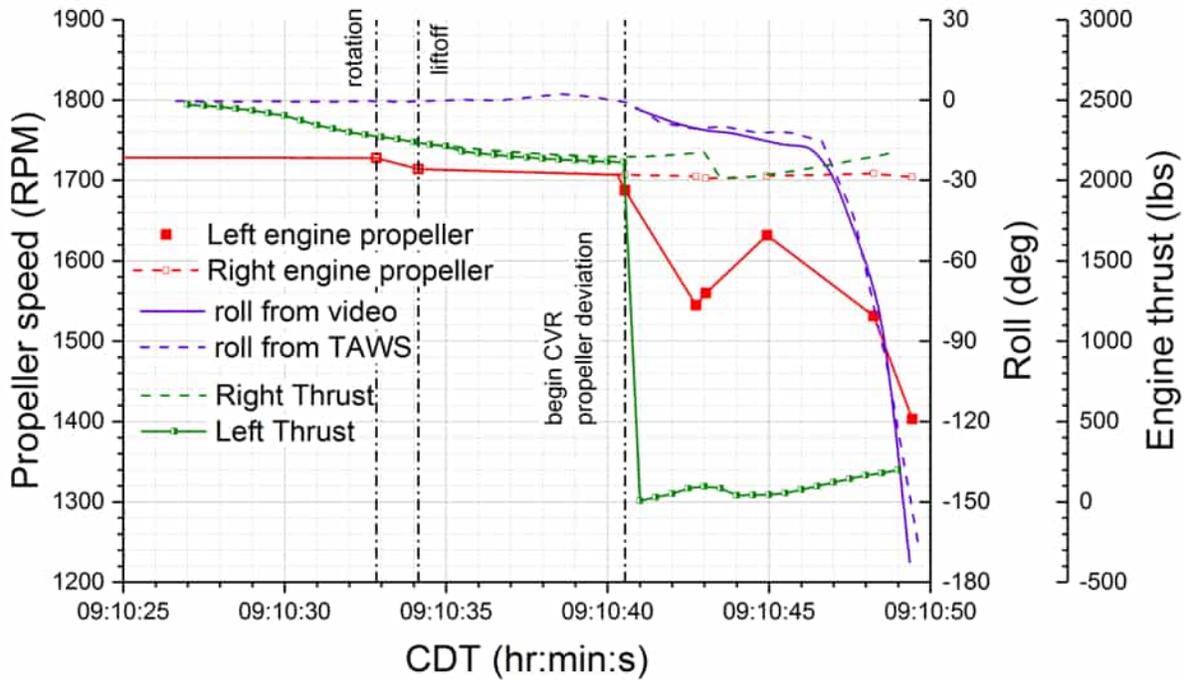
Figure 9. Accident flight propeller speeds, engine thrust, and airplane roll.

Hartzell Propeller Inc. provide engine power and propeller thrust estimates based on the airplane's speed and propeller RPM from the CVR. Hartzell stated that propeller thrust is relatively insensitive to inflow angles (angle of attack and sideslip) less than 30°. Figure 9 shows that when the left engine propeller speed dropped from 1,700 to 1,550 RPM, the thrust produced by the left engine dropped to near zero. The right engine was still producing over 2,000 lbs of thrust until the end of flight. The thrust disparity was consistent with the left yaw and roll of the airplane.

But the thrust vector shifts?
 (which determines which engine
 is the critical engine)

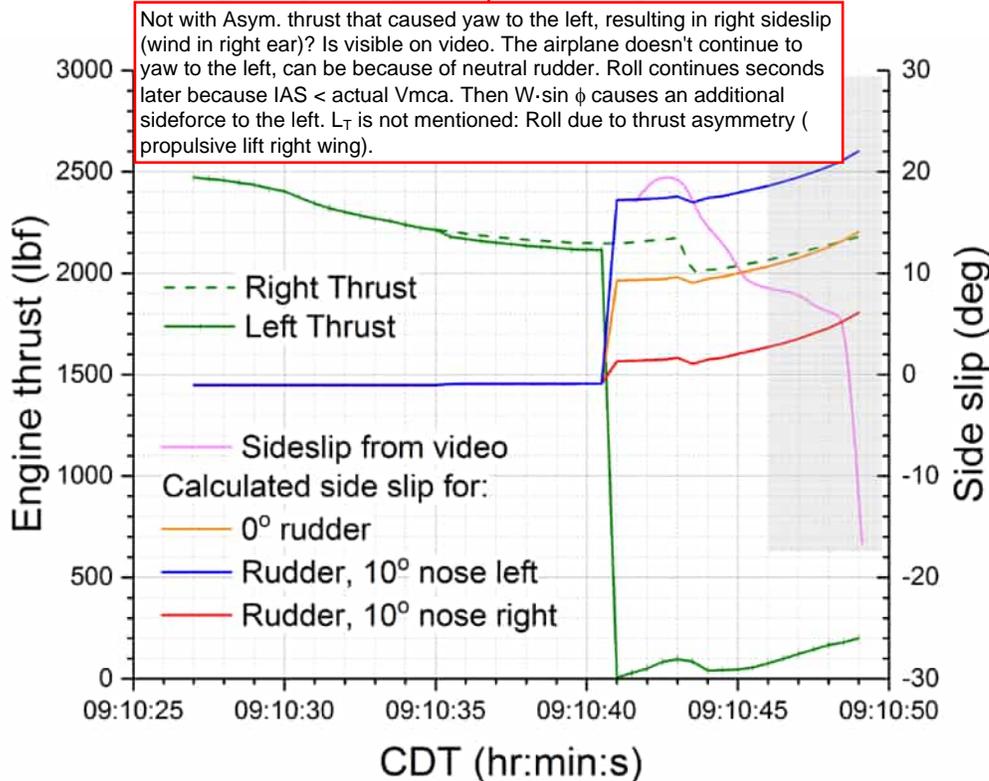
Figure 10 shows the resultant calculated sideslip from no rudder, 10° nose left rudder, and 10° nose right rudder versus the accident sideslip from the video analysis. The shaded region is a region of lower calculation confidence as the airplane roll angle rapidly increased. The initial accident sideslip angle is consistent with nose left rudder before moving towards nose right rudder. Figure 11 shows only the calculated rudder to result in the accident sideslip. Two seconds after the divergence in engine thrust, calculated rudder is about 11° nose left. Two seconds later, left rudder has decreased, passing through zero rudder to right rudder input.

Not with Asym. thrust that caused yaw to the left, resulting in right sideslip (wind in right ear)? Is visible on video. The airplane doesn't continue to yaw to the left, can be because of neutral rudder. Roll continues seconds later because $IAS < actual V_{mca}$. Then $W \cdot \sin \phi$ causes an additional sideforce to the left. L_T is not mentioned: Roll due to thrust asymmetry (propulsive lift right wing).

Effects of weight and bank angle ($W \cdot \sin \phi$) and ailerons not included. This figure is definitely wrong. Was left propeller feathered?

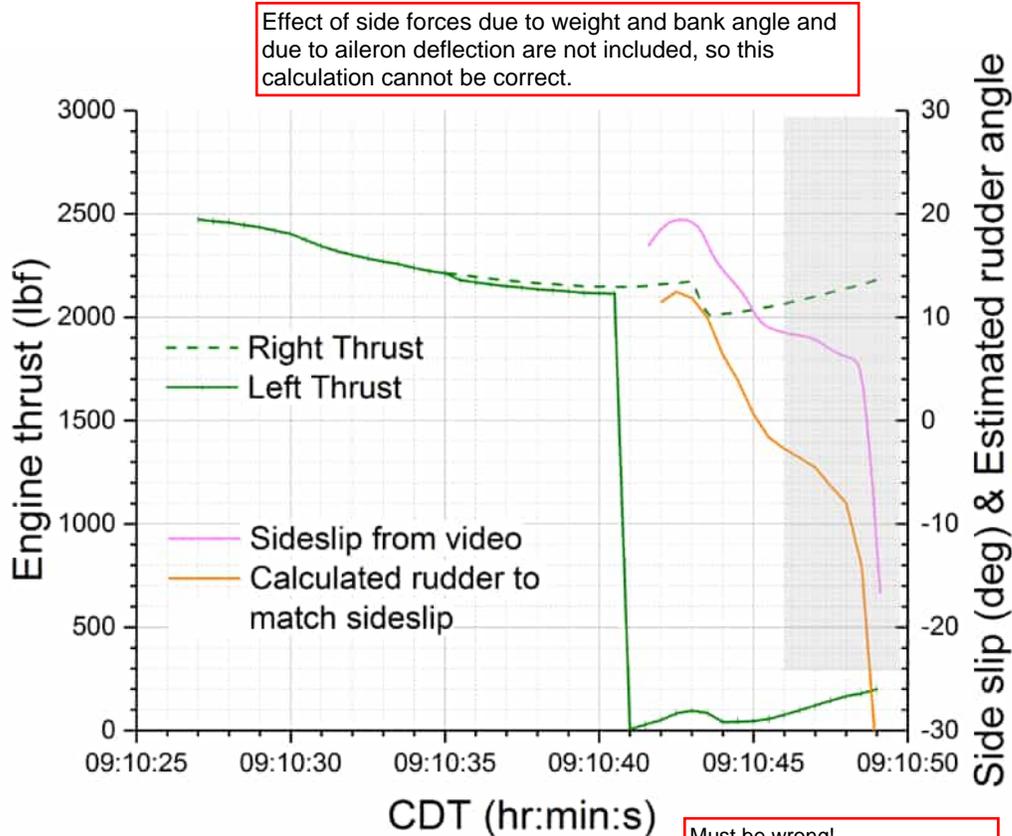
Figure 11. Calculated rudder to match sideslip from video.

Must be wrong!
 Other sideslips sources than rudder are not included.
