**Review of the Final Report**  
**that was written by**  
**J.-L. Françon, L. Bloncourt, D. Kügler**

Dated 18 April 2017

The HAGUE DISTRICT COURT (Chamber of Commercial Affairs)

by  
**Experts of Claimants**

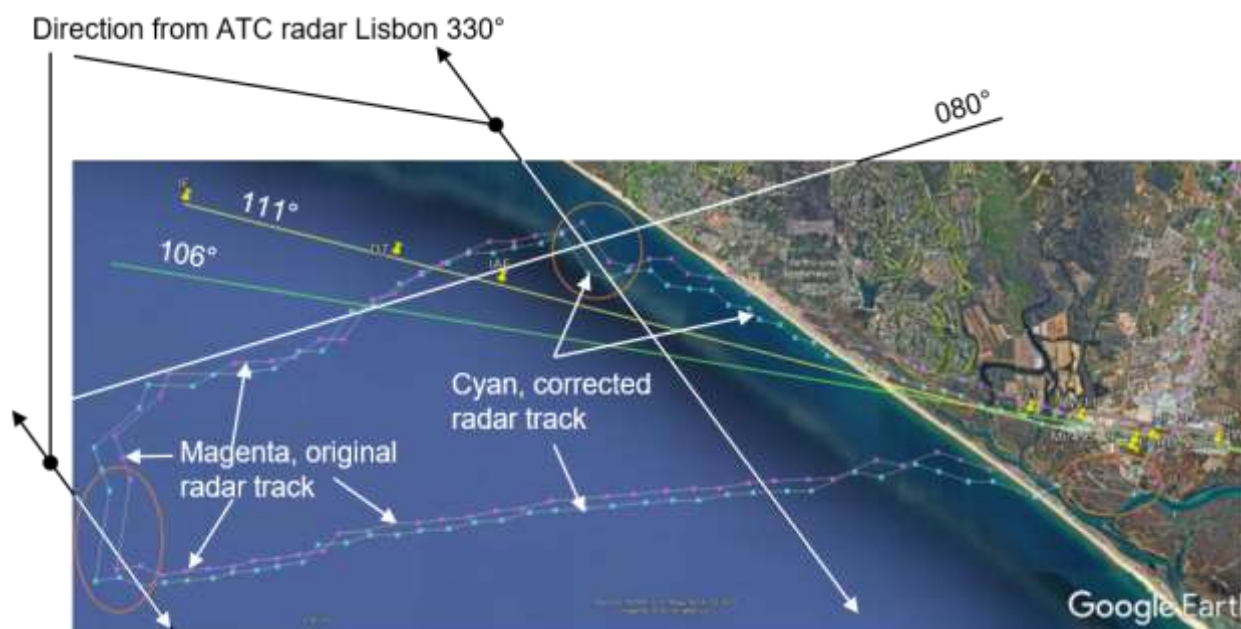
Experts use the "*bearing error*" to explain "*a changing lateral position quality of the radar plots*", meaning position data north or south of the 111° radial. However, with range measurements from the ATC radar that is located perpendicular to the airplane track, this so-called 'lateral' error is a range error and should be zero.

Lateral flight profile based on radar data (Figure 1 out of the Final report page 123). Added are auxiliary lines showing ATC radar direction, and legends of the original (magenta) and corrected (cyan) radar tracks.

errors are near zero, the distance of the airplane track data points to the ATC radar should be very accurate. Yet, the experts emphasize "*In figure 1, the areas with orange circles mark areas with large lateral deviations within the radar track (orange circles). These effects cannot be fully explained at this point*". Experts of claimants can explain: the line connecting the data points within these orange circles point in the approximate NNW direction of the ATC radar near Lisbon; for these points the range errors would apply, not the lateral deviations (if seen from the airport). As explained, range data is very accurate, hence the data plots might not be as accurate as experts think they are. The cause of the data jumps could be errors in the acquired data; these data points should not be used. The radar horizon may play a role here as well.

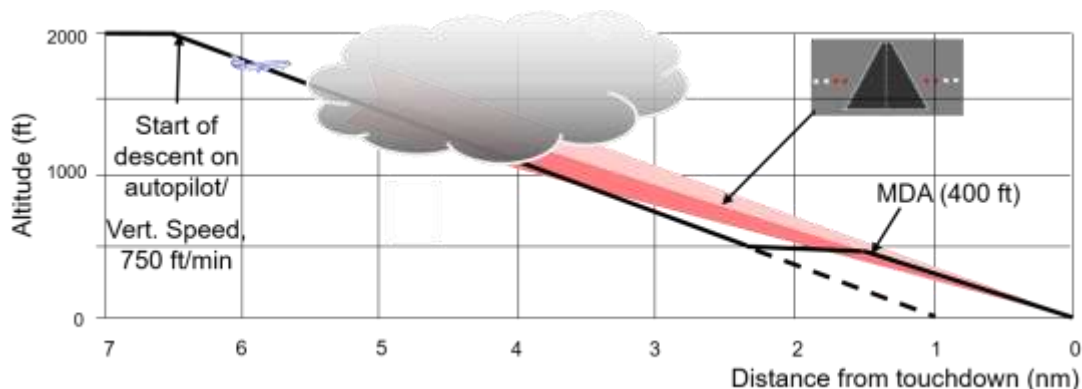
VOR/DME Approach for 125 kt ground speed. Initially, a vertical speed of  $\approx 750$  ft/min set on Autopilot, i.a.w. AOM 3.3.5 – 09). Continued on CWS as soon as PAPI is visible.

5.1.2.2. Experts, in any case the two pilots, should have verified whether the NLR used the correct flight operations assumptions, but they didn't. The NLR research engineer and his superiors, who signed and hence agreed with the report, were obviously not pilots, did not know what the consequence is of the transition from a constant vertical speed in the Command mode of the autopilot to a manually controlled final descent with visual guidance of a PAPI system, which is that the airplane might have to fly level for some time to intercept the PAPI lights if the initial vertical speed, that was set in the autopilot, was a little too high, or the headwind was stronger than anticipated (and the ground speed lower). The PAPI glidepath always has to be intercepted from below, for safety reasons. Refer to the figure above, and to ref. D, § 2.6.1. This short level flight is not evidence of the occurrence of windshear, up- and or downdrafts (and not of tail wind either) but is normal for a non-precision approach.

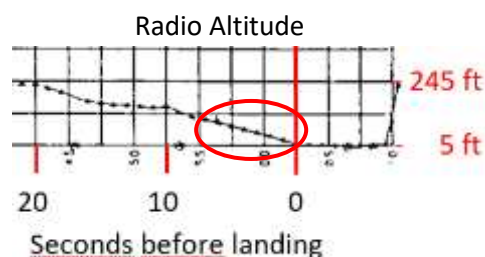
5.1.3.1. Experts wrote "an important flight path deviation" but did not include what they exactly are referring to and what they mean. The airspeed of the aircraft was 139 kt plus a frequent and automatic gust additive of 5 kt by the ATS, until 7 seconds before touchdown, as DFDR airspeed data prove. An increased crosswind would initially only

result in a small increase of the drift angle, because of the  $\geq 139$  kt forward airspeed. Experts should have been able to calculate this increase, like experts of claimants did in ref. D. In addition, an increased headwind might have caused a small increase of the glide path angle, but DFDR data do not prove this either: the rate of descent during the last 7 seconds of flight was constant, as shown in the adjacent figure. The DFDR did not record

abnormal lateral and longitudinal accelerations either, that would prove an abrupt change and "an important flight path deviation". The vertical (normal) acceleration graph in § 5.1.4.1 below proves that the airplane was not pushed down during the last 2.5 seconds of flight but was rather withheld from descending any further because the pitch angle was increased by the captain for a go-around. The NLR noticed this pitch increase in their draft report, but the lead investigator of the DASB required this to be deleted, because it would lead to a different cause/ conclusion of the accident than windshear. Hence, the Portuguese Commission did not get to see this specific NLR conclusion.

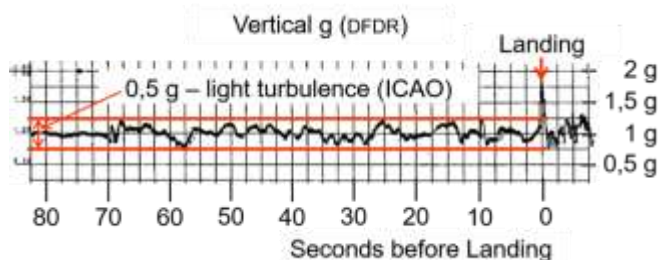
display at 10 sec. before touchdown (190°/ 20 kt, see also § 5.1.7.4 below). Were there "induced accelerations"? Experts "refer to passengers' or crew members' statements", but objective DFDR data only show normal (vertical) accelerations less than

0.5 g, as result of light atmospheric turbulence, during the last 70 seconds of flight, as the DFDR data in the figure above proves.

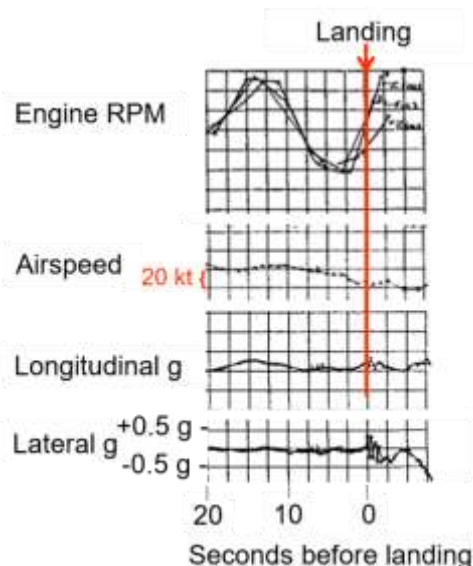
5.1.4.2. There were no (induced) lateral accelerations before landing as the DFDR

data proves (adjacent figure). The small recorded lateral accelerations were caused by rudder inputs by the copilot. The only recorded longitudinal accelerations coincide with engine RPM changes that occurred because the pilot pushed and pulled the elevator controls to which the autothrottle respond immediately (refer to § 3.8 above), and in the last seconds, the longitudinal acceleration increased due to the application of thrust for the go-around. The airspeed decreased because the copilot kept the throttles closed from 15 seconds before landing, until the captain increased them for the go-around at 4 seconds before landing. There were no other accelerations, hence the winds did not "induce accelerations and turbulences", as

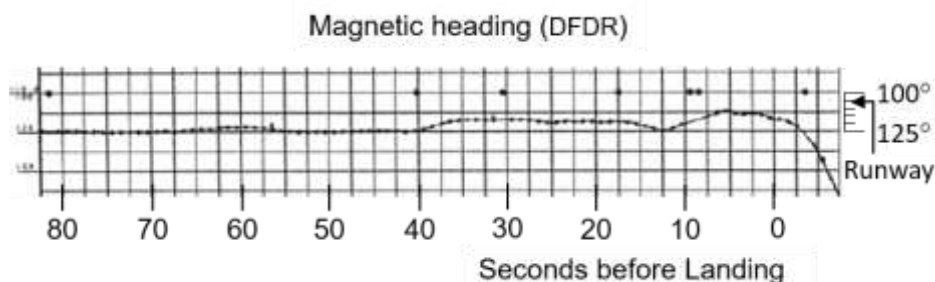
5.1.7.1. The DFDR data (figure below) show that the approach heading of 125° did not change during the last 80 s of flight, with the exception of the small heading changes (yawing) due to (inappropriate) rudder inputs by the copilot between 40 and 13 seconds before landing and during the last 12 seconds of flight. This also means that the wind was constant, otherwise the heading would have been increased to larger than 125°.

5.1.7.2. On FR page 150, Experts wrote: *"The rudder movements are quite important but it is not possible to qualify them as abnormal according the weather conditions (thunderstorm, wind rotation and rain)"*. Abnormal is the inappropriate application of

rudder already from 40 seconds before touchdown, even before reaching the 1 nm point in front of the runway threshold, as shown in the figure above. Experts will not have reviewed AIDS data, RoA Annex 9 chart 6. An expert will be able to "qualify" rudder movements, because these data are in the DFDR and AIDS reports. See also ref. D. The rudder movements during the last 12 seconds are indeed not abnormal because of the requirement to align the airplane with the runway before landing.

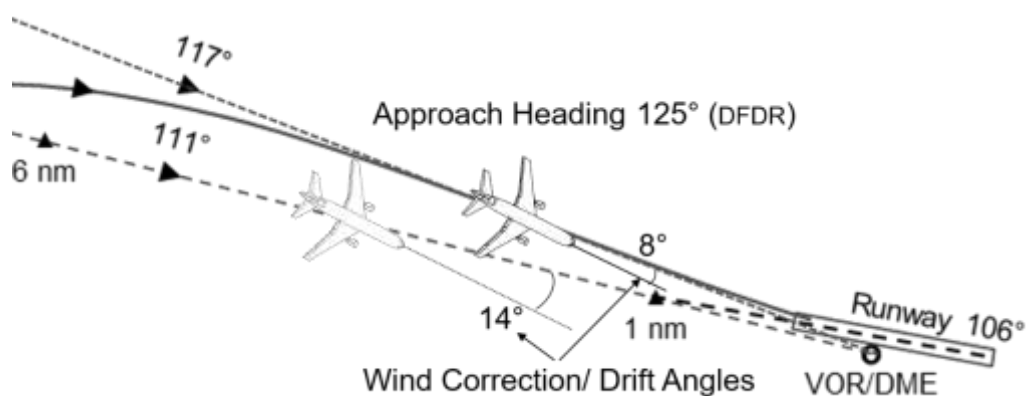
When the airplane would have followed the 111° approach radial with a constant heading of 125° (grey outlined aircraft image in the figure below), meaning a WCA/ drift angle of 14° (!), and at an airspeed of 139 kt, the crosswind component must have been a constant and considerable 34 kt ( $139 \cdot \sin 14^\circ$ ), quite unimaginable because an experienced pilot would not have continued the approach; impossible. The drift angle of a DC-10 at this approach speed at the maximum approved crosswind component of 30 kt is only 12° ( $\sin^{-1} 30/139$ ).

Actual approach course (117°), heading (125°) and required approach radial (111°).

5.1.7.4. Following iterating heading and wind calculations, it can be proven that the ground course of the airplane can only have been 117°, as shown in the figure above (and by ATC radar data in the RoA – front cover), and that the wind during the last 80 seconds of the approach was a constant 190°/ 20 kt, as the captain also read at 10 seconds before landing from the display of navigation computer. This resulted in a more practical WCA of 8°, leading to a required approach heading of  $117^\circ + 8^\circ = 125^\circ$  that was objectively recorded on the DFDR. The final approach, within 1 nm of the runway threshold, will be analyzed in § 5.2.1.2 below.

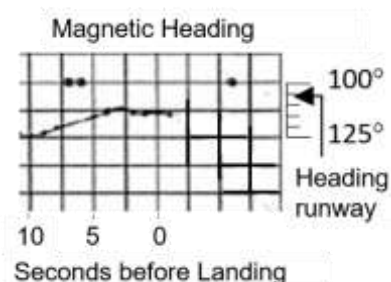
DFDR magnetic heading data in the adjacent figure show that the airplane yawed from the approach heading 125° to 112°, a change of 13° which was, however, not adequate to reach the runway heading of 106°. The yawing angle of 13° however, was approximately equal to the heading change that is required to align the airplane at the maximum approved crosswind component of the DC-10 (30 kt) for which the vertical tail with rudder are designed. The

difference between the approach heading to align from (125°) and the runway bearing (106°) to align to, being 19°, obviously exceeded the control power of the rudder at the given approach speed. This knowledge assists in revealing the actual final approach path of the airplane as well.

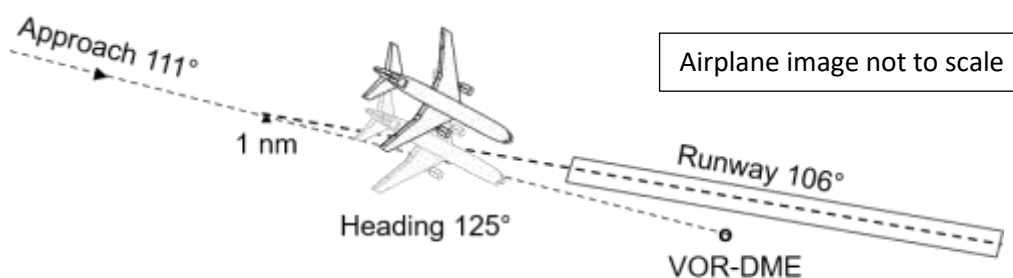
5.2.1.2. If the airplane would have been flying at the extended runway centerline (106°), with the on-board measured actual crosswind (190°/ 20 kt) that was confirmed to be correct in § 5.1.7.4 above, then the wind correction angle would have to be 8° and the heading within 1 nm from the threshold had to be 106° + 8° = 114°. With the ATC-provided wind (150°/ 20 kt), these data would be 6° and 112°, respectively.

In both of these cases, there would have been ample rudder control power to reach the 106° runway bearing with 90% rudder deflection. Even if the wind would have been 220°/ 35 kt, as was suggested, then still adequate rudder control power would have been available to line up with the runway. The 90% rudder input by the copilot however, was not adequate to align the airplane with the runway from the DFDR recorded approach heading 125°, as shown in the figure with the magnetic heading of the last 5 seconds above. Hence, the airplane was not approaching on the extended runway centerline (106°) but on the 117° radial as analyzed in § 5.1.7.4 above and shown in the figure below. Ref. D presents the detailed analysis on this subject.

The shaded aircraft image shows the position according to the experts, the solid lined image according to experts of claimants i.a.w. DFDR and AIDS data analysis.

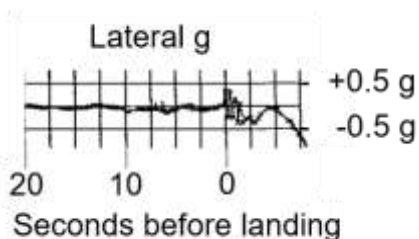
The DFDR lateral acceleration (g) data in the adjacent figure only show very small

changes that coincide with the changing rudder inputs from 10 seconds before the landing, and a larger value at touchdown, caused by the lateral forces due to the 11° crabbed landing. The objective DFDR data in the figure above shows that there was no lateral acceleration during the last seconds of flight and hence, do not confirm the conclusion by experts that "*there is a lateral*

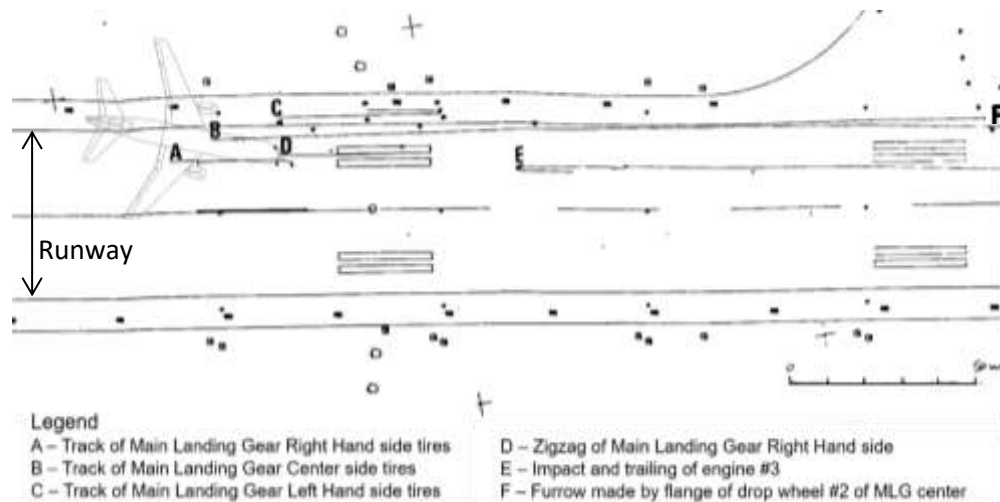
Impact area MP495 on runway 11, RoA Annex 11.

The scratches of the tires (A – C) and of the right engine nacelle (E), and the wide and deep groove (F) caused by a rim of the center main landing gear after the initial touchdown, were all in the direction of the runway, not to the left as would be the case following a lateral movement towards the left of the runway, as experts concluded. It is impossible to change the path of a 161-ton body from the centerline to the left side of the runway in a jiffy; the laws of physics applied to MP495 as well. A rapid increase of the wind would have had little influence on an aircraft of which the forward airspeed was still about 130 knots; only the heading would have increased a bit. The heading did increase a few degrees, but this was due to the pilot releasing the rudder (§ 5.2.1.4 above).

The impact on the left side of the runway (the left main landing gear touched down outside of the runway) and the scratches and groove (furrow) in the direction of the runway, as presented in RoA Annex 11 (refer to B in the figure below), support the claimants' conclusion that the aircraft just made it to the left edge of the runway coming from the left, on approach radial 117° rather than 111°, as the figure in § 5.2.1.2 shows.

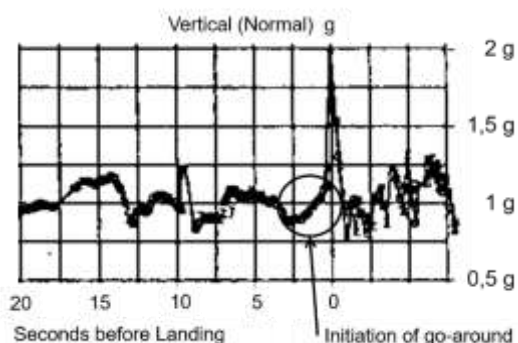
down, because pitching-up for the initiation of a go-around decreases the rate of descent of an airplane, as also shown in the adjacent figure with DFDR data of the normal, vertical acceleration.

The normal g increases in the last 3 seconds of flight proving the decrease of the rate of descent just prior to touchdown rather than *"subsequently a high rate of*

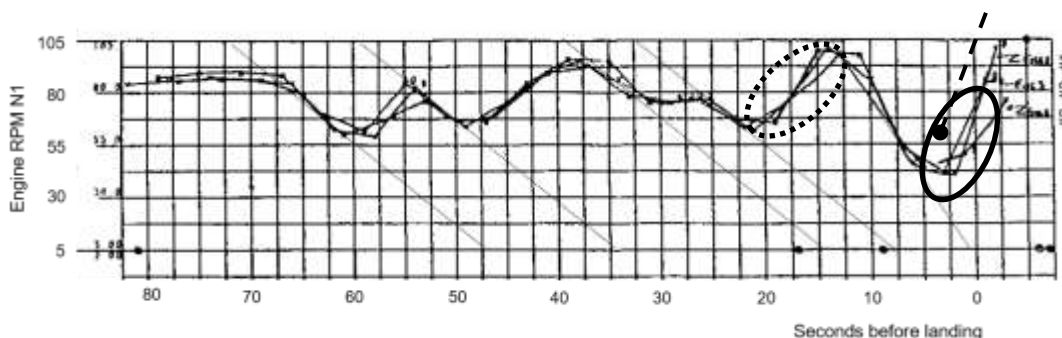
Comparison RPM decrease by autothrottle (4x) and manually by the copilot (1x); this last rate of decrease is larger (DFDR-data, RoA Annex 15).

5.6.1.1. The "*strong thrust increase*" mentioned by the experts must be the increase from 20 seconds before the landing (dotted oval in DFDR engine RPM data in the figure above). This increase was not caused by initiating "*a missed approach procedure*" at that time, but by the autothrottle system because the copilot pulled on the control yoke increasing the pitch after the captain said three times "*bit low*" (CVR), and also because the airspeed decreased. The captain said this because AOM 3.3.5 – 14 requires for a PAPI approach below 200 ft that "*the aircraft must be brought gradually above the "on glide slope" indication to provide a 30 to 40 ft wheel clearance at the threshold*". Otherwise the landing gears of the large DC-10 would touchdown in front of the runway threshold, at Faro's not too long runway.
