ACCIDENT

Aircraft Type and Registration:	Cessna 310Q, G-BXUY	Limited review by Lt-Col (ret'd) Harry Horlings/ AvioConsult, graduate FTE of the USAF Test Pilot School (class 1985A) and former chief Flight Test of the Royal Netherlands Air Force. First text box is on page 15.
No & Type of Engines:	Two Continental IO-470-VO piston engines	
Year of Manufacture:	1970 (Serial No: 310Q-0231)	The sole objective of this review is the improvement of investigations of engine failure related accidents to prevent future accidents. It is not the purpose of this activity to apportion blame or liability.
Date & Time (UTC):	15 November 2013 at 1158 hrs	
Location:	Hawarden Aerodrome, Chester	
Type of Flight:	Private	
Persons on Board:	Crew - 1 Passengers - 1	
Injuries:	Crew - 1 (Fatal) Passengers - 1 (Fatal)	
Nature of Damage:	Aircraft destroyed	
Commander's Licence:	Commercial Pilot's Licence	
Commander's Age:	58 years	
Commander's Flying Experience:	1,645 hours (of which 261 were on type) Last 90 days - 18 hours Last 28 days - 6 hours

Information Source:	AAIB Field Investigation

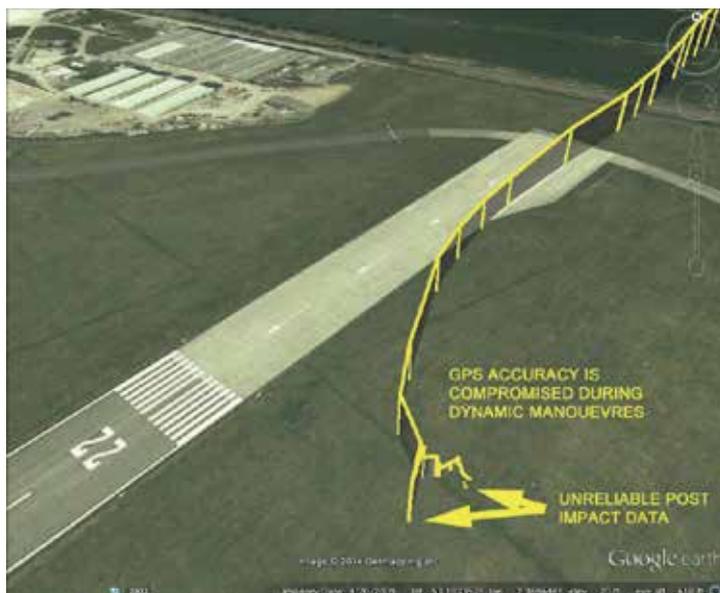
Figure 1

Recorded flight path: final approach and accident sequence

It is probable that G-BXUY's deviation to the left on final approach was a result of the left engine losing power, a situation which the properties of the constant speed propeller system may initially have masked from the pilot and which would have given rise to the apparent control difficulties described by all eyewitnesses. The aircraft drifted to the side of the runway, with very little height or time available to the pilot to correct. Faced with the alternative of landing on the grass, the pilot appears to have attempted to fly a go-around.

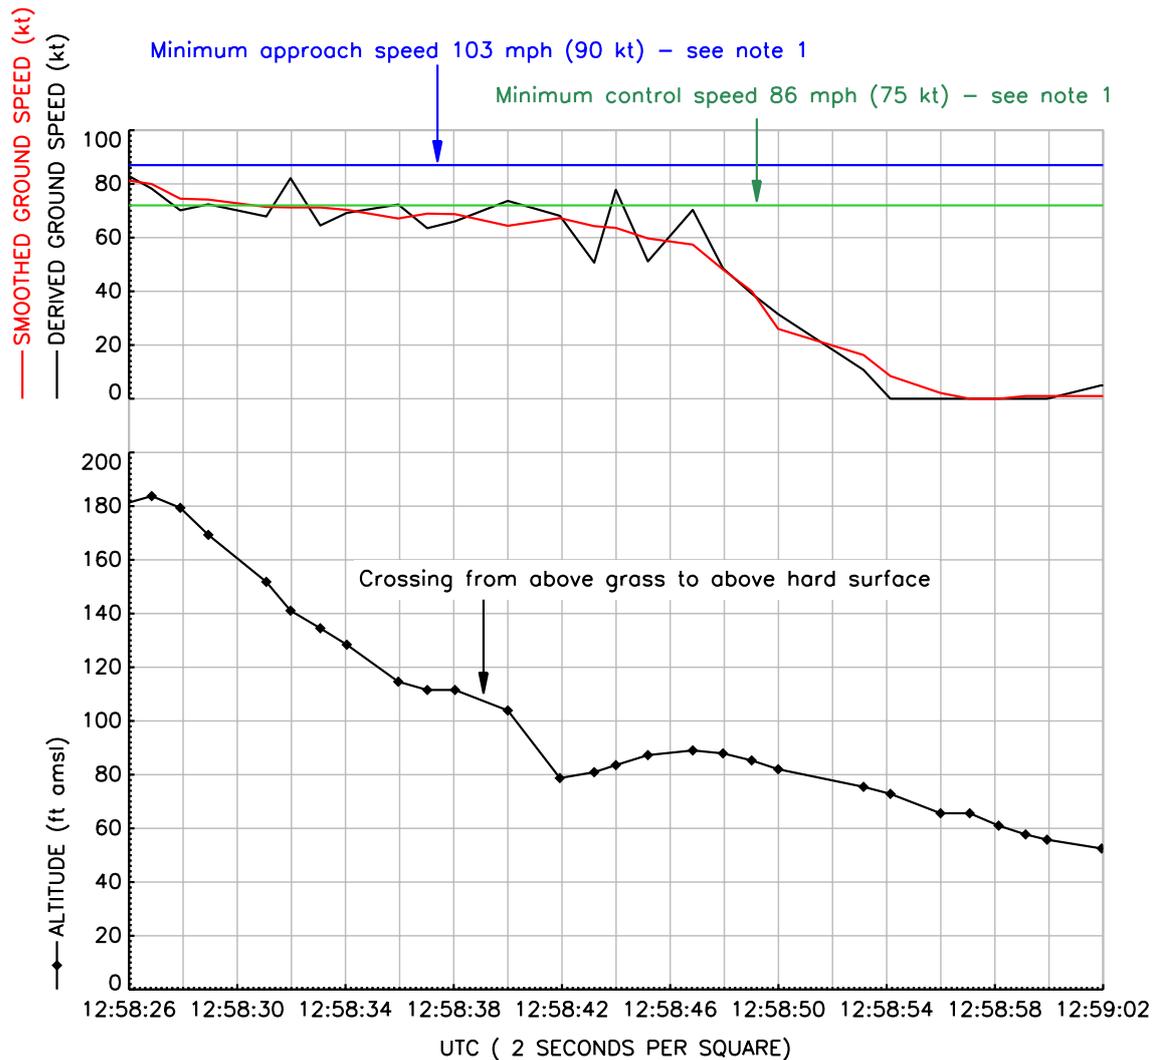
Figure 2

Recorded altitude data and derived speed

Note 1. A 3 kt headwind allowance is factored into the displayed minimum speed

Note 2. GPS accuracy is compromised during dynamic manoeuvres

Note 3. GPS altitude continued to drift down post-impact as altitude errors continued over time

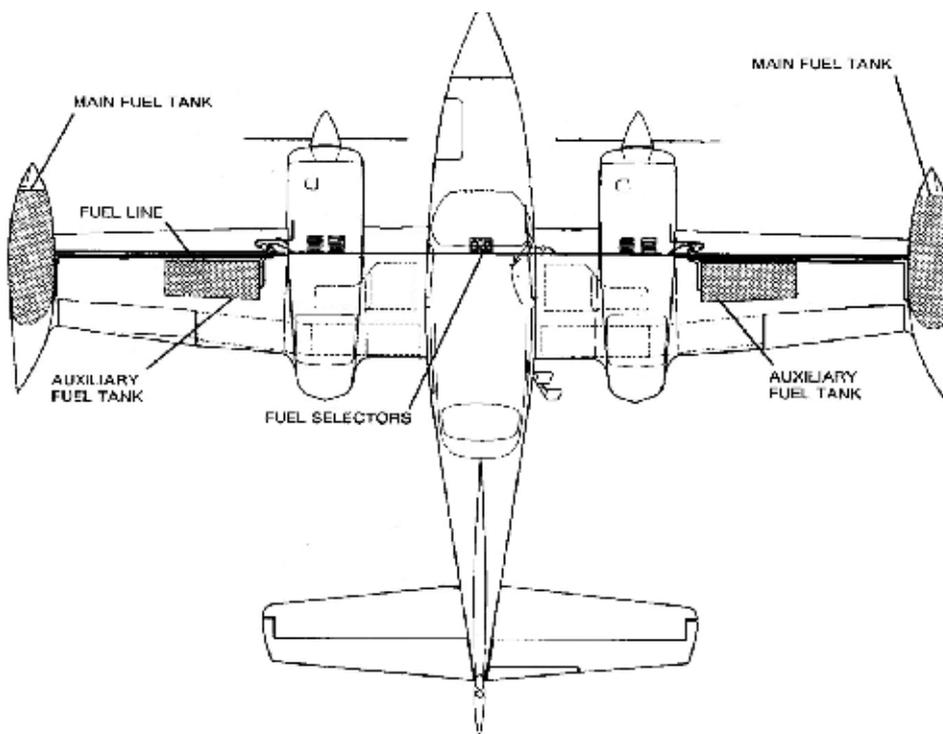
The aircraft was a Cessna 310Q powered by two Rolls Royce Continental IO-470-VO engines. The fuel system for the aircraft consisted of four fuel tanks: two 51 US gallon (193 litre), wingtip-mounted, main fuel tanks and two 20.5 US gallon (78 litre) auxiliary fuel tanks in the outboard section of each wing (Figure 3). A pair of fuel selector switches, mounted on the cockpit floor, operated a fuel selector valve immediately outboard of each engine, which allowed each engine to receive fuel from its respective main or auxiliary tank, or to cross-feed fuel from the other main tank. The cross-feed, which was intended for emergency use, was the only interconnection between the left and right fuel systems.

Figure 3
G-BXUY fuel system

The absence of fuel within the left main fuel tank and the limited quantity of fuel recovered from the left engine fuel injection manifold valve indicated that the probable reason for the difference in engine power was fuel starvation. Given the lack of evidence of fuel spillage from the right main fuel tank, it is considered that the right hand fuel system was also at a low level and that the right engine would also have begun to experience fuel starvation problems had the flight continued for any length of time.

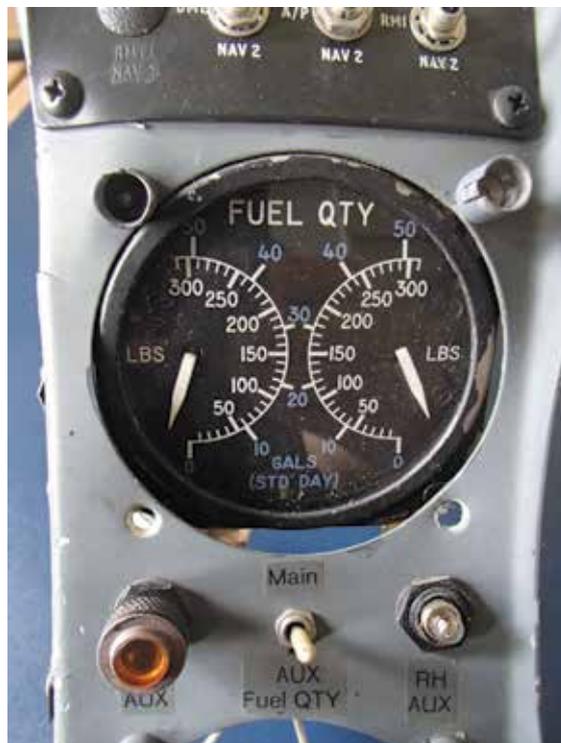
Each fuel tank is fitted with a capacitive sensor which provides fuel quantity readings to a pair of gauges in the cockpit. The gauges (Figure 4) automatically provide an indication of the fuel quantity in the fuel tanks selected by the fuel selector. A self-centring switch below the gauges allows the pilot to verify the contents of the other, non-selected tanks. Auxiliary tank indicator lights below the gauges illuminate when the associated auxiliary tank is selected for engine feed. The optional main fuel tank low quantity warning lights had not been fitted to G-BXUY. A dual fuel flow gauge was also fitted.

Figure 4
G-BXUY fuel quantity gauge
(electrical power not applied)

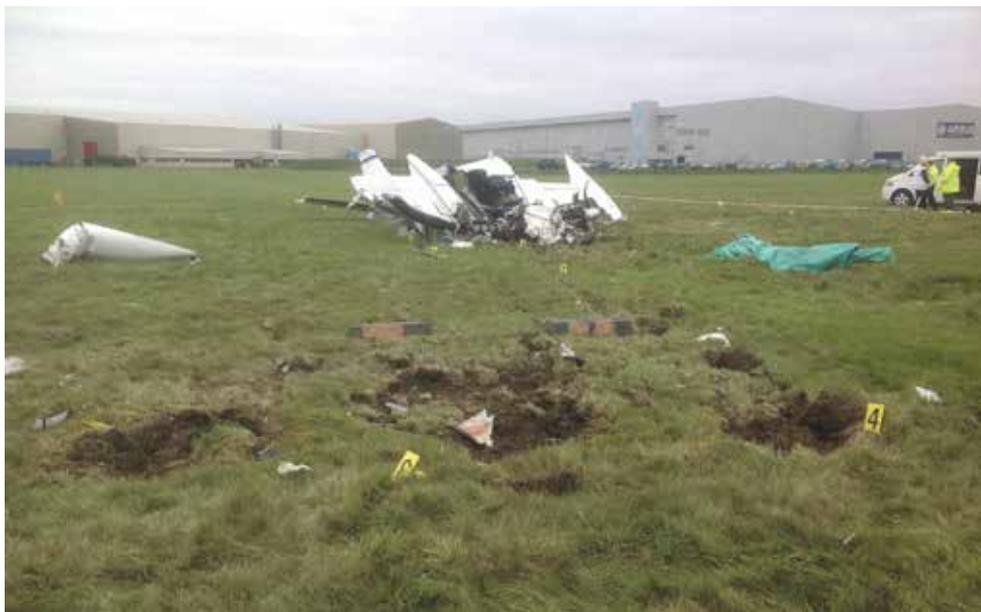
Ground marks indicated that the aircraft first struck the ground inverted, in a steep nose-down attitude 115 m beyond the left edge of Runway 22 and 15 m before the threshold markings. After the initial impact the aircraft travelled backwards on its main landing gear for approximately 20 m before coming to rest (Figure 5). The fuselage of the aircraft had failed immediately aft of the main spar and the nose of the aircraft had been severely damaged. The right tip tank had ruptured and separated from the wing and the right wing exhibited compression damage to the outboard leading edge. The right propeller had dug into the ground during the initial impact which had resulted in a failure of the engine crankshaft and separation of the propeller. The left propeller remained attached to its associated engine.

Figure 5
Accident site

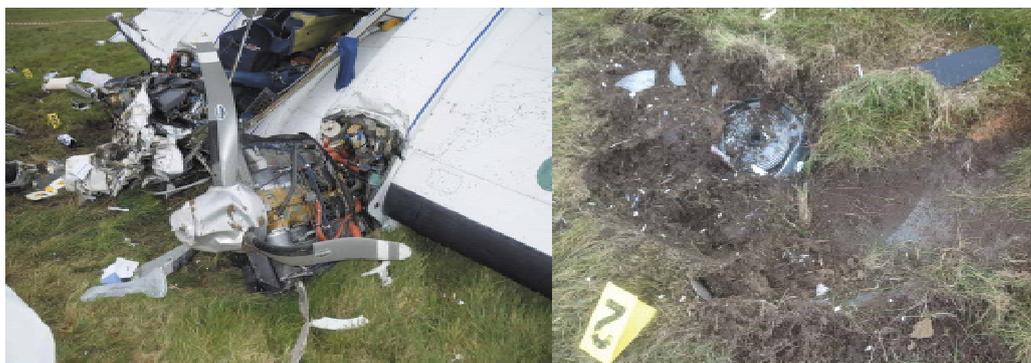
Figure 6

Examination of the right propeller showed that rotation of the propeller during the initial impact had caused all three blades to dig into the ground; two of the blades exhibited significant rearwards bending of the blades at approximately half span as a result of rotation through the soil (Figure 6). The left propeller exhibited significantly different damage from the right; one blade had been bent backwards and the remaining two blades had been bent forward at mid-span. There was little evidence of rotational damage to any of these blades.

Left and right propellers

Two of the blades fitted to the right propeller showed chordwise witness marks and exhibited significant twisting and rearward bending along the span of the blade. One of these blades, the first to enter the ground, was found to be at a higher pitch setting when compared to the other two blades, which appeared to be at or close to the FINE pitch position.

The damage to the left propeller showed significant differences from that observed on the right. Damage to the propeller spinner was restricted to one third of the circumference, corresponding to the position of the propeller blade which had been bent backwards and little evidence of rotational damage was observed. All three of the blades on the left propeller appeared to be at or close to the FINE pitch position.

The witness marks observed on the faces of the right propeller preload plates indicted that all three propeller blades were at the same pitch angle of 15° at the start of the impact sequence. The damage observed to the right propeller blades and the failure of the right engine crankshaft was consistent with the engine operating at high rpm at impact. Analysis of the blade pitch angle data by the propeller manufacturer confirmed that a blade pitch angle of 15° was consistent with a Continental IO-470-VO engine operating at its maximum governed speed of 2,625 rpm, as may be expected during the early stages of a go-around. Given that the No 3 blade of the right propeller was the first blade to enter the ground, it is thought that the forces acting on the blade were sufficient to twist the blade in the hub, resulting in the failure of the pitch change knob and an increase in blade pitch when compared to the remaining two blades.

The lack of rotational damage to the left propeller, and the deformation of its blades, was consistent with the left engine operating at low power at impact despite all of the engine controls being in the 'full power' position. The closure of the left propeller blade pitch locks
