Emergency landing at sea with Britten-Norman Islander near Bonaire on 22 October 2009

Limited number of comments included following review by Harry Horlings - AvioConsult, graduate of the USAF Test Pilot School - the highest level flight training in the world.

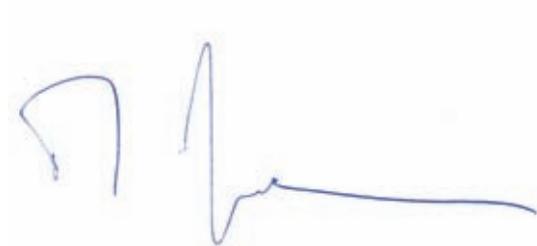
T.H.J. Joustra
Chairman of the Dutch Safety Board

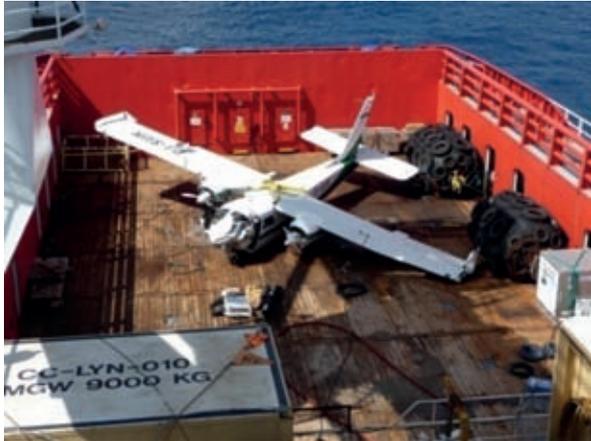
Figure 2: PJ-SUN after it was salvaged

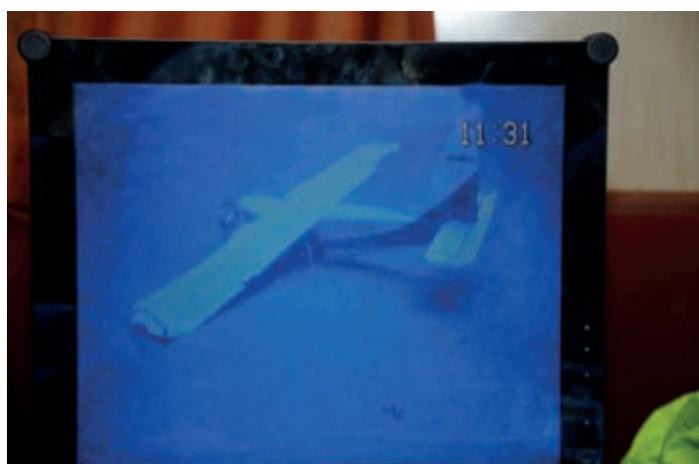
Figure 4: monitor with an image of the PJ-SUN on the seabed

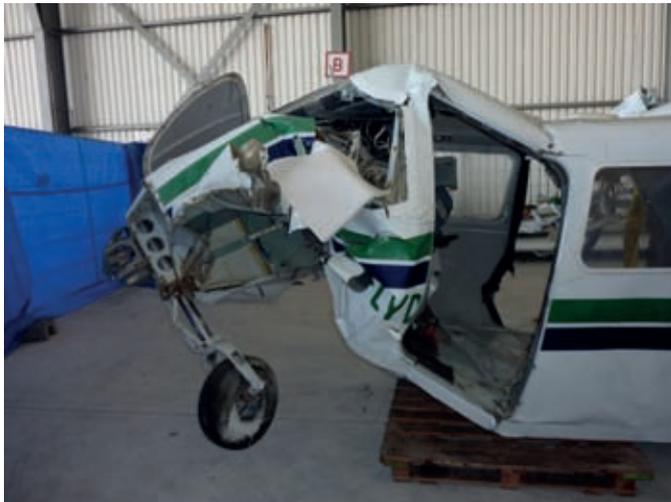
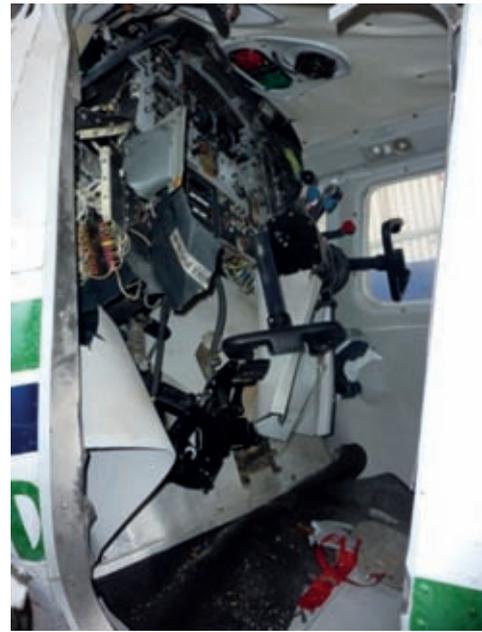
*Figures 5 and 6: side view of the deformation of the aircraft nose and cockpit (seats removed)
Left: damage to aircraft nose, cockpit floor twisted upwards. Right: instrument panel against the roof.*

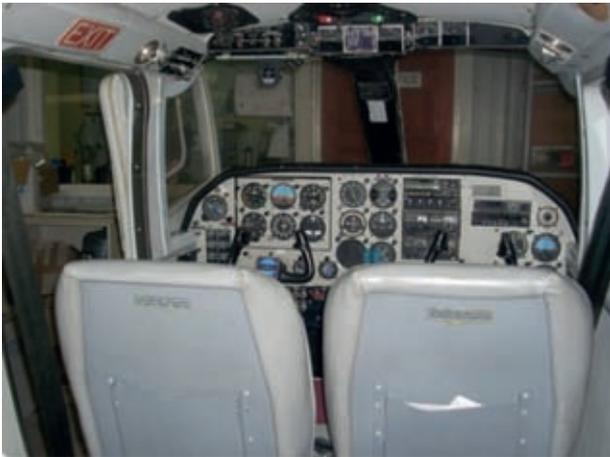
Figure 7: cockpit space of a comparable Britten-Norman Islander viewed from the second row

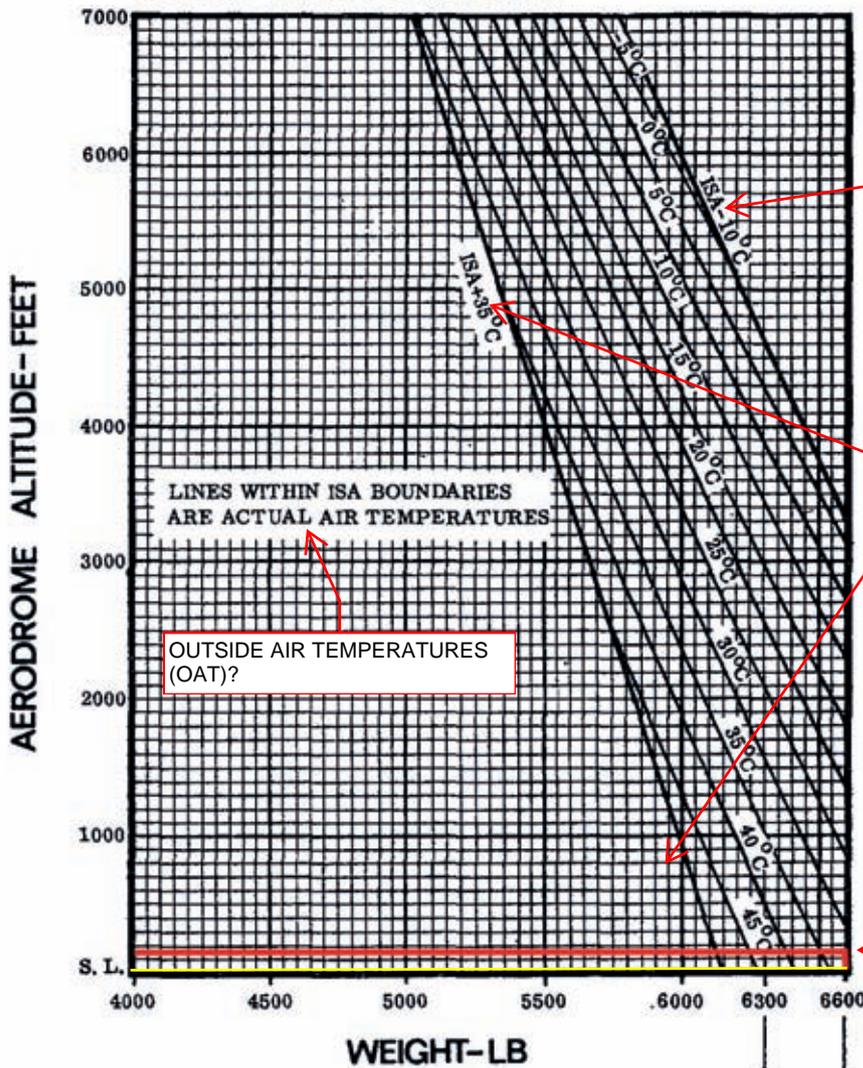
The use of ISA with the figures is confusing and incorrect. Is this line for +15 (ISA at SL) - 10 = +5° like for the most left side line? No, this line must be for an actual OAT of -10°C (would be ISA - 25°).
