Loss of control — Embraer S.A. EMB-120ER Brasilia, VH-ANB

Darwin Airport, Northern Territory | 22 March 2010

ATSB Transport Safety Report
Aviation Occurrence Investigation
AO-2010-019
Final

Report No. AO-2010-019

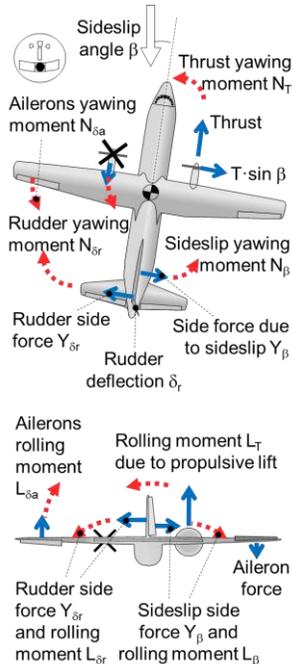
Figure 1. Forces and moments when wings are kept level.

Figure 1 shows that balance of side forces can only exist with a sideslip. The rudder deflection required to balance the asymmetrical thrust moment causes the airplane to accelerate to the left increasing the sideslip. The side force due to sideslip increases until the side forces are in balance. This equilibrium results in additional drag and a flight path to the left (of the extended takeoff runway centerline).

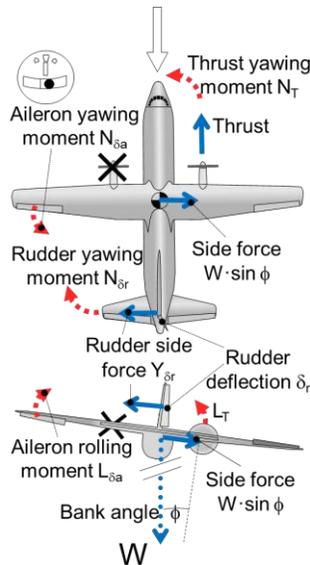
Figure 2. Forces and moments when maintaining a small 5° bank angle away from the inoperative engine.

Figure 2 shows that the side force due to sideslip can be replaced by the side force due to the small bank angle ($W \cdot \sin \phi$). The rudder now only has to counteract the thrust yawing moment, and not the sideslip yawing moment anymore. Airspeed can be decreased until the rudder is again fully deflected: V_{MCA} is lower than for wings level.

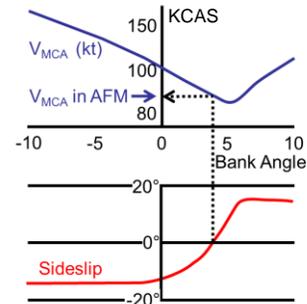
Figure 3. The relationship between bank angle and V_{MCA} after failure of engine #1, sample airplane.

Figure 3 shows the relationship between V_{MCA} and sideslip of a sample airplane. The V_{MCA} is determined at the bank angle for zero sideslip (for maximum remaining climb performance). As shown, (actual) V_{MCA} varies with bank angle. When the wings are level, (actual) V_{MCA} in this case is 15 kt higher than the AFM published V_{MCA} . At bank angles greater than +6°, the airspeed needs to be higher to avoid the vertical fin to stall.

The airspeed also decayed due to the increased sideslip into the dead engine' side, because the pilot didn't maintain the bank angle for zero sideslip, minimum drag. Refer to Figure 3 on page 52.

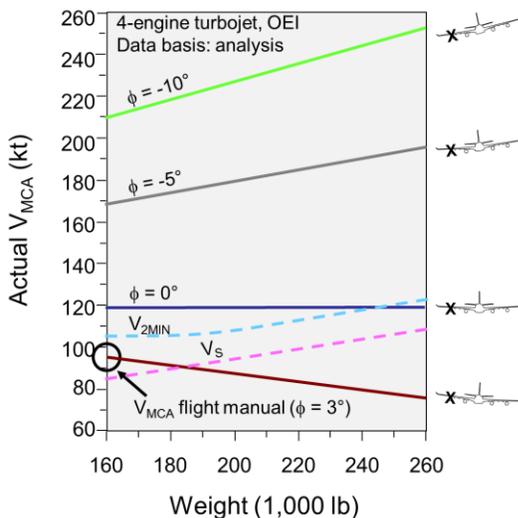
Figure 4. Effect of weight and bank angle on V_{MCA} .

Minimum weight, because V_{MCA} at low weight is higher than at high weight (effect of 5° bank angle). Low weight is worst case for V_{MCA} and is therefore used. Refer to Figure 4 on page 52.

Relationship between weight and V_{MCA} is illustrated in Figure 4 on page 52.

Figure 4 shows the effect of weight and bank angle on V_{MCA} . V_{2min} for this sample airplane is also presented. Notice that when the wings are kept level, V_{2min} is lower than V_{MCA} . Lockheed Hercules and Electra pilots will recognize this figure, because it is similar to a figure in their Performance Manual SMP777.

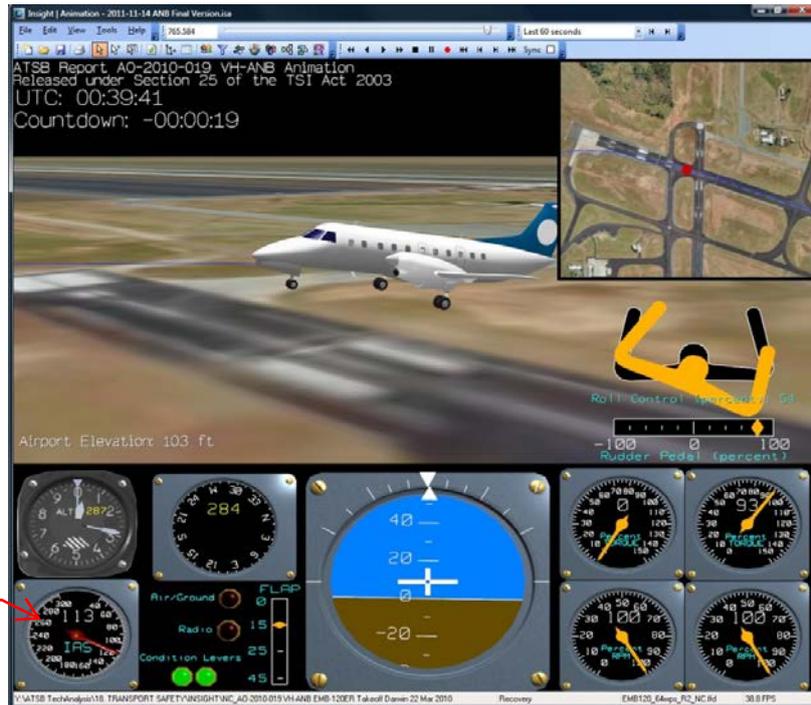
Figure C-3: Left engine torque decreases to 0% V and 19 seconds to end of recording

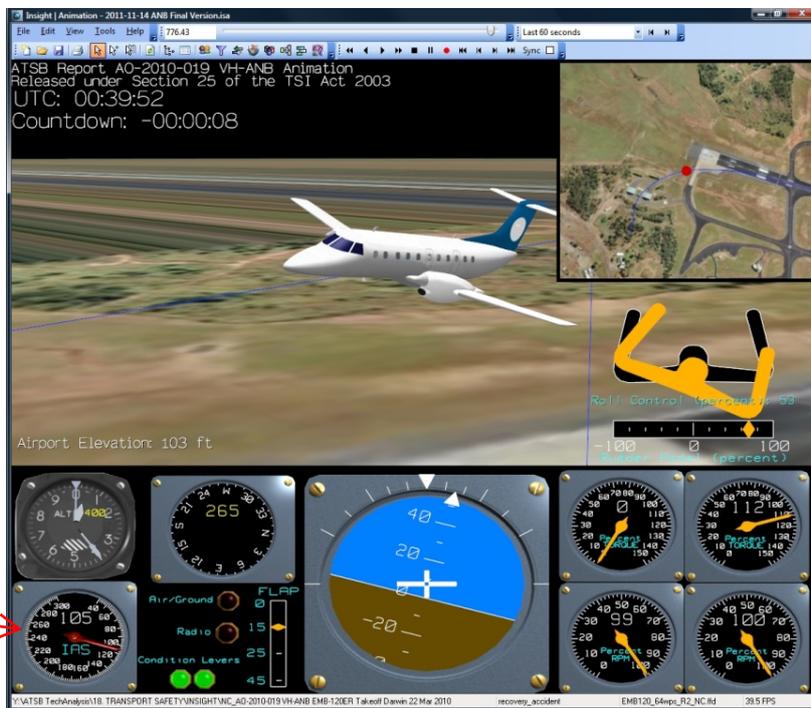
Figure C-4: Heading 20° left of runway, banking left and 8 seconds to the end of recording

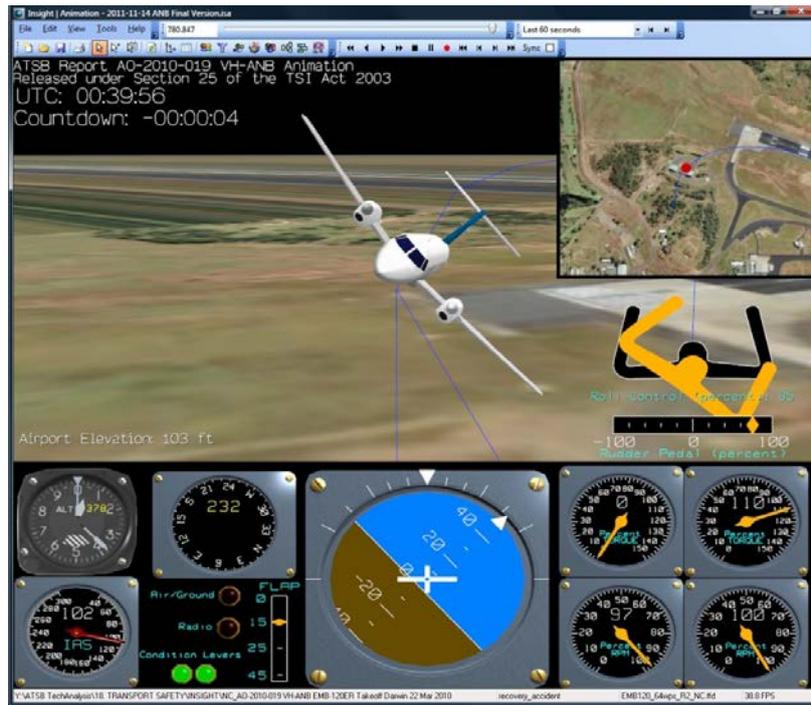
Figure C-5: Bank angle 50° left and 4 seconds to the end of recording
