**ANALYSIS**  
of  
**ACCIDENT MARTINAIR DC-10-30F, MP495**

**FARO, 21 DEC. 1992**

**Limited supplemental analysis  
including comments on the investigation**

**Limited Supplemental Analysis Of The Accident With Martinair DC-10-30F, MP495**

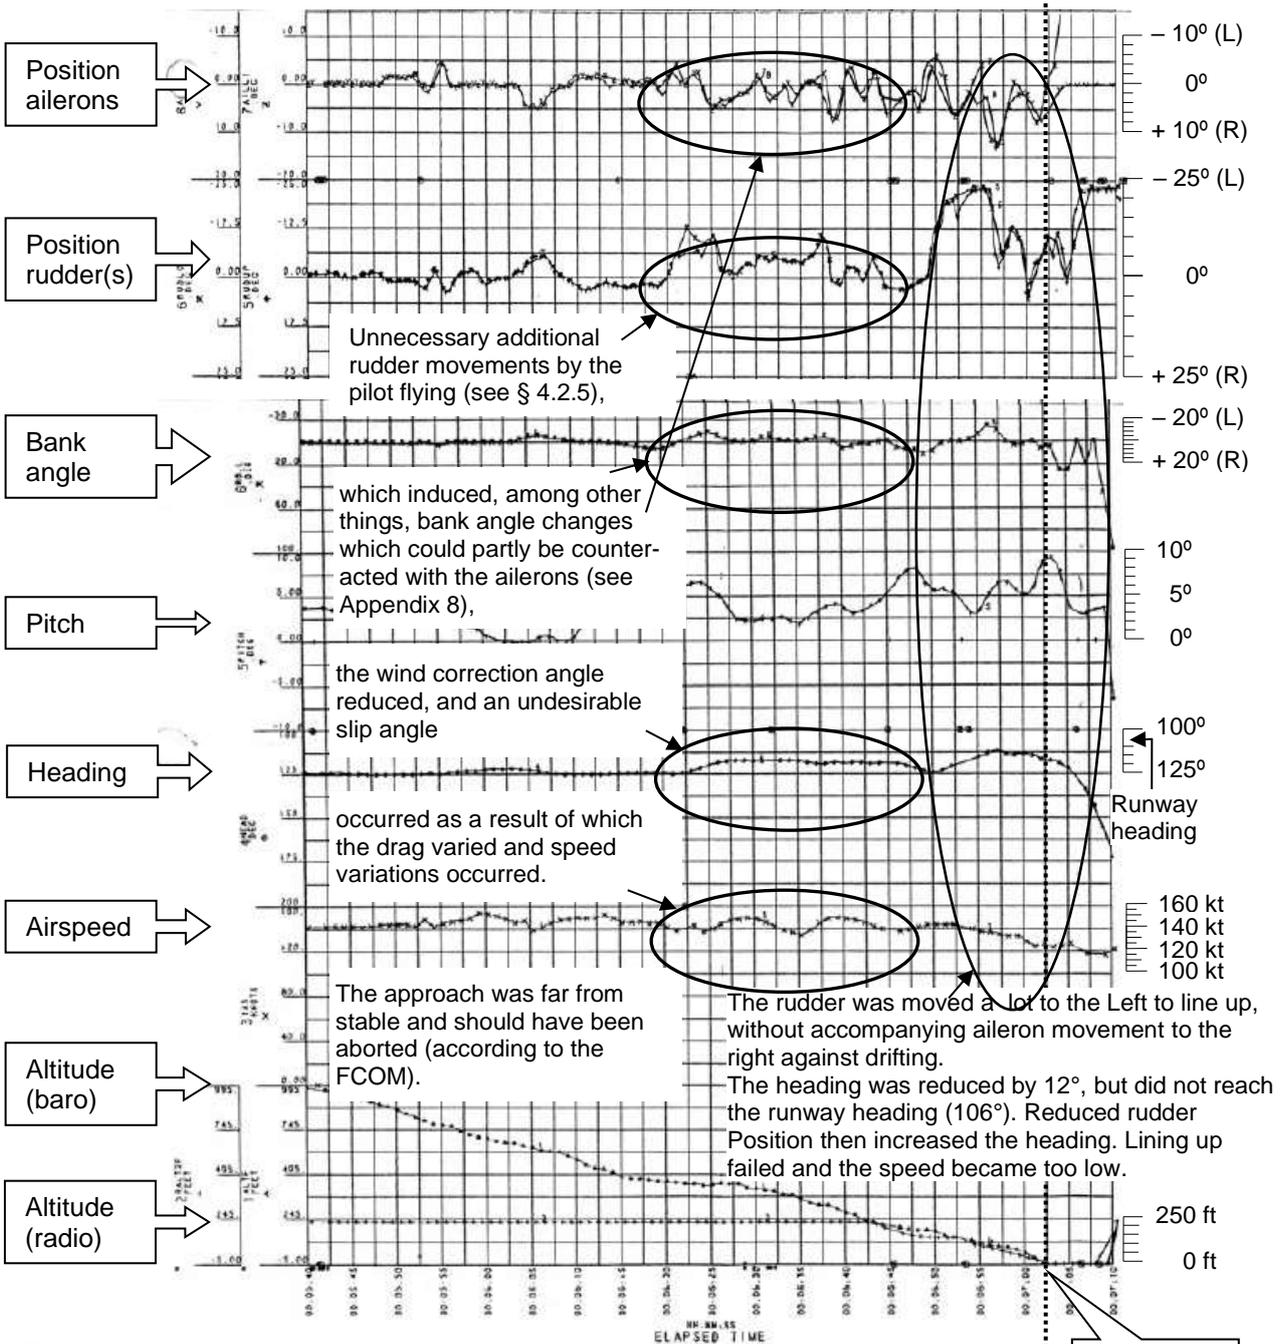
**Appendix 5. Combined DFDR graph for analysis**

Elapsed time +  
07:25:48 = Radar time  
+ 30 sec = UTC

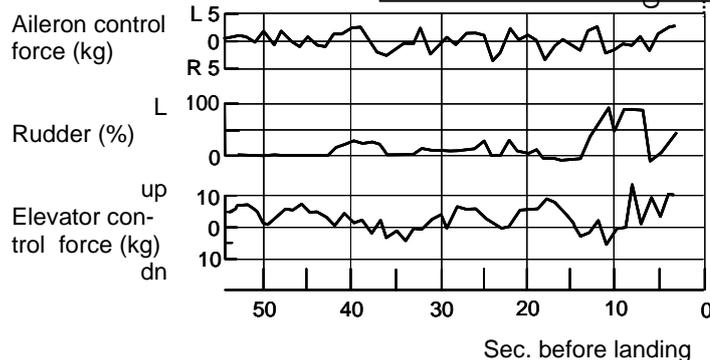
Control forces during the last 50 seconds of the flight, from the graphs in Appendix 6, Appendix 7 and Appendix 8 with the same time scale as the above graph..
