ANALYSIS

of the controllability of the crashed Saab SF-340B
at Schiphol Airport, 4 April 1994, during the final flight phase

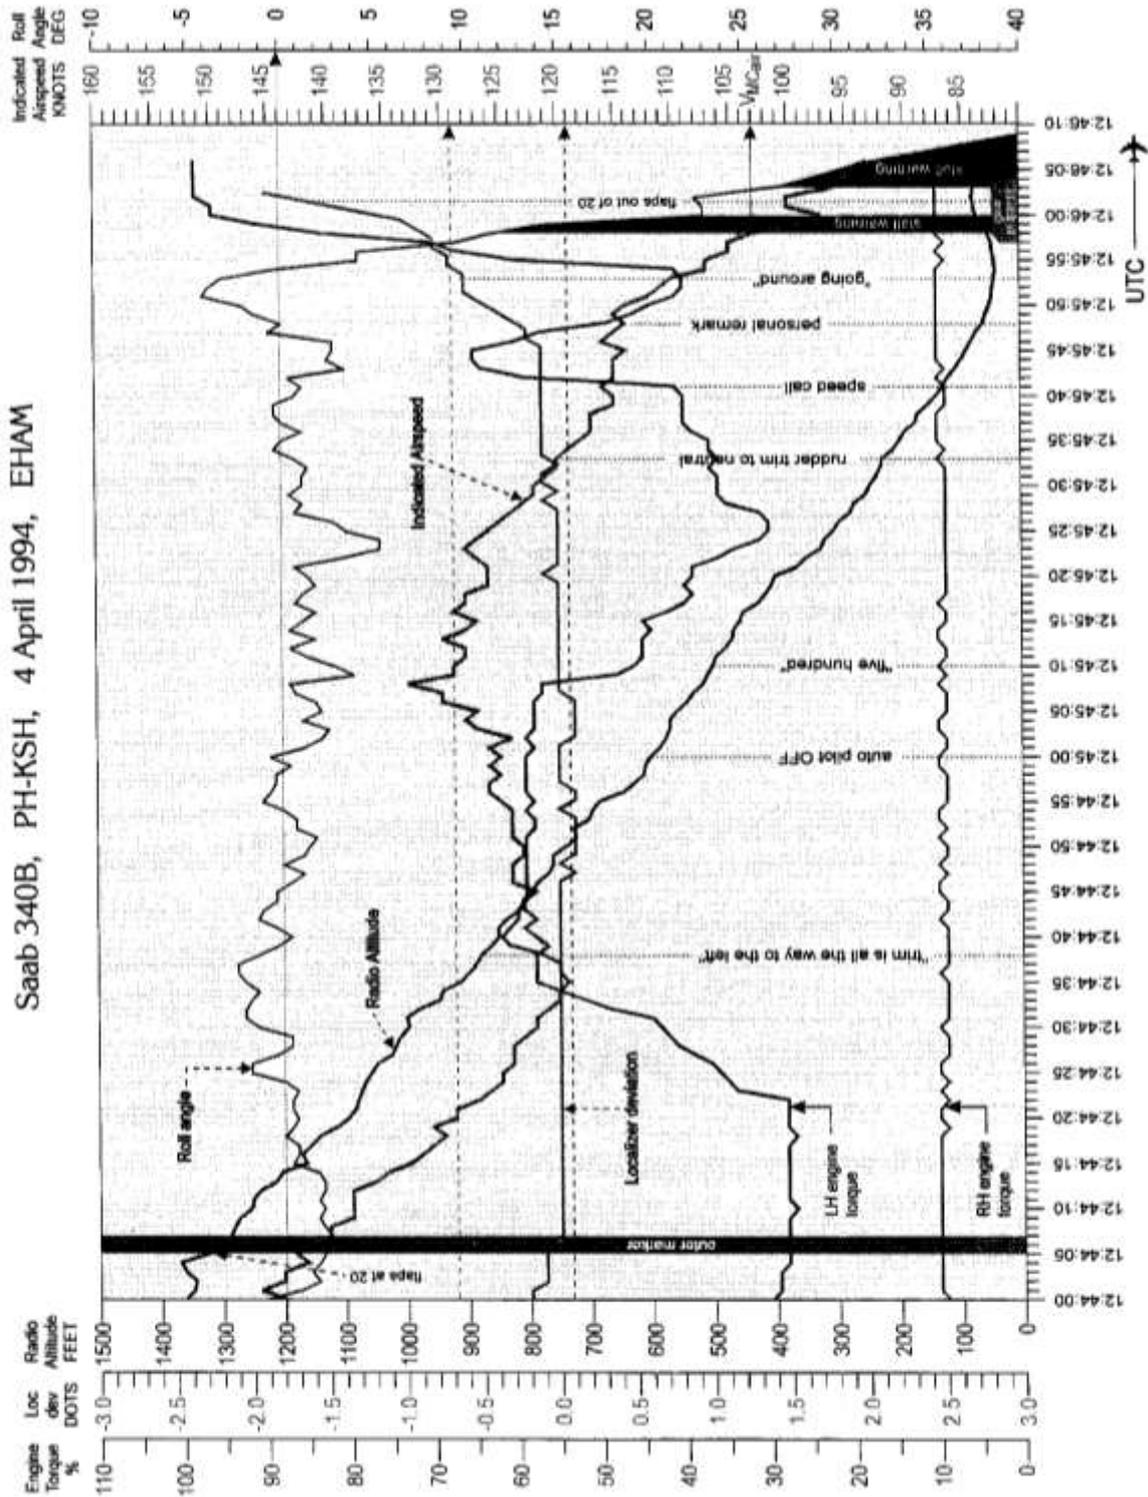
Attachment 2: Graph with bank angle and airspeed out of the Aircraft Accident Report.

The bank angle (roll angle) and airspeed data from this plot were copied into the plot in Attachment 1 on the previous page to allow for easier analysis. This plot is included for reference purposes only.
