Controllability of a Boeing 747-258F After Separation of Two Engines

4 October 1992, Amsterdam

**Including The Theory of Engine-Out Flight
And
Systemic Errors in Controlling Multi-Engine Airplanes
When Engine(s) Failed**

Harry Horlings
Graduate FTE USAF Test Pilot School

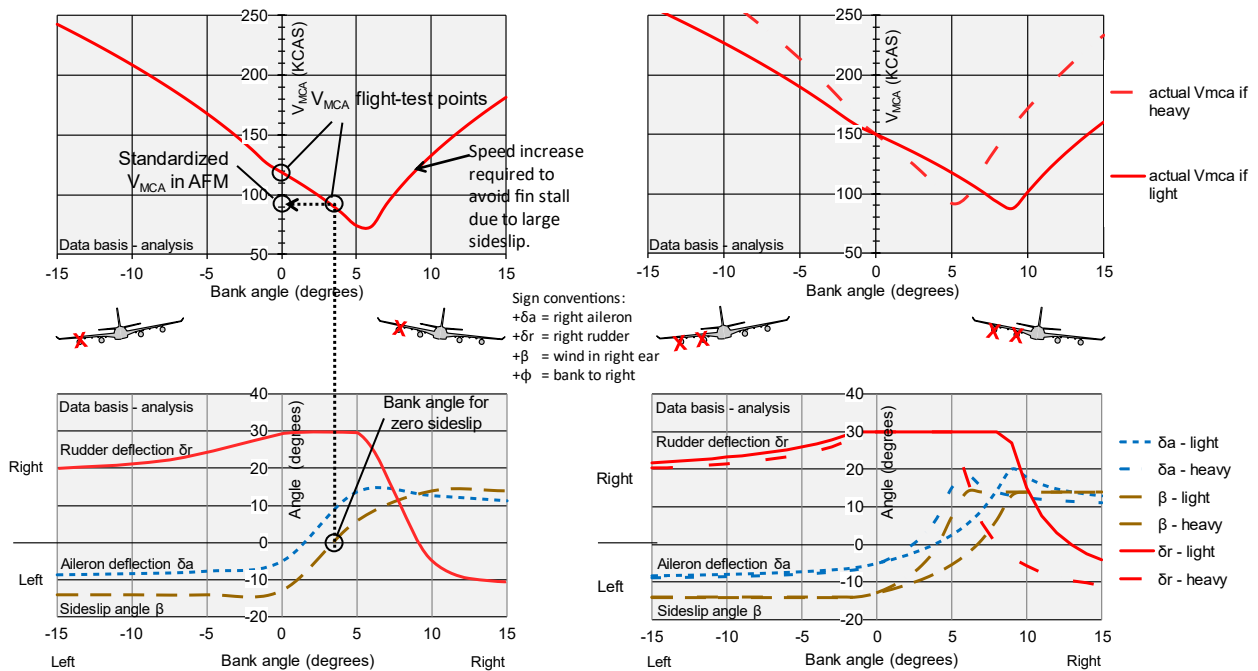
Figure 6. Effect of bank angle on V_{MCA} (top), and on the required control angle deflections and resulting sideslip (bottom) for OEI and TEI on left wing, other engines max. thrust.

3.3.3. **The Effect of Bank Angle On V_{MCA} .** The calculated graphs in the top of Figure 6 show the resulting minimum required airspeeds of a sample 4-engine airplane (like a Boeing 707) when OEI (the left engine #1) and when TEI (#1 and #2), and when maximum thrust is set on the engine(s) opposite of the inoperative engine(s). The graph on the right side also shows data for both high and low gross weights. The figures could not be recalculated for a Boeing 747-200, because its lateral-directional stability derivatives were not available. The airspeeds (q for dynamic pressure in Figure 5) shown in the top left and right graphs of Figure 6 are the **actual V_{MCA} 's** of the airplane for bank angles (ϕ) between -15° and $+15^\circ$ for the lowest gross weight (W , is mg in the side force equation in Figure 5).

by the FAA and EASA Flight Test Guides (lowest weight, aft cg, etc.), the sideslip angle β is zero when the bank angle is 3° away from the failed engine. At this bank angle, the drag is minimal, hence the remaining climb performance maximum. Therefore, the corresponding **actual V_{MCA}** (93 kt) will be published as the **standardized V_{MCA}** in the AFM (after extrapolating from the safe test altitude to sea level). The **actual V_{MCA}** , being the V_{MCA} that a pilot will experience in-flight, at bank angles other than the bank angle used for sizing the vertical tail and for measuring the standardized V_{MCA} during flight-testing (in this case $+3^\circ$), is calculated with up to

In addition, at $\approx 9^\circ$ of bank into the good engines the rudder deflection needs to be zero for balancing the forces and moments; the sideslip side force alone, caused by side force $W \cdot \sin \phi$, takes care of counteracting the asymmetrical thrust yawing moment (weathercock). Some test pilots will also determine this bank angle for zero rudder. At larger bank angles into the good engines, such as shown in Figure 7, the increasing sideslip side force due to the increased sideforce $W \cdot \sin \phi$ needs to be counteracted by an opposite side force: the rudder deflection needs to be reversed to avoid excessive yawing into the good engine(s). As the V-shaped lines in the top graphs of Figure 6 show, the **actual V_{MCA}** , being the airspeed required to keep the control deflections required for maintaining the equilibrium of forces and moments within their mechanical limits and the sideslip smaller than 14° , increases when the bank angle increases.

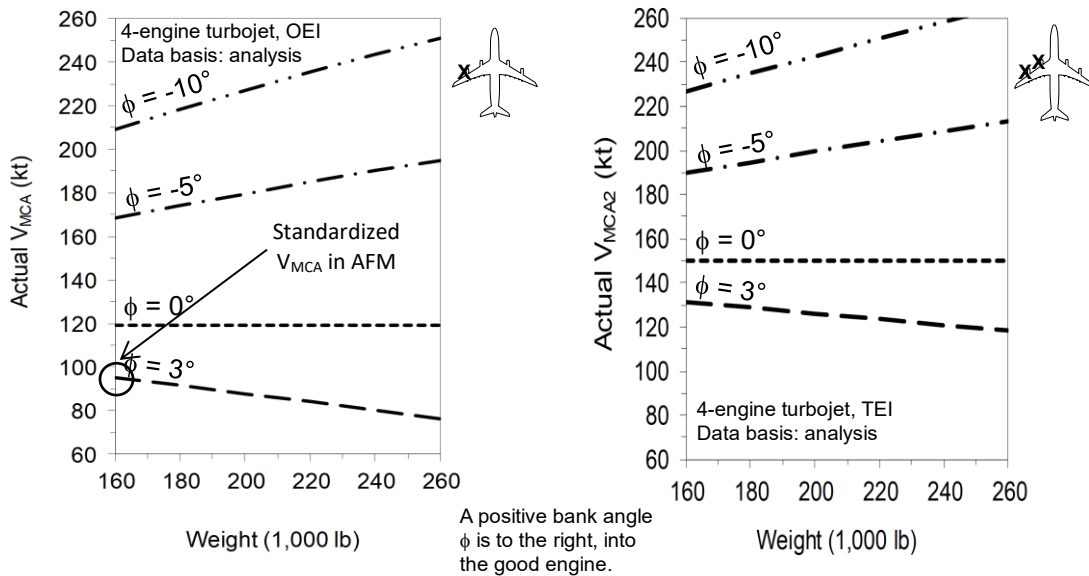
Figure 8. Effect of weight W on V_{MCA} of a sample 4-engine airplane for #1 (and #2) inoperative for several bank angles ϕ . Other engines max. thrust.

3.3.8. The Effect of Weight On V_{MCA} . The graphs in Figure 8 show the effect of weight for several bank angles of the same sample airplane. The airspeeds at the intersection of the bank angles with the ordinate, the vertical *actual* V_{MCA} axis, are the same as in Figure 6 above. Figure 8 is similar to the figure that Lockheed presents in the C-130 Performance Manual SMP777, and will also be similar to Boeing 747 data, as for any multi-engine airplane when an engine is inoperative, and the thrust of the opposite engine is maximum; only the numbers will be different.

When the wings are level (bank angle $\phi = 0^\circ$), weight has no effect on the side forces, because $\sin \phi$ in side force $W \cdot \sin \phi$ is zero. The asymmetrical thrust can only be counteracted by a side force due to rudder deflection, which results in a near -14° sideslip (wind in the left ear), which also causes much drag (see Figure 6 and Figure 3 above).

When banking into the inoperative engine (negative ϕ in this example in Figure 8), the *actual* V_{MCA} increases with weight. At the maximum weight of 260,000 lb, the *actual* V_{MCA} is ≈ 250 kt, 155 kt higher (!) than the standardized AFM-published V_{MCA} (see also Figure 6). When the bank angle is 3° into the good engine (as used during flight-testing this airplane), the *actual* V_{MCA} decreases with increasing weight. At this bank angle, V_{MCA} is highest at low weight, hence, low weight is the worst-case weight for V_{MCA} and safest to publish for whatever the weight of the airplane. This is the reason that V_{MCA} is determined at the lowest possible weight during flight-tests.

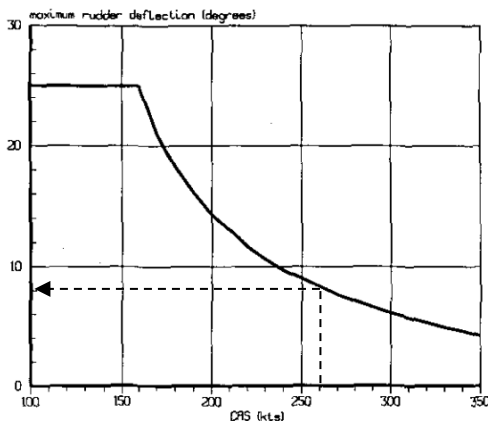
Figure 17. Rudder deflection as a function of air-speed with full rudder pedal.

5.4.20. **Rudder Ratio Changers** of the Boeing 747 reduce the deflection of the upper and lower rudders with increasing airspeed to keep the air loads on the fin with rudders within structural (design) limits. The (asymmetrical) engine thrust does not change with increasing airspeed, so the side force that the fin with rudder must be able to generate for counteracting an asymmetrical thrust condition, does not have to change with airspeed either. Since this force (horizontal lift) is proportional to the square of the airspeed ($\propto V^2$), the rudder deflection should decrease with airspeed as a quadratic function as well ($\propto 1/V^2$). This is achieved by the rudder ratio changers, as shown in Figure 17. The maximum available rudder yawing moment, required to counteract the thrust yawing moment, remains approximately equal to the maximum asymmetrical engine thrust yawing moment at all airspeeds. A pilot might not notice differences in directional control when using the rudder pedals at low and high speeds, and will not have to worry about overloading the fin at high speeds, not even with full rudder pedal input, although the AFM might still warn to avoid abrupt inputs. Small differences might occur between the deflection of the upper and lower rudders because they are controlled by two separate ratio systems, which are cross-connected to the left and right upper and lower pitot tubes and static pressure sources. This effect can be seen in the FDR data in Figure 18 when the rudder pedal input increases and hence the

5.6.3. As the EPR increased (① in Figure 18), so did the rudder pedal input (②) to counteract the thrust yawing moment. As shown, the rudder surface deflection did increase and reached the maximum 8° (③) as allowed by the rudder ratio system (Figure 17) during the final seconds of flight at an airspeed of 260 kt, although the EPR, and therewith the thrust yawing moment, had already decreased (④).

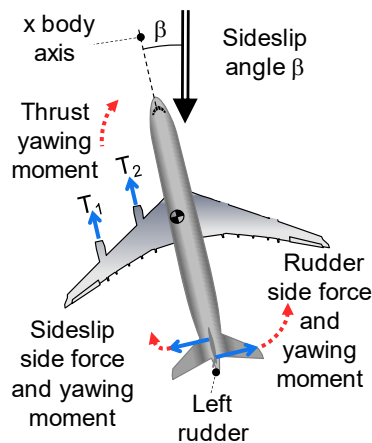
Figure 19. Most important directional forces and yawing moments during straight, engine-out flight, wings level.

5.4.21. **Directional Controllability Flight 1862.** After the separation of the right-wing engines, the asymmetrical thrust yawing moment generated by the engines on the left wing yaws the airplane to the right about the cg. The sideslip angle increases instantaneously (wind from the left), as does the drag.

fects/moments using the ailerons to re-establish straight flight. The rudder side force not only generates a yawing moment to counteract the thrust yawing moment, but also accelerates the airplane sideways, reversing and increasing the sideslip angle, in this case to the right. The sideslip angle increases until the increasing opposite side force due to this sideslip, generated by the fin and airplane fuselage, equals the rudder side force. The side force due to sideslip however, also generates a sideslip yawing moment that enhances the thrust yawing moment (Figure 19). The rudder deflection needs to be increased to overcome this as well; the sideslip increases. Both the resulting sum of the side forces, generated by the vertical tail by rudder and sideslip, and the resulting sum of the yawing moments, generated by the thrust and the vertical tail by rudder and sideslip, must be zero to achieve an equilibrium of

After the separation of the engines, the directional equilibrium of forces and moments could obviously be re-established and maintained at the current airspeed and the (less than maximum) asymmetrical thrust setting of engines 1 and 2; the airplane remained controllable, but a sideslip angle remained, as shown in Figure 19 and in Figure 6 for straight wings-level flight. Hence, the drag was not minimal, which in this case was not bad; the airplane had to descend for the return to the airport anyway.

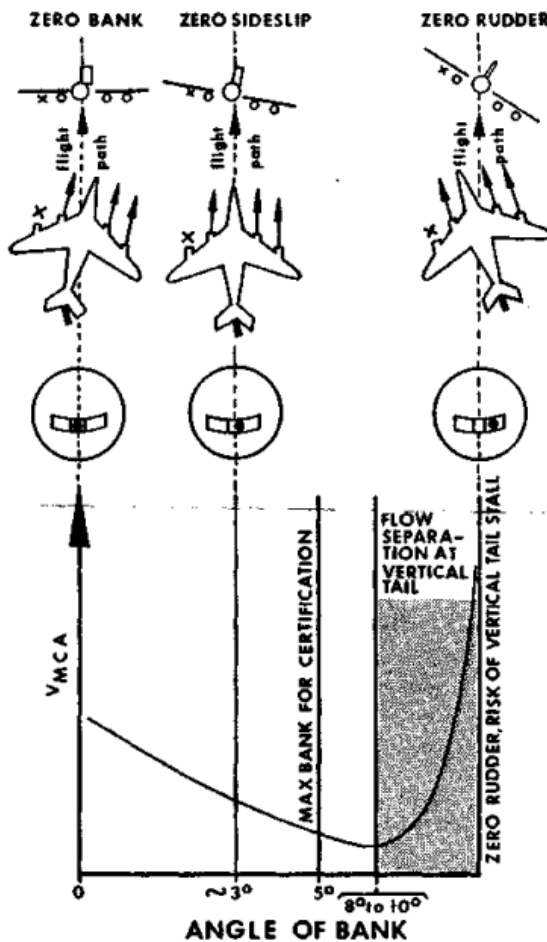
Figure 20. V_{MCA} versus Angle of Bank, Engine #1 inoperative, KLM DC-8-50 Flight Crew Reference Guide, 1988.

5.8.25. **KLM Flight Crew Reference Guide.** The V_{MCA} 's of a DC-8-50, also a 4-engine turbofan airplane, were published in § 1.3.2 of the KLM Flight Crew Reference Guide (FCRG – ref. 22) of 1988, as shown in Table 1 above.

This table confirms that the effect of bank angle is indeed large for this swept-wing airplane; V_{MCA} with one engine inoperative when the wings are kept level is 32 kt higher than published V_{MCA} (which is determined with a 5° bank angle into the good engines for smallest sideslip, hence lowest drag, and max. climb performance). The published V_{MCA} when

two engines are inoperative (V_{MCA2}), which is also determined with 5° of bank into the good engines, is 155 kt and increases to an *actual* value of 191 kt when the wings are kept level. The *actual* V_{MCA2} at other bank angles into or away from the inoperative engines will be much higher than 191 kt for a DC-8, as might have become clear in the analysis presented in § 3.3.3 above and shown in the adjacent Figure 20 for a turn into the good engines. This figure confirms what is shown in the calculated Figure 6 on page 19 above, for engine #1 inoperative.
