National Transportation Safety Board Aviation Accident Final Report

Location:	Addison, Texas	Accident Number:	CEN19MA190
Date & Time:	June 30, 2019, 09:11 Local	Registration:	N534FF
Aircraft:	Textron Aviation B-300	Aircraft Damage:	Destroyed
Defining Event:	Loss of control in flight	Injuries:	10 Fatal
Flight Conducted Under:	Part 91: General aviation - Personal

Performance Study
CEN19MA190, Textron Aviation B300, N534FF

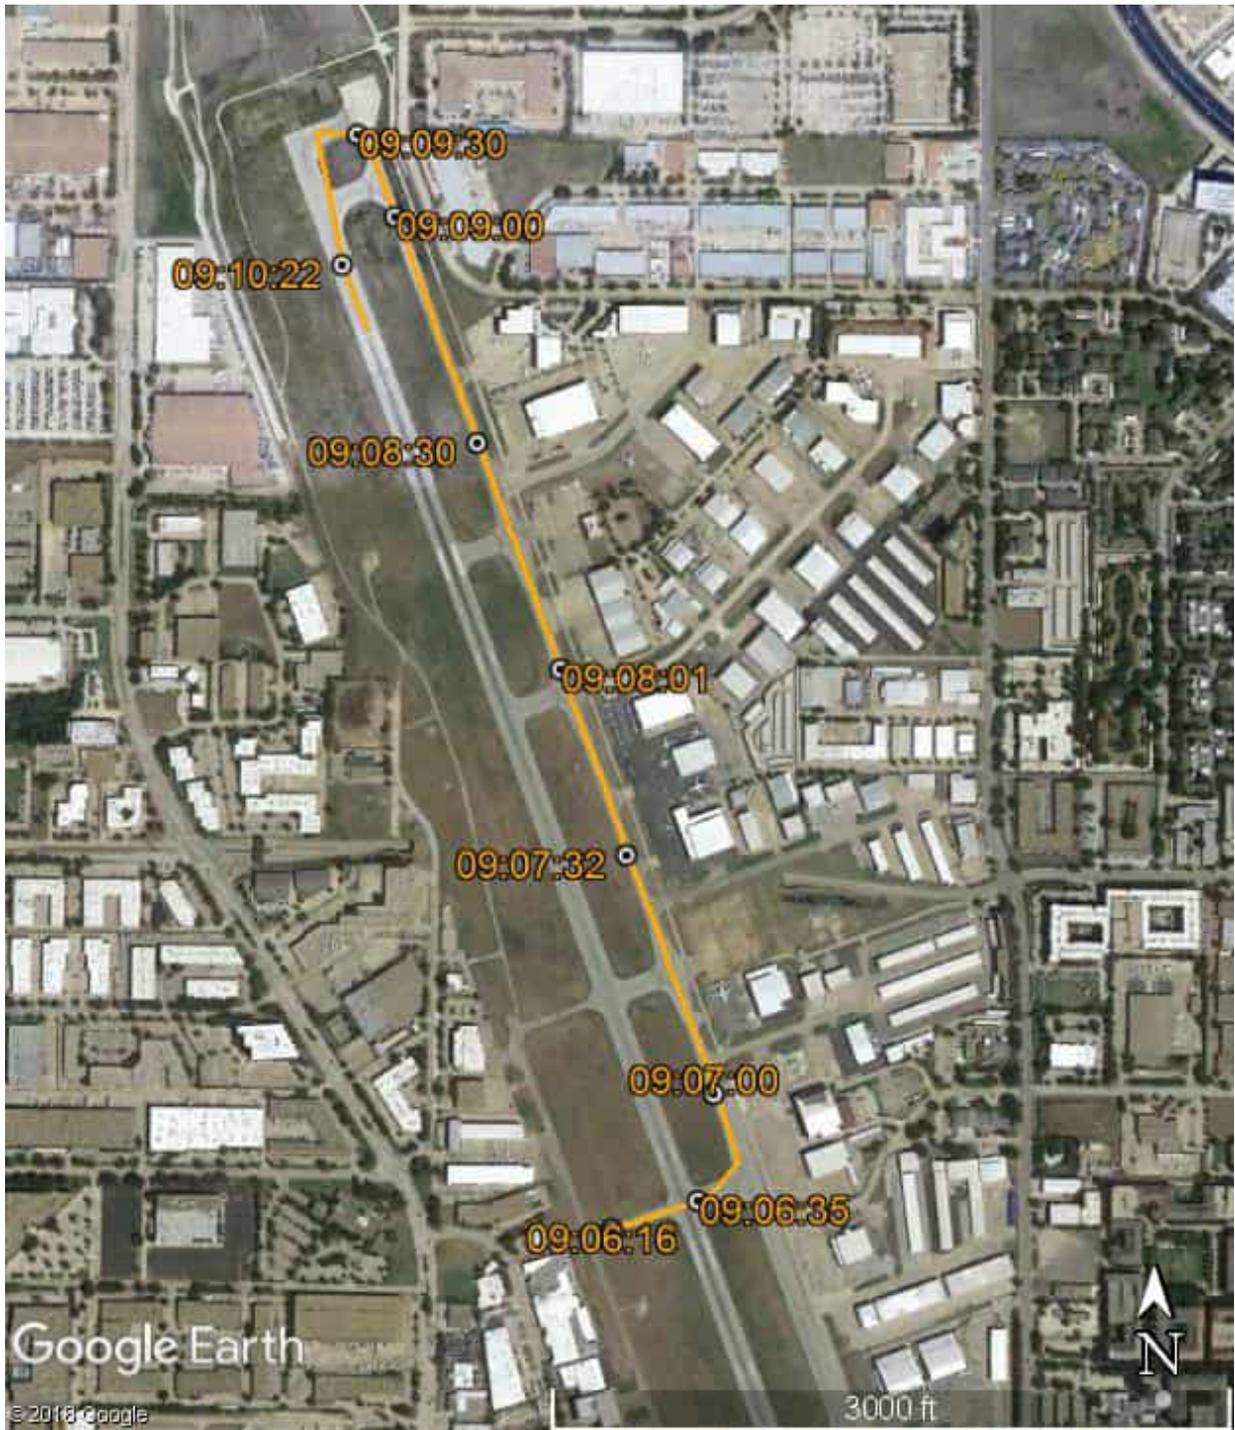
Figure 1. Accident airplane's taxi path from ADS-B.

The airplane was taking off from runway 15 at Addison Airport at the time of the accident. Runway 15 is 7,203 ft long and 100 ft wide and it has a 979 ft long displaced threshold. Its elevation is 636 ft. Figure 1 shows the airplane taxiing from the west side of the airport, across taxiway E, and then north to the displaced threshold of runway 15. The total time from the start of the ADS-B data to runway 15 was less than four minutes.

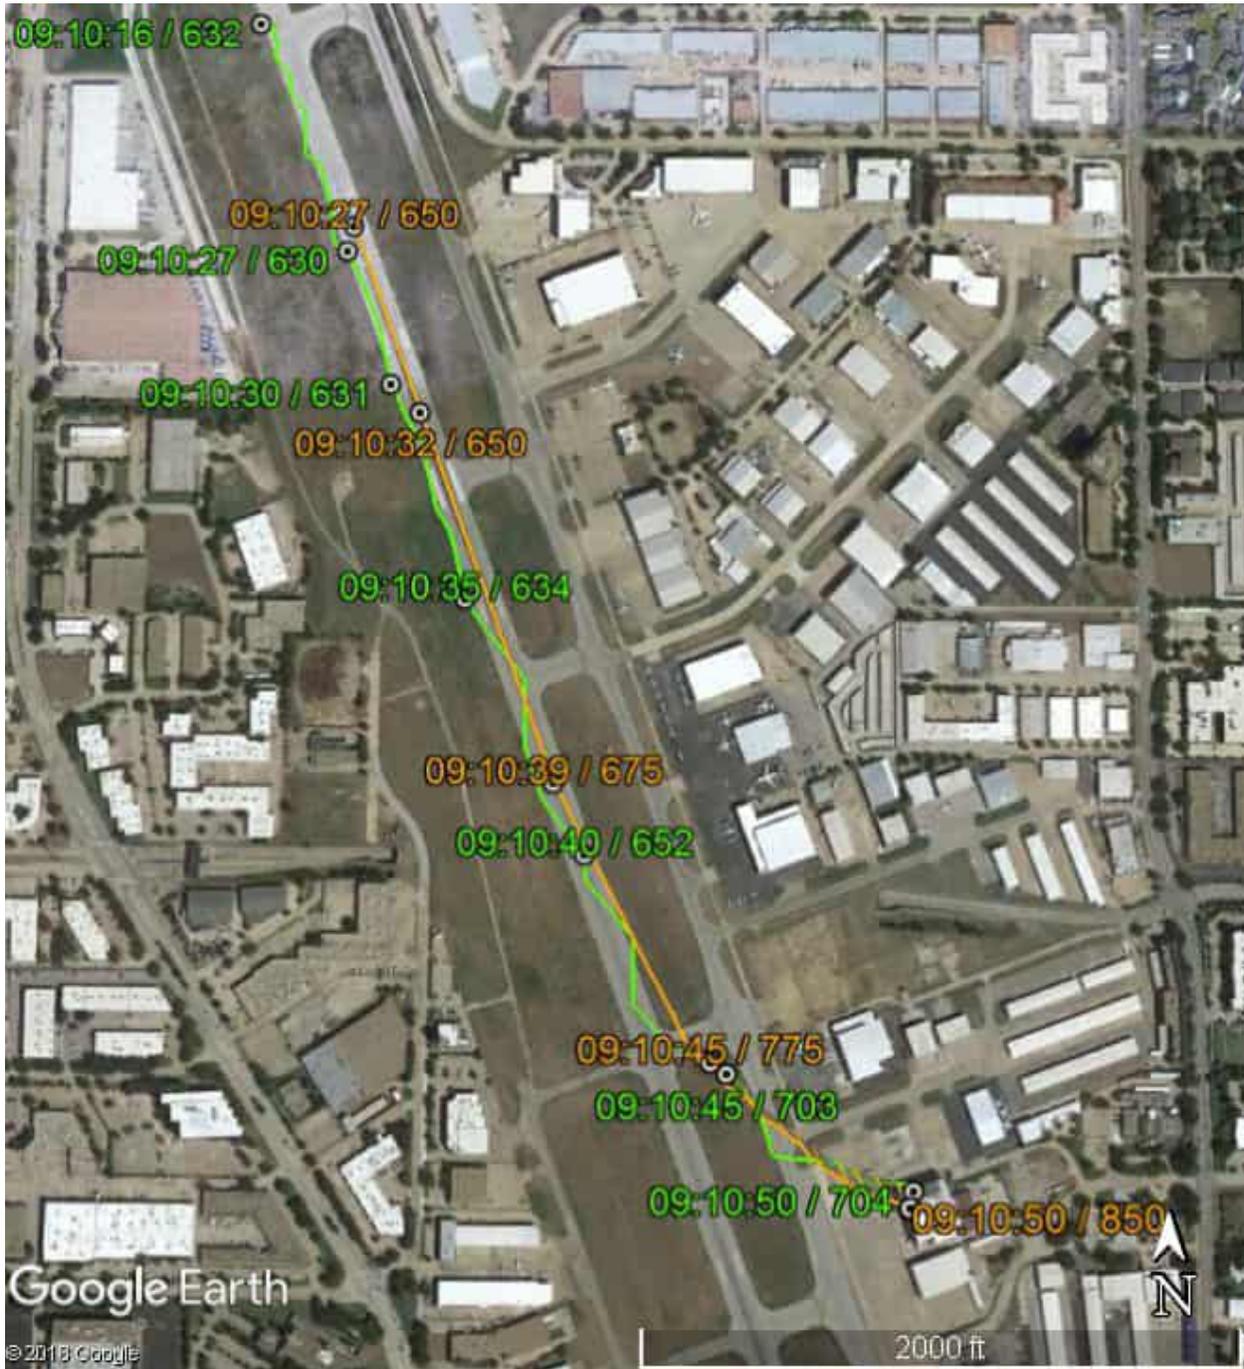
Figure 2. Accident flight with ADS-B data in orange and TAWS data in green.

Figure 2 shows a both the ADS-B (orange) and TAWS (green) data of the take-off roll and accident flight. The ADS-B data was sparse during the take-off roll, only recording five data points between 09:10:27 and 09:10:44. The ADS-B path tracked the centerline of the runway until sometime between 09:10:39 and 09:10:44 when it began to track left. The TAWS data was recorded once a second, but the position data was noisy and showed the airplane path along the right edge of the

runway, which was not consistent with the ADS-B data and other accident accounts. However, the TAWS path did track left in a similar manner to the ADS-B data, beginning just after 09:10:40. Additionally, the TAWS recorded roll angles (which will be discussed further in *Reduction in left engine propeller speed*), and it recorded a left roll beginning about the same time. Note the recorded altitudes between the two data sources also disagreed throughout the flight.

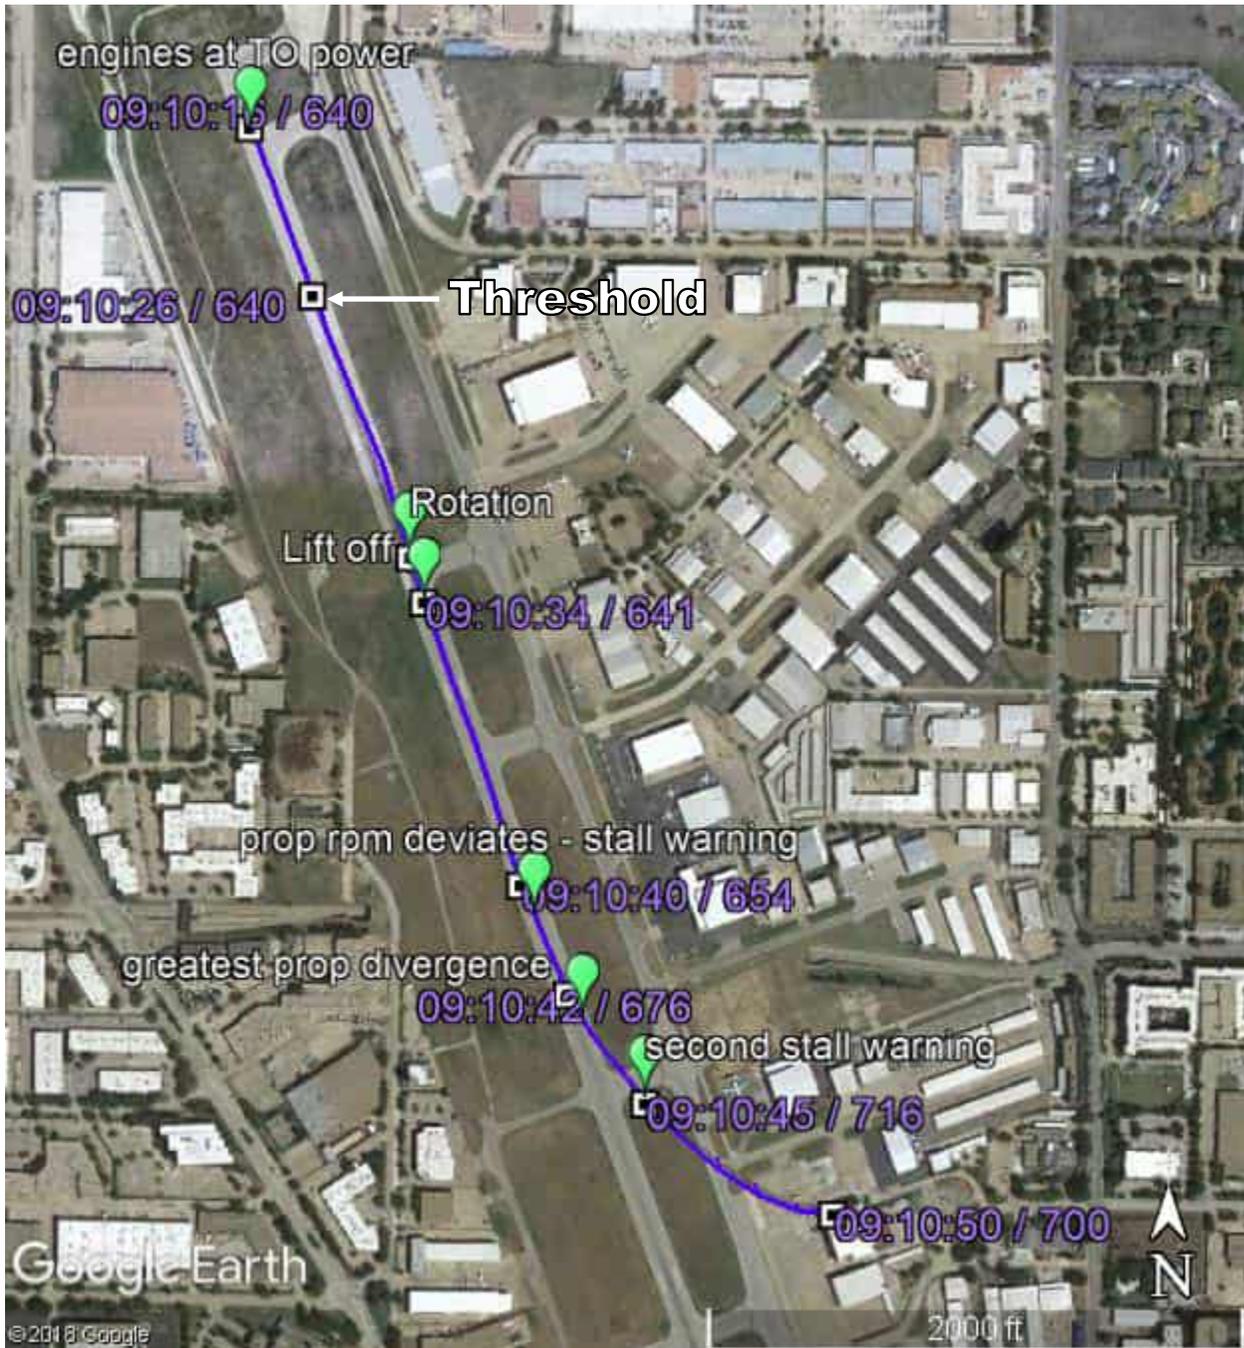
Figure 4. Composite flight path with CVR events.

Figure 3 shows TAWS and ADS-B data before the runway threshold. The engines were at take-off power at 09:10:16. There was no ADS-B data between 09:10:10 and 09:10:22, and so ADS-B could not be used to determine the location of the beginning of the ground roll. TAWS data was recorded during this time, but the latitude and longitude were irregular. Therefore, the TAWS data was shifted to align with the runway centerline to be consistent with the ADS-B data and the beginning of the ground roll was determined to be at 09:10:16, about 700 ft before the threshold of runway 15. The composite path, shown in purple, is a combination of the ADS-B and TAWS data.

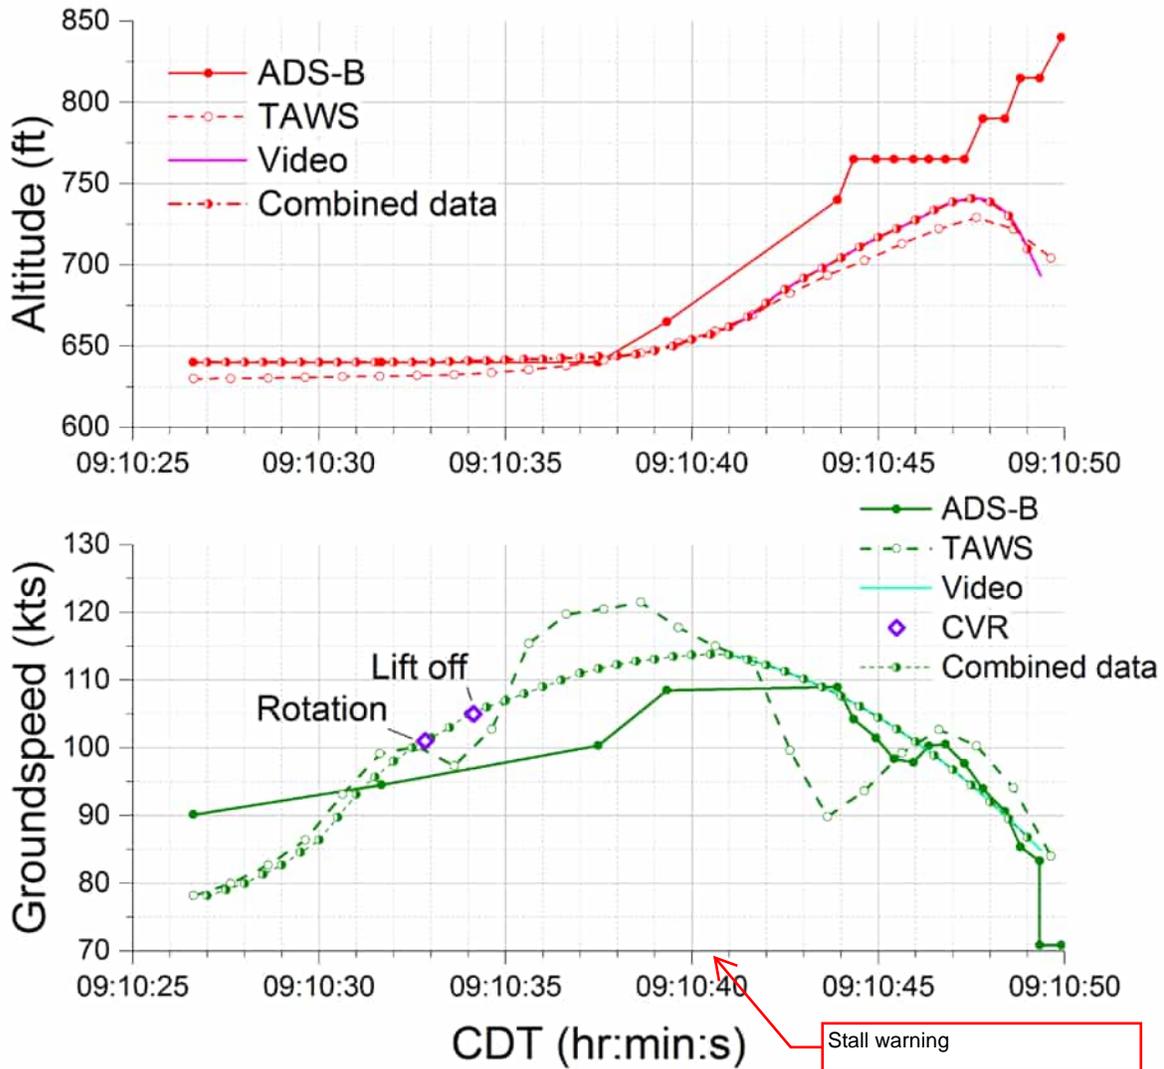
Figure 5. Accident flight altitude and groundspeed from multiple sources.

The altitude for the composite path is shown in Figure 5 with the recorded altitude from ADS-B, TAWS, and the video analysis (height above ground plus a ground elevation of 640 ft). Also included is the calculated groundspeed from ADS-B, a smoothed TAWS track, the video analysis, and the CVR groundspeed estimate at rotation and lift-off. The composite flight path altitude and groundspeed derived from the recorded data are labeled as “combined” in the figure. Data from the CVR and video analysis were weighted heavily, but ADS-B and TAWS data were also incorporated.
